## Building Inspection Report

Inspection Date: Tue, 18 Feb 2025

Property Address: 62 Hutt St, NORTHAM, WA, 6401, Australia

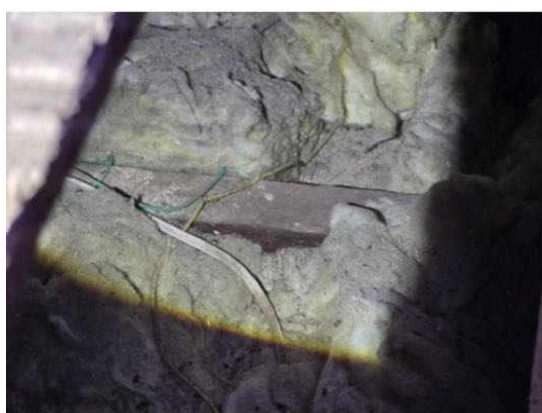
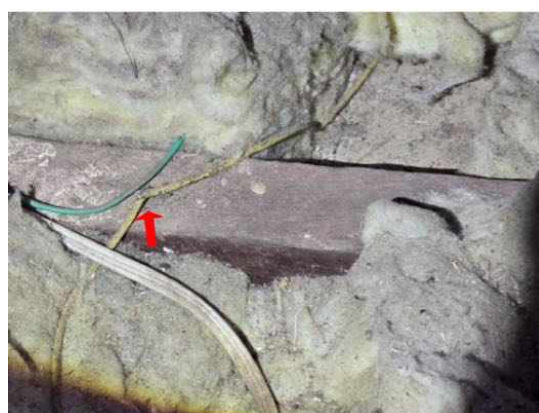
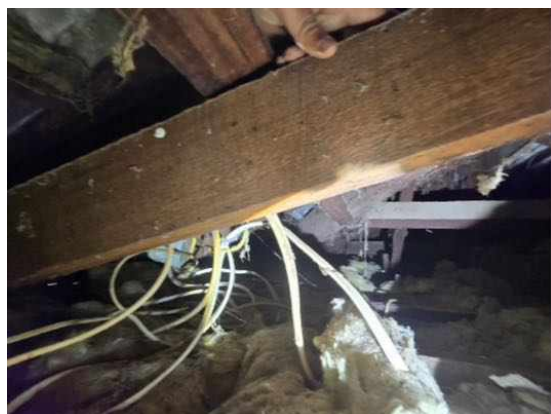
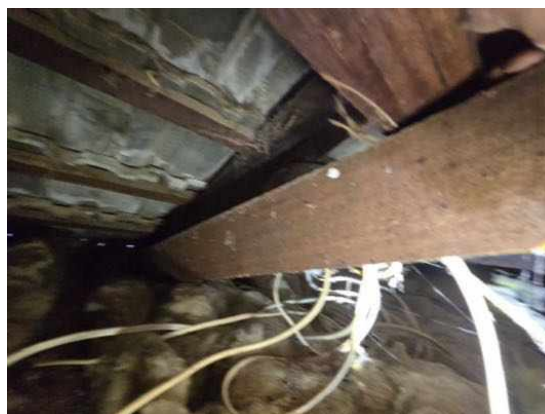
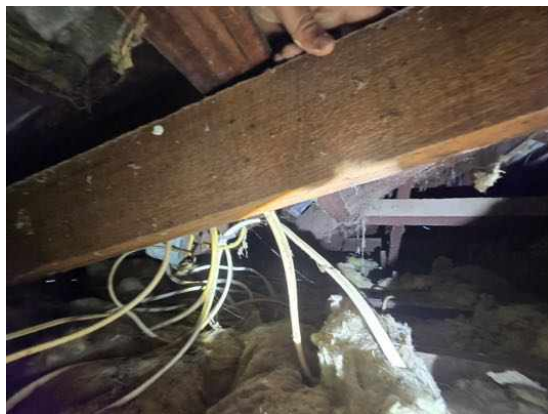
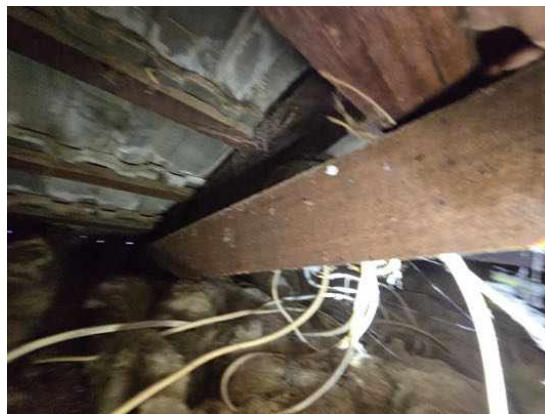
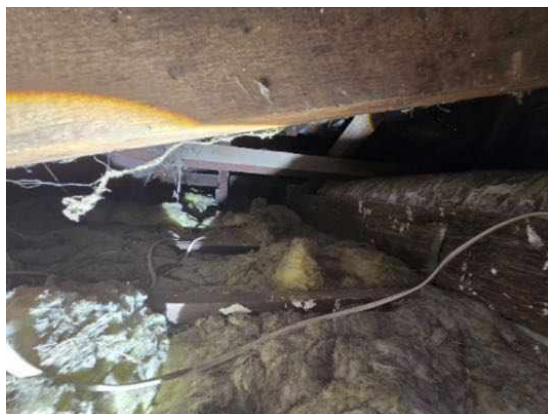
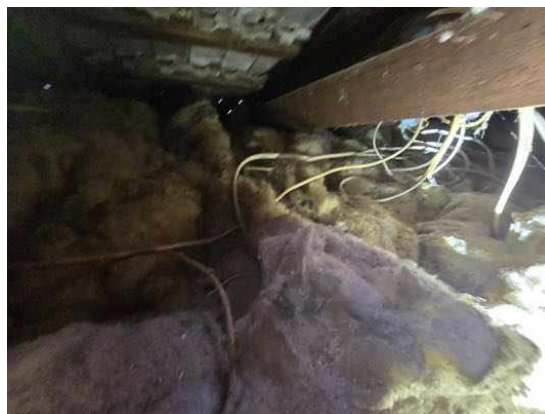
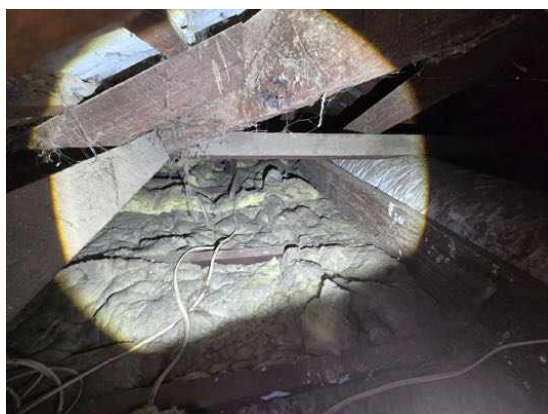
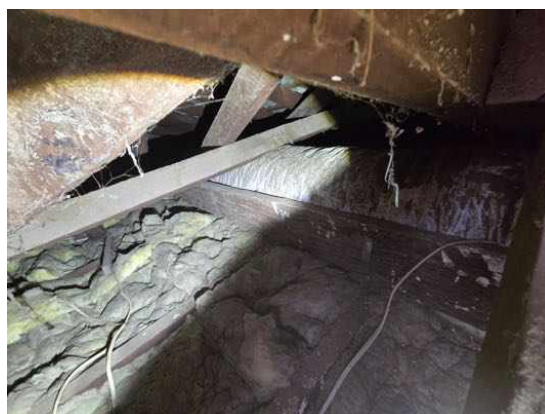
#### Defects 1.01

| Location: | Roof Void > Rear, Centre |
| Finding: | Electrical wires exposed |
| Information: | Exposed electrical wiring was identified. Exposed electrical wiring represents a potential safety hazard including for fire and personal contact. Contact a licensed electrician urgently for further inspection investigation and rectification. |

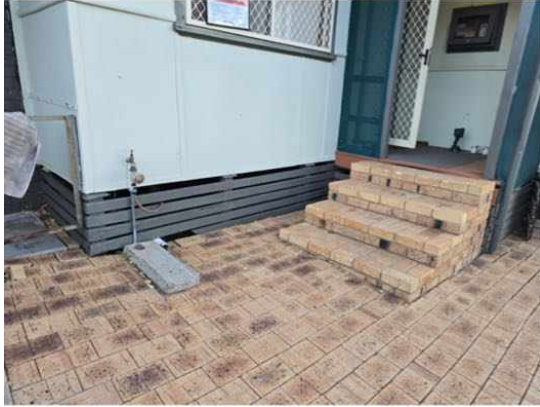
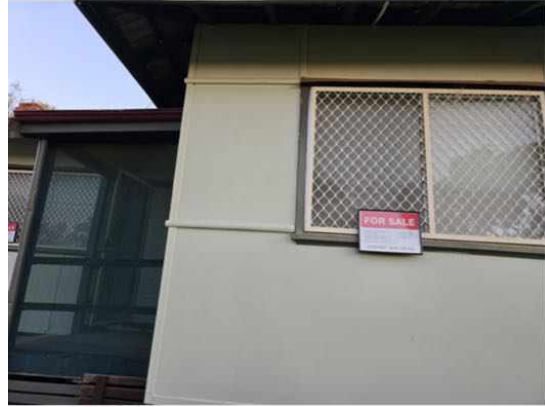
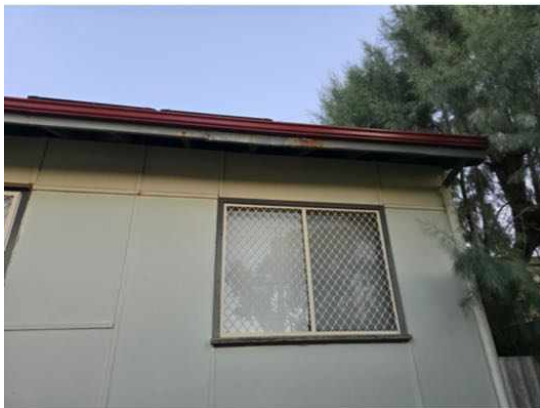
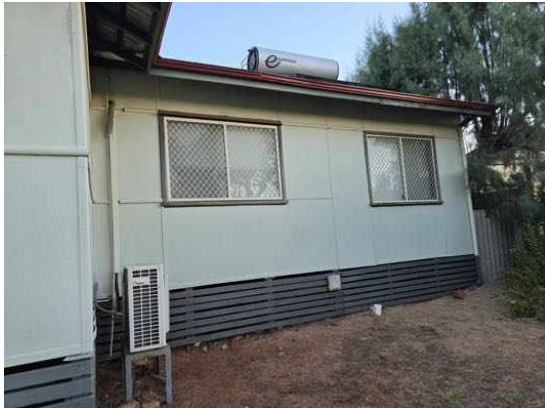
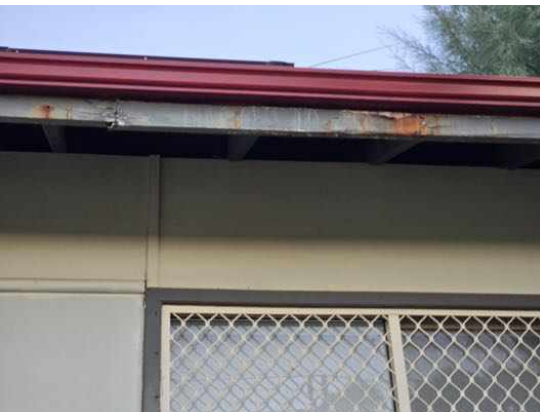
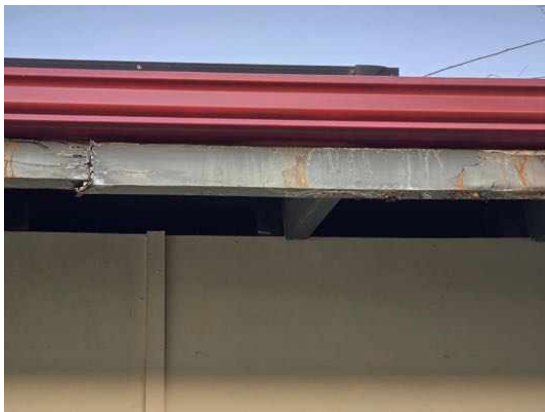
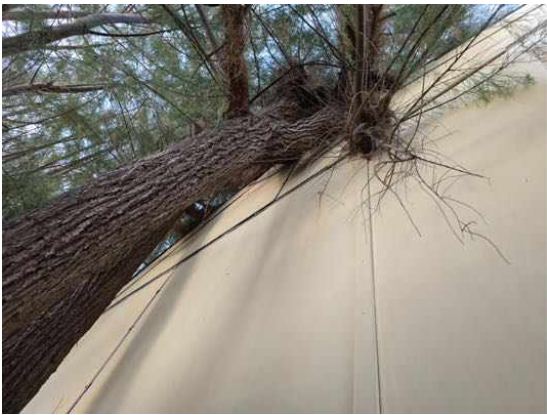
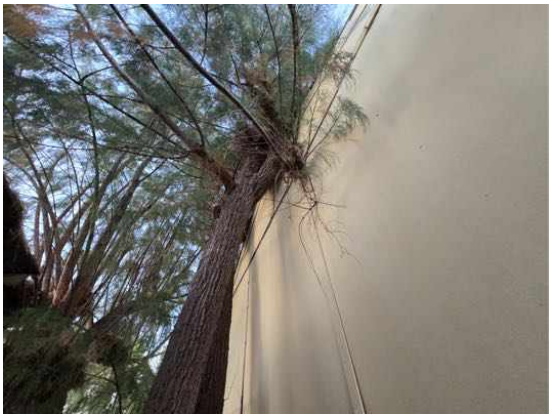
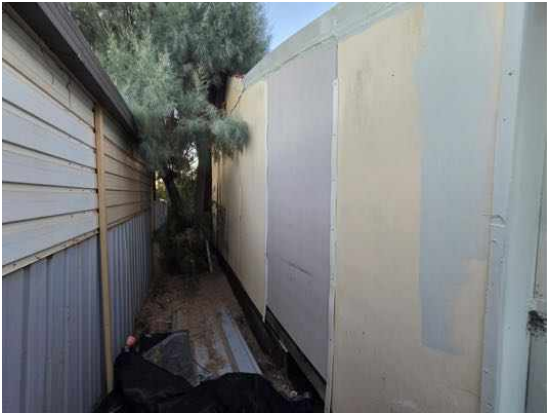
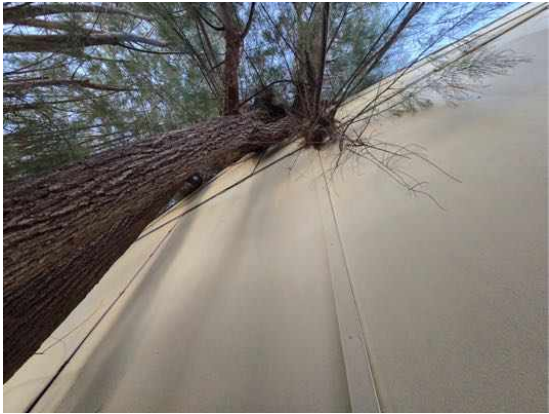
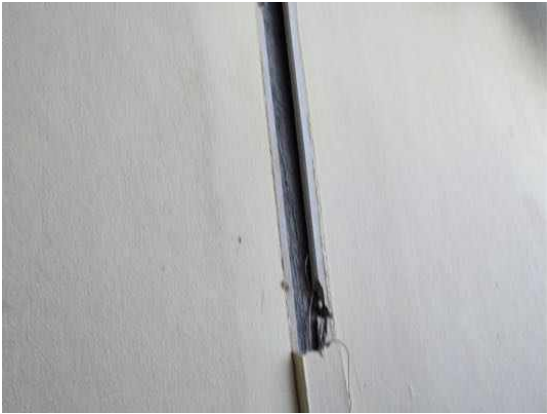
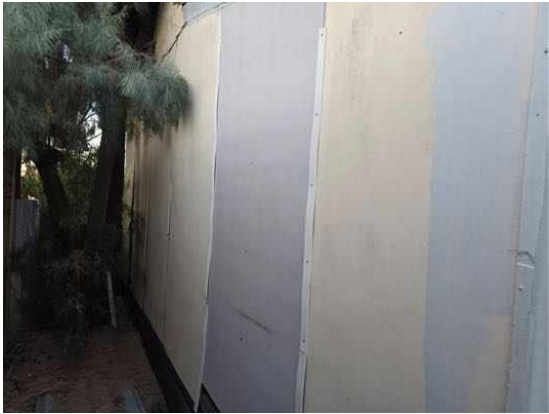
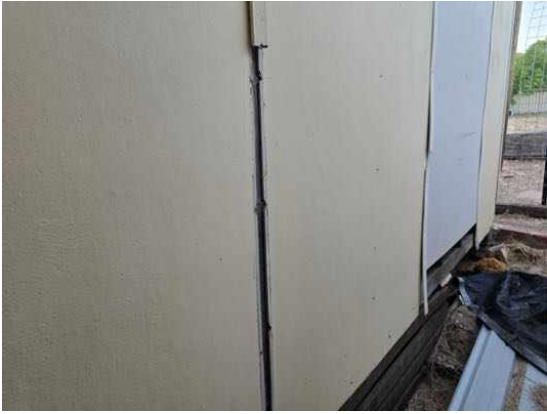
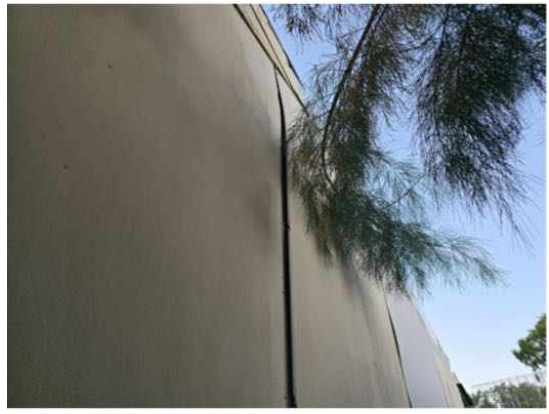
## Defects 1.02

| Location: | Exterior Walls > All Areas |
| Finding: | Asbestos - Suspected ACM Identified on Site |
| Information: | Reporting on Asbestos is outside the Scope of this Report. This suspected defect is highlighted as a caution only. We suspect, based on our experience in the building industry, that there is a higher risk of the identified building element containing asbestos. |

As Asbestos Reporting is outside the scope of this report, we advise that you consider a separate Asbestos Inspection and Condition Audit, which can include the taking of samples for definitive confirmation of the presence of Asbestos.

In the interim, the client is advised to act with caution, especially when considering any damage to building materials general wear and tear renovations extensions demolition and general maintenance activities due to the suspected presence of Asbestos.

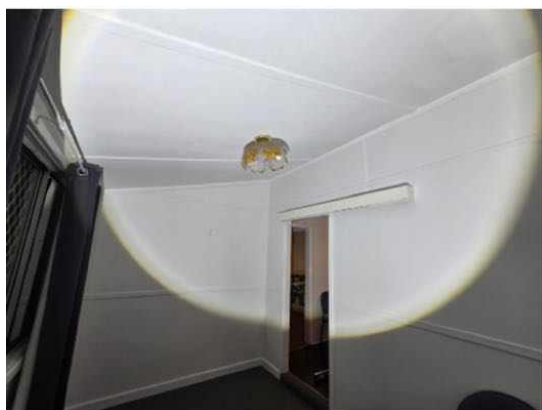
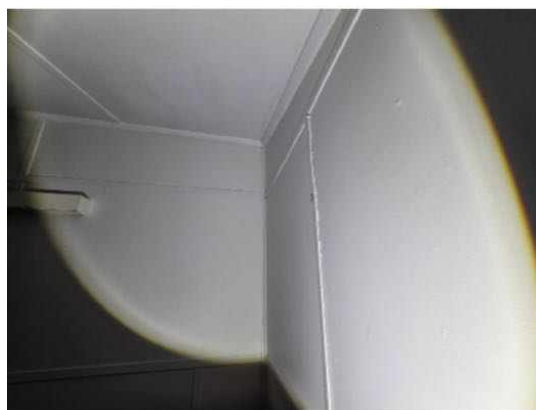
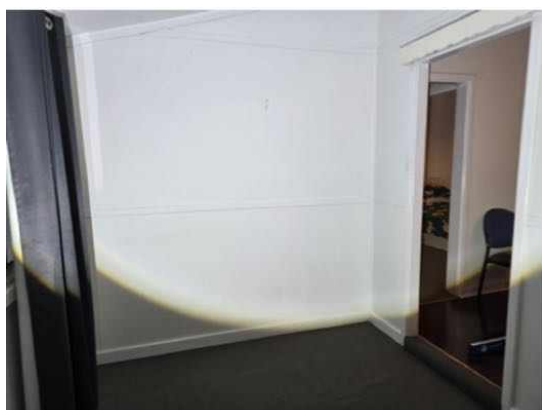
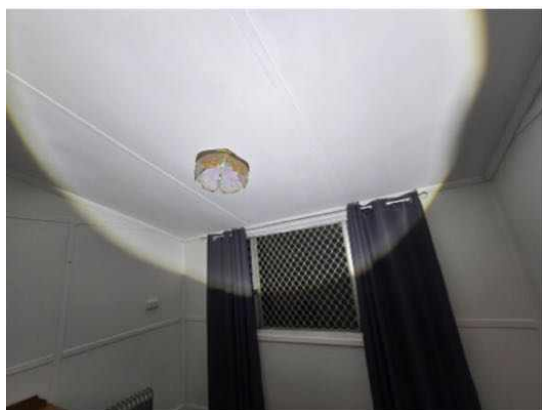
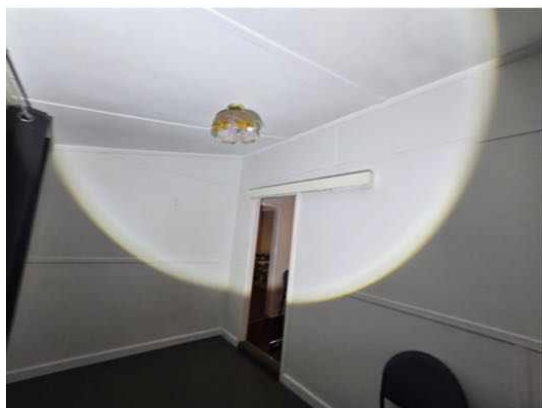
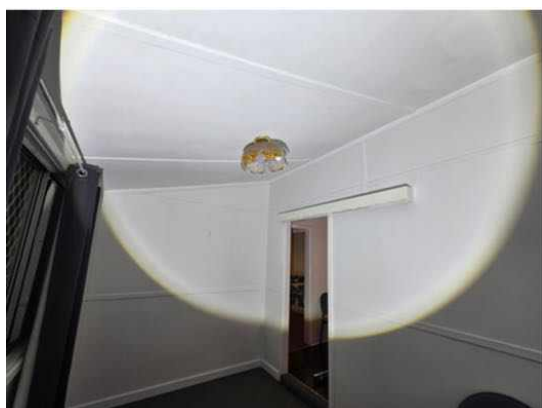
Defects 1.03

| Location: | Internal Walls > Centre Right,Rear Right |
| Finding: | Asbestos - Suspected ACM Identified on Site |
| Information: | Reporting on Asbestos is outside the Scope of this Report. This suspected defect is highlighted as a caution only. We suspect, based on our experience in the building industry, that there is a higher risk of the identified building element containing asbestos. |

As Asbestos Reporting is outside the scope of this report, we advise that you consider a separate Asbestos Inspection and Condition Audit, which can include the taking of samples for definitive confirmation of the presence of Asbestos.

In the interim, the client is advised to act with caution, especially when considering any damage to building materials general wear and tear renovations extensions demolition and general maintenance activities due to the suspected presence of Asbestos.

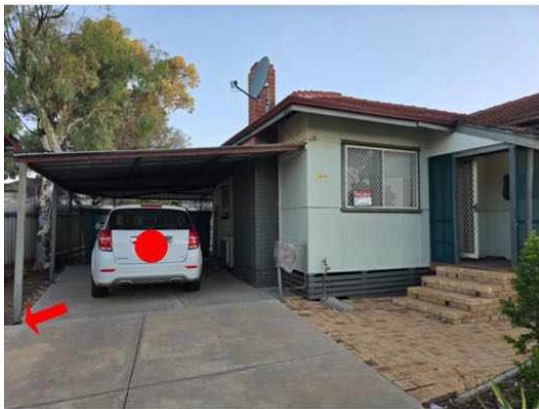
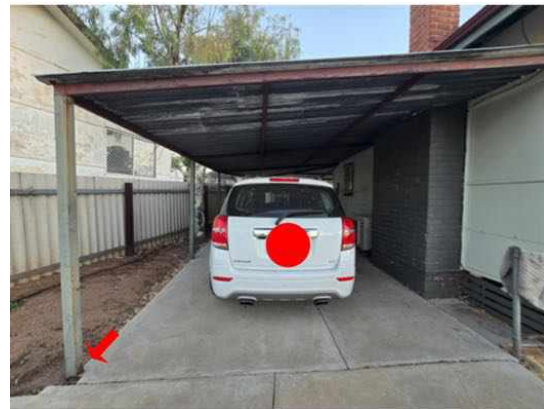
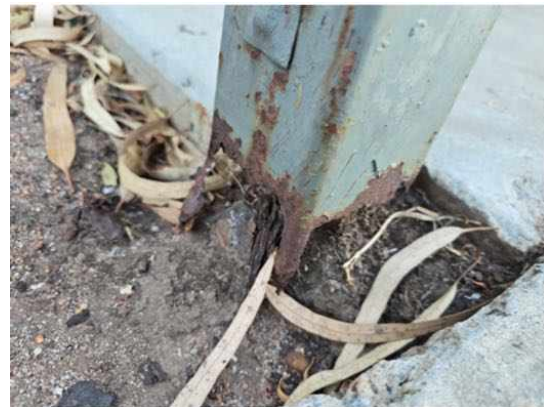
### Defects 2.01

| Location: | Carport > Front Left |
| Finding: | Post/Column - Severely Rusted or corroded at base (Carport) |
| Information: | Post/Column of the carport shows evidence of severe rusting and corrosion, which is likely to have developed as a result of excessive exposure to moisture and or inadequate coatings. |

As surface rust provides no protection to the underlying iron, the deteriorating condition is likely to worsen structural integrity if not addressed in the short-term future.

Base of the column/post fully corroded away which requires replacement on urgent basis to restore the structural integrity.

Where possible, the use of galvanized (treated) metals or aluminium coated metals aid in rust prevention, as does regular general maintenance. Rust formation can be controlled with coatings, such as paint, that isolate the iron from the environment.

Rusting and corrosion should be managed by ideally removing or limiting the affected surface from exposure to moisture. A registered builder may be appointed to replace any building elements that have been severely affected by rust or water damage.

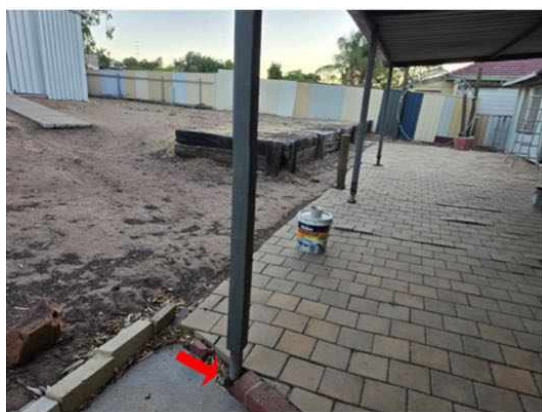
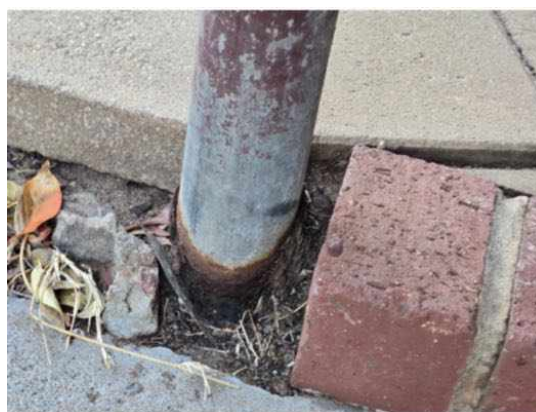
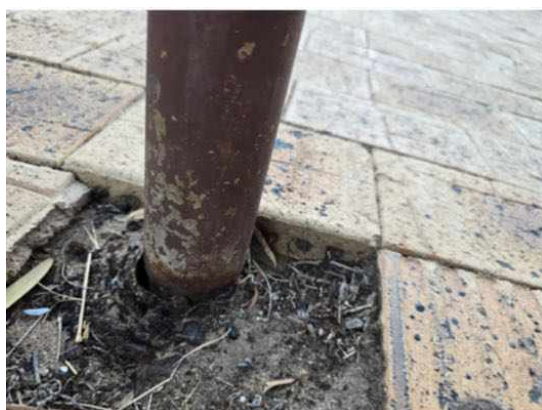
## Defects 2.02

| Location: | Rear Patio > Rear Left |
| Finding: | Post/Column - Severely Rusted or corroded at base (rear patio area) |
| Information: | Post/Column of the rear Patio shows evidence of severe rusting and corrosion, which is likely to have developed as a result of excessive exposure to moisture and or inadequate coatings. |

As surface rust provides no protection to the underlying iron, the deteriorating condition is likely to worsen structural integrity if not addressed in the short-term future.

Base of the column/post fully corroded away which requires replacement on urgent basis to restore the structural integrity.

Where possible, the use of galvanized (treated) metals or aluminium coated metals aid in rust prevention, as does regular general maintenance. Rust formation can be controlled with coatings, such as paint, that isolate the iron from the environment.

Rusting and corrosion should be managed by ideally removing or limiting the affected surface from exposure to moisture. A registered builder may be appointed to replace any building elements that have been severely affected by rust or water damage.

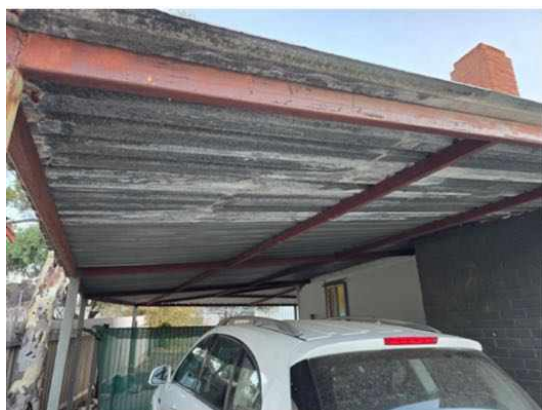
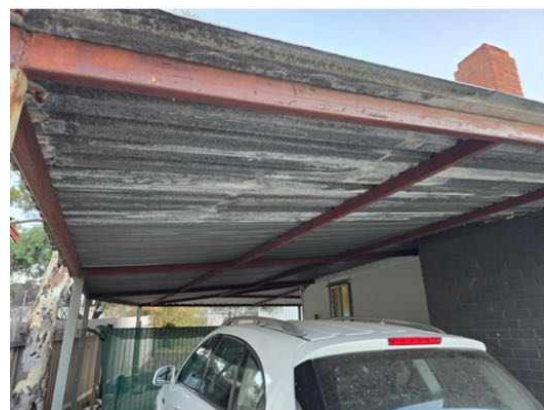
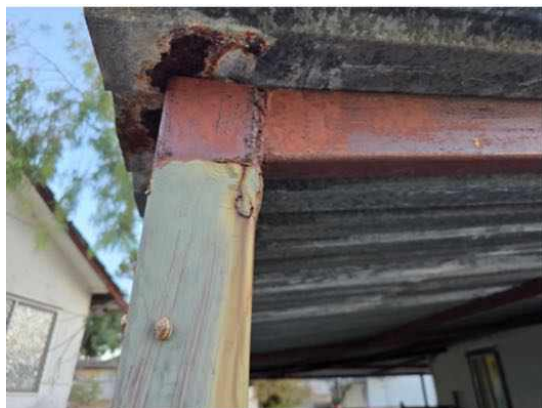
### Defects 3.01

| Location: | Carport > Front Left |
| Finding: | Carport Roof Steel Rafter - Rusted or corroded (non-severe) |
| Information: | Carport Roof Truss shows evidence of rusting and corrosion, which is likely to have developed as a result of excessive exposure to moisture and or inadequate coatings. |

As surface rust provides no protection to the underlying iron, the deteriorating condition is likely to worsen if not addressed in the short-term future.

Where possible, the use of galvanized (treated) metals or aluminium coated metals aid in rust prevention, as does regular general maintenance. Rust formation can be controlled with coatings, such as paint, that isolate the iron from the environment.

Rusting and corrosion should be managed by ideally removing or limiting the affected surface from exposure to moisture. A registered builder may be appointed to replace any building elements that have been severely affected by rust or water damage.

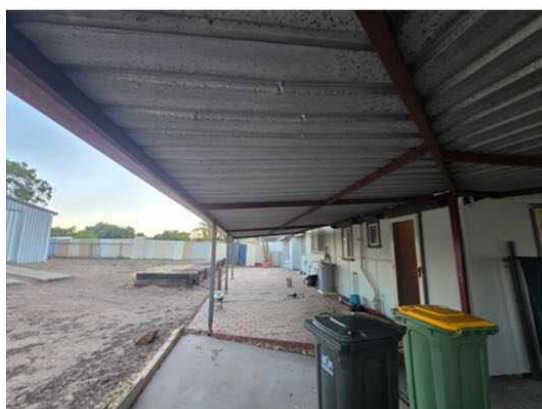
### Defects 3.02

| Location: | Rear Patio > Rear Left |
| Finding: | Patio Roof Truss - Rusted or corroded (non-severe) |
| Information: | Rear Patio Roof Steel Rafter shows evidence of rusting and corrosion, which is likely to have developed as a result of excessive exposure to moisture and or inadequate coatings. |

As surface rust provides no protection to the underlying iron, the deteriorating condition is likely to worsen if not addressed in the short-term future.

Where possible, the use of galvanized (treated) metals or aluminium coated metals aid in rust prevention, as does regular general maintenance. Rust formation can be controlled with coatings, such as paint, that isolate the iron from the environment.

Rusting and corrosion should be managed by ideally removing or limiting the affected surface from exposure to moisture. A registered builder may be appointed to replace any building elements that have been severely affected by rust or water damage.

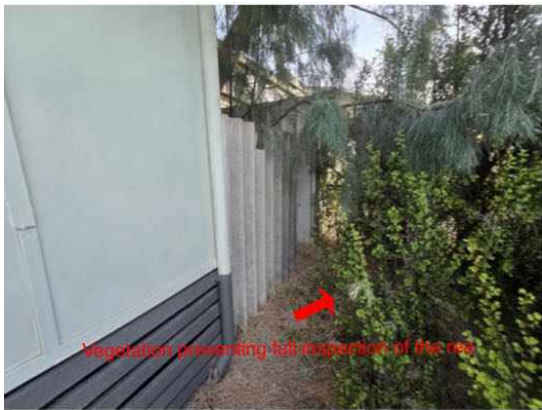
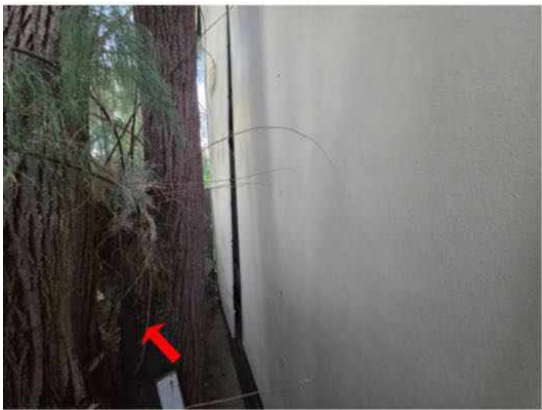
Building: Main Building  
Location: All Areas > All Areas  
Finding: Additional Photos - Obstructions and Limitations  
Information: These photographs are an indication of the obstructions and limitations which impeded full inspection of the property at the time of inspection. These obstructions can hide an array of defects and should be removed to allow full inspection to be carried out. A re-inspection is recommended once the areas are made accessible.

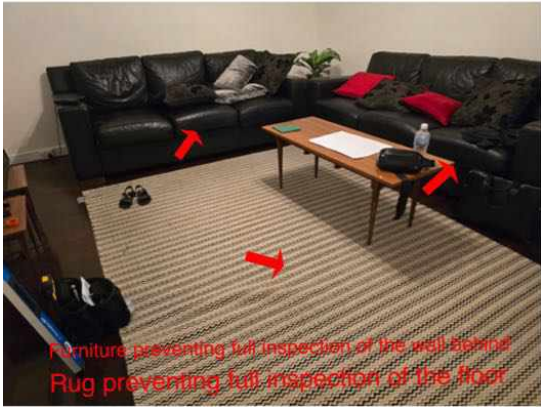
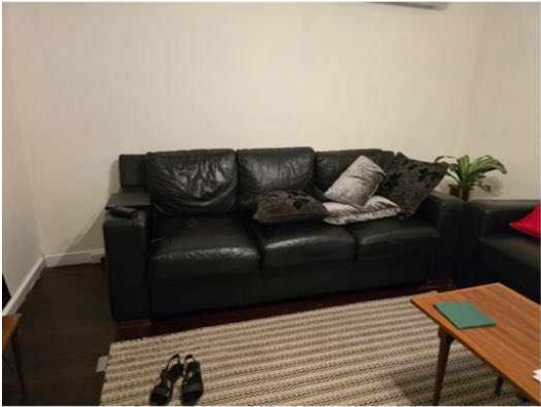
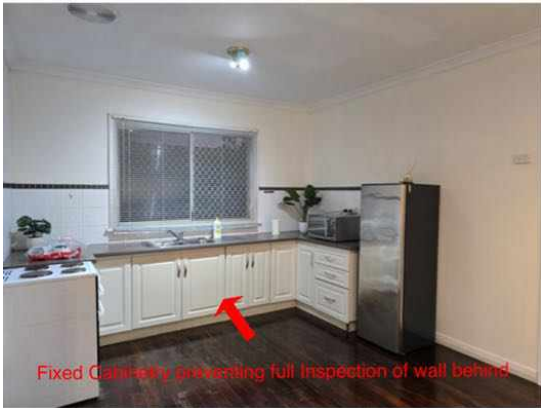
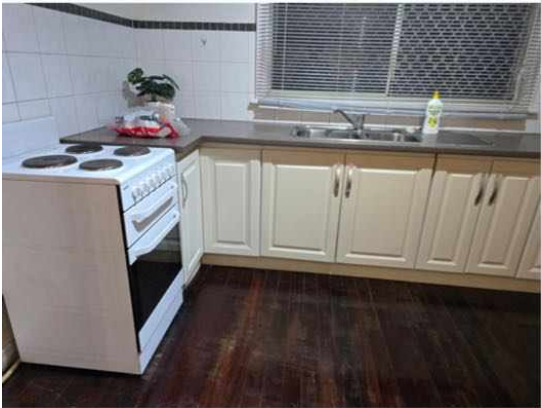
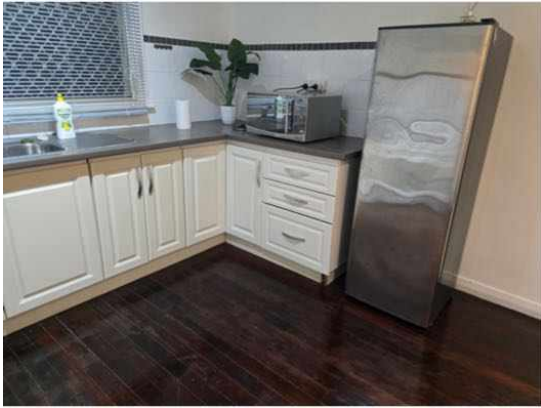
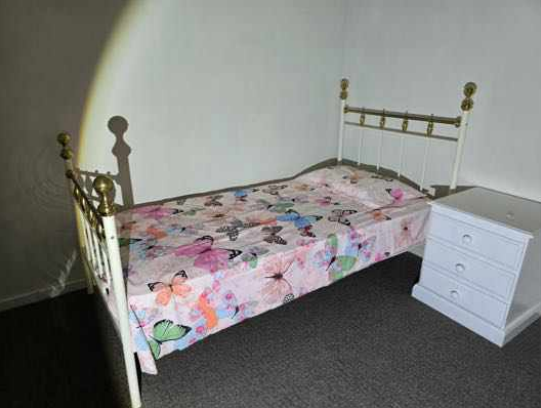
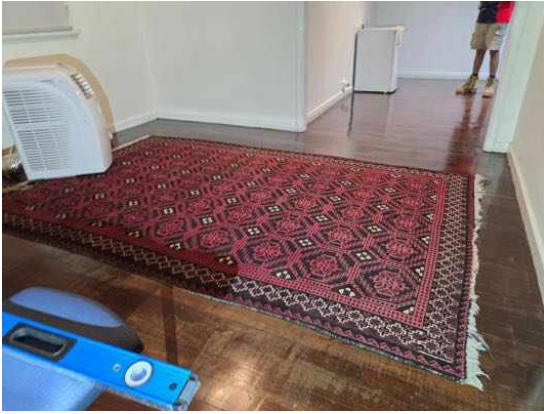
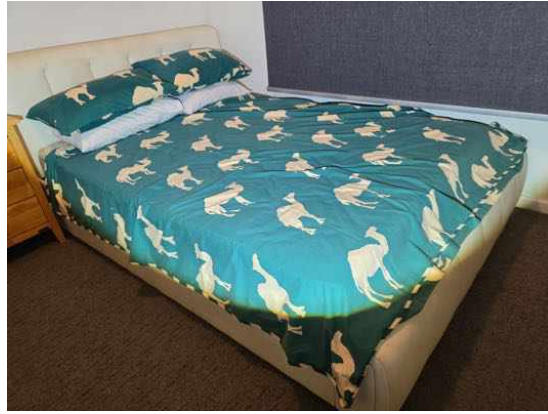
Building: Main Building  
Location: All Areas > All Areas  
Finding: Additional Photos - Obstructions and Limitations  
Information: These photographs are an indication of the obstructions and limitations which impeded full inspection of the property at the time of inspection. These obstructions can hide an array of defects and should be removed to allow full inspection to be carried out. A re-inspection is recommended once the areas are made accessible.

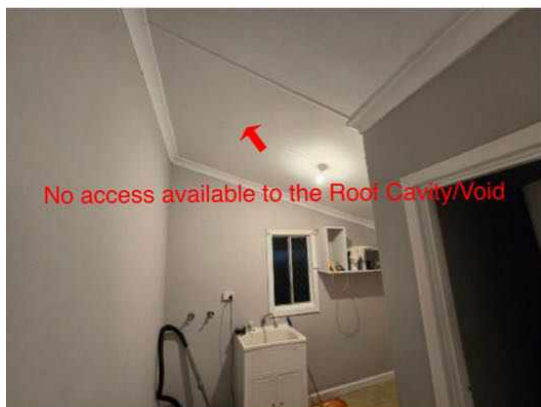
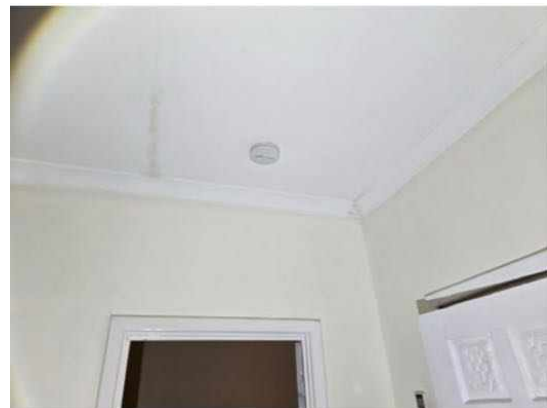
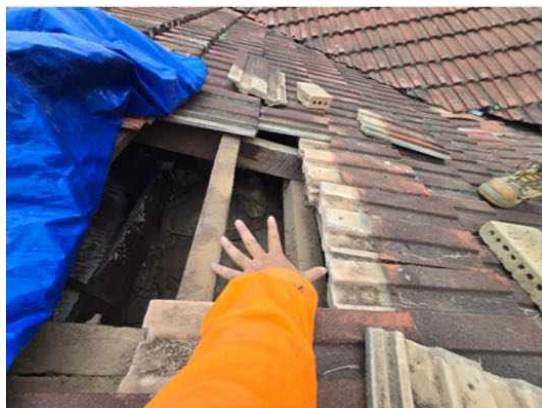
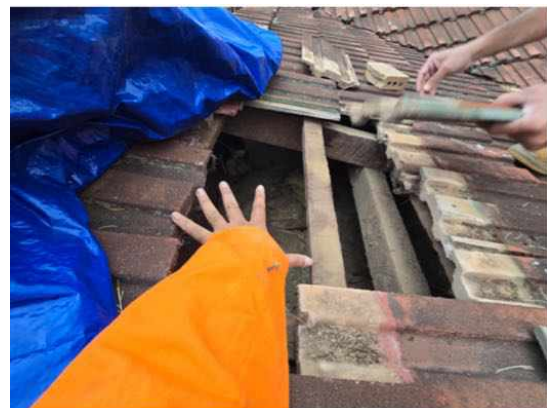
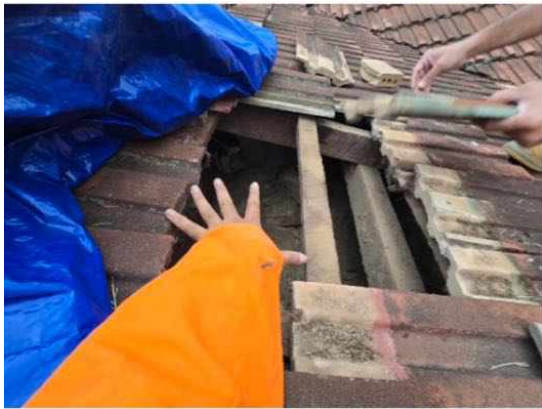
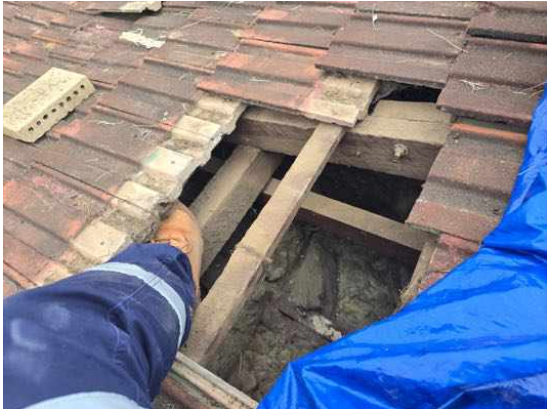
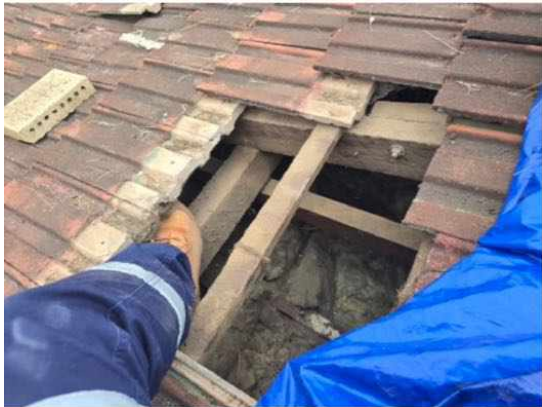
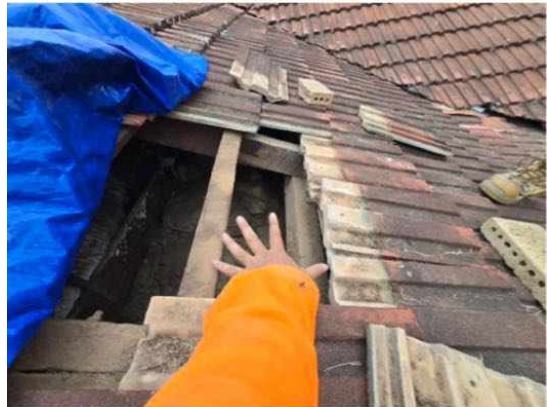
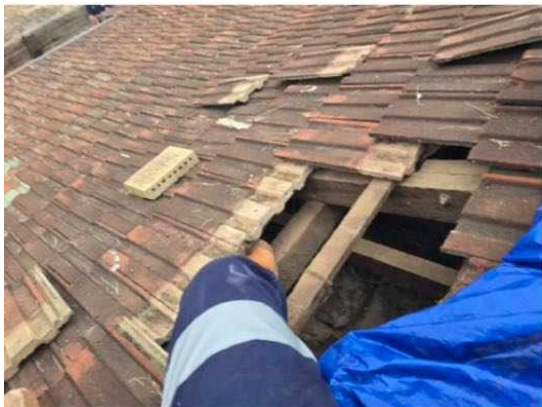
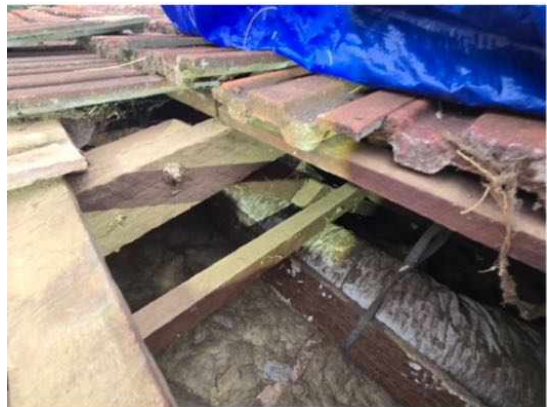
Building: Main Building  
 Location: Roof Void > All Areas  
 Finding: Obstructions and Limitations - Roof Cavity  
 Information: These photographs are an indication of the obstructions and limitations which impeded inspection of the Roof Cavity area at the time of inspection. These obstructions can hide an array of defects and should be removed to allow full inspection of the Roof Cavity to be carried out. A re-inspection is recommended once the areas are made accessible.
