Inspection Report

Property Address:
10101 Older Dallas Property
Dallas TX 75218

PROPERTY INSPECTION REPORT

By: Kevin R. Weiss 7108 / Absolute Inspections, LLC 2/10/2016

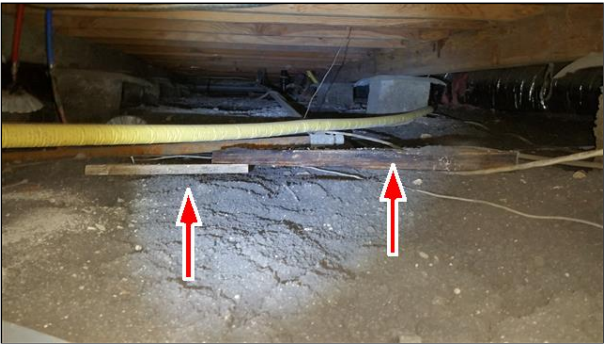
A. Item 5(Picture)

- (3) Observed construction or repair debris in the crawlspace. All refuse should be removed.
-

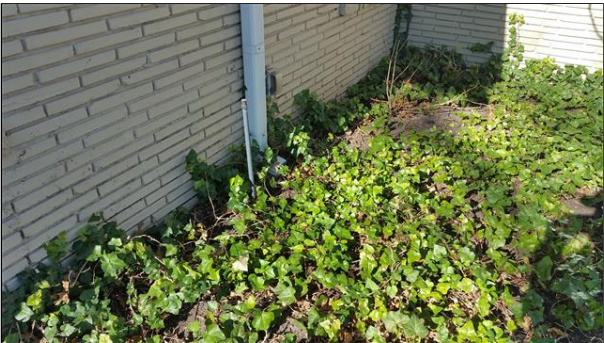
B. Item 4(Picture)

(2) Observed a minor negative slope in the grading towards the house/foundation. These areas do not appear to drain water away from home and may need landscaping and drainage alterations. Locations include but are not limited to: front, North side

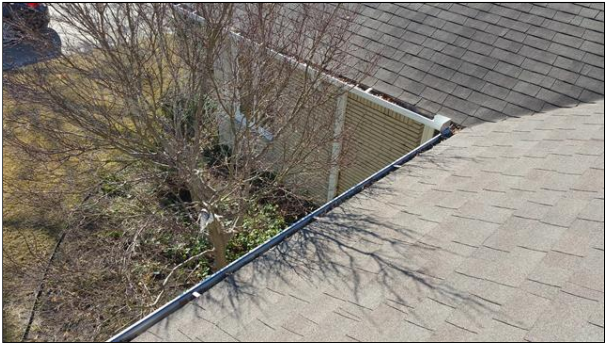
B. Item 8(Picture)

(5) Observed gutter downspout(s) that are missing the bottom elbow piece to properly route water. This condition is detrimental to the performance of this system. Recommend review and repair as needed by a qualified contractor. Locations include but are not limited to : garage, rear yard

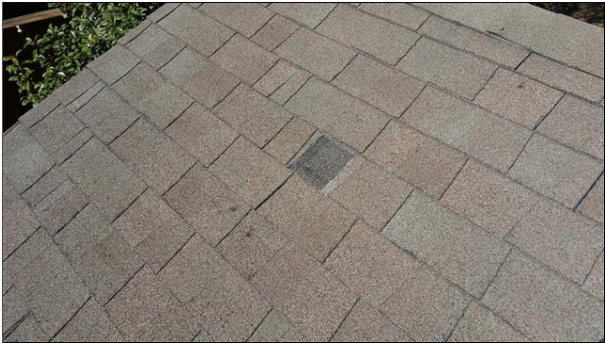
C. Item 9(Picture)

(6) Observed wear from wind at shingles edges. Recommend review and repair as needed by a qualified contractor.

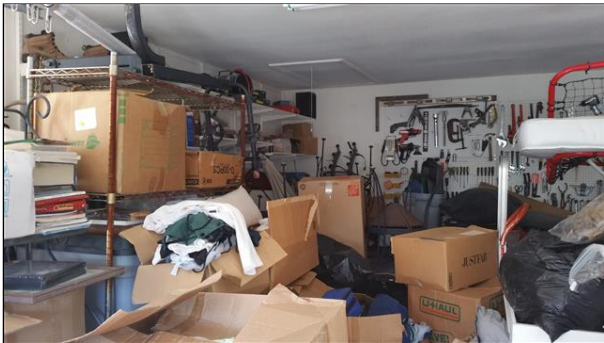
D. Item 4(Picture)

(2) Garage attic not accessible due to storage.

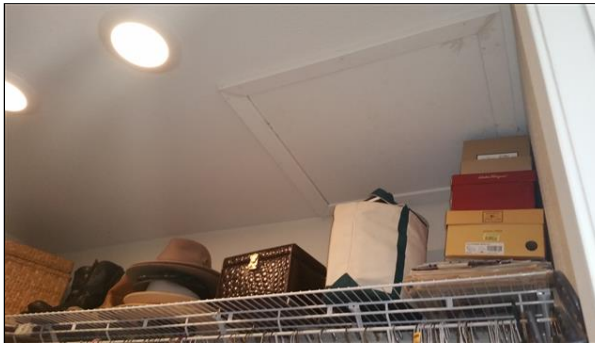
D. Item 5(Picture)

(3) Master bedroom attic access was not accessible.

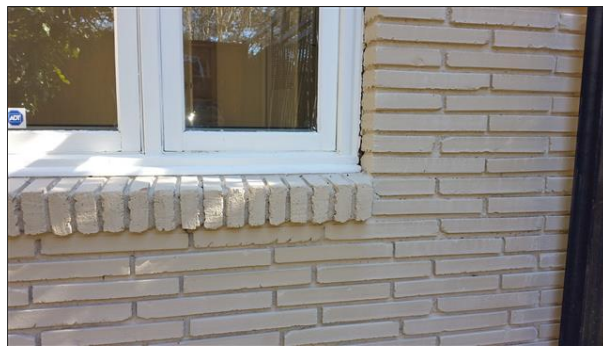
H. Item 2(Picture)

- (2) Caulking touchup/repair is needed at various window exteriors. Caulking incomplete in corners / voids, cracked caulk or missing areas observed. All windows should be checked and improved as needed for optimum efficiency and to prevent possible water intrusion.
- (3) Observed multiple Windows that are painted shut. Recommend review and repair as needed by a qualified contractor.

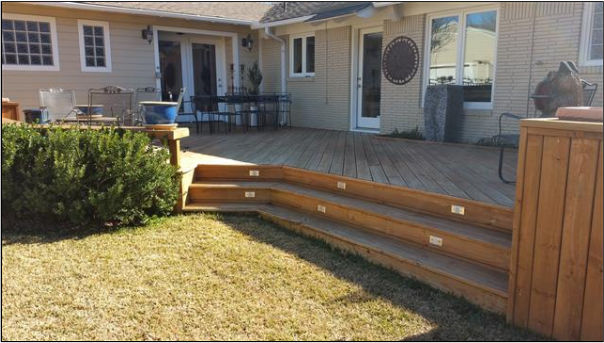
K. Item 1(Picture)

(1) Wood deck present in rear. No structural analysis completed. Obstructs view of a large portion of the rear foundation. Appears to be in generally good condition.

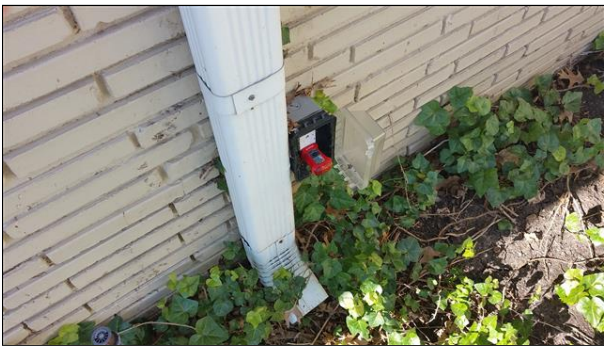
B. Item 3(Picture)

- 🏠 (3) Noted GFCI (ground fault circuit interrupter) outlets that did not trip when tested. Recommend review and repair as needed by a licensed electrical contractor. Locations include but are not limited to : exterior
- 🏠 (4) Exterior outlet cover damaged. Recommend review and repair as needed by a qualified contractor. Locations include but are not limited to : north side

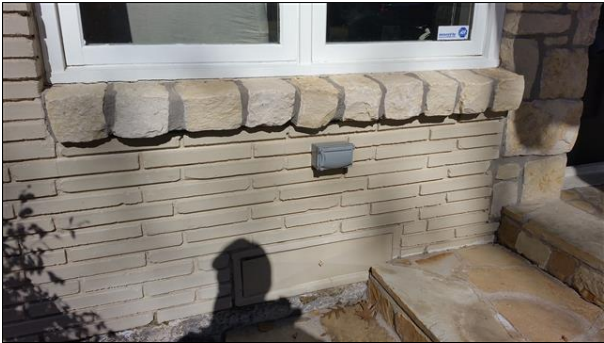
B. Item 5(Picture)

(5) GFCI outlet defective / did not trip when tested. Recommend review and repair as needed by a licensed electrical contractor. Locations include but are not limited to : rear exterior

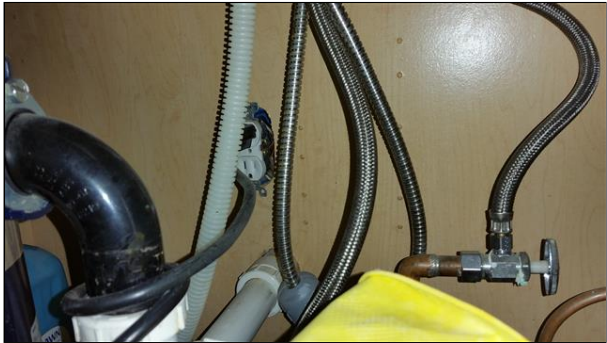
B. Item 6(Picture)

(6) Front gfci outlet did not have power. Recommend review and repair as needed by a qualified contractor.

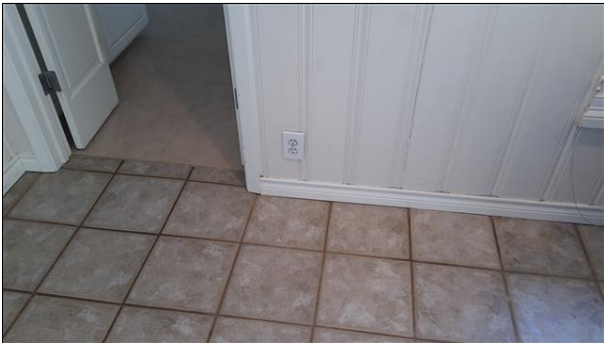
B. Item 9(Picture)

(7) Observed Covers missing at outlets. Recommend review and repair as needed by a qualified contractor. Locations include but are not limited to : under kitchen sink, laundry room

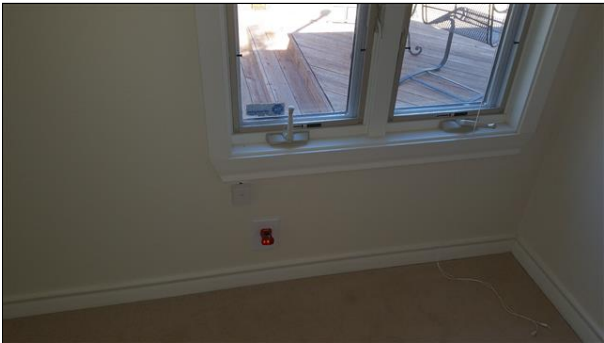
B. Item 10(Picture)

(8) Loose duplex outlets were observed. All outlets should be repaired so that they are securely mounted to the wall box and do not move when used. Locations include but are not limited to: pictured
