# Inspection Report

11111 Newer Slab Foundation Existing Home Sample Inspection Report  
Plano TX

# PROPERTY INSPECTION REPORT

**By:** Kevin R. Weiss 7108 / Absolute Inspections, LLC 1/8/2016

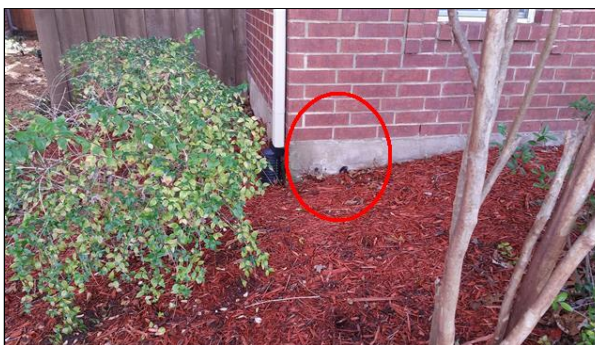
A. Item 1(Picture)

(2) Post tension cable live ends were observed to be exposed. These should be covered with non-shrink grout. Recommend repair by qualified contractor to prevent corrosion and possible failure of post tension cables over the span of years. Picture represents an example, entire foundation edge should be checked and repaired as needed.

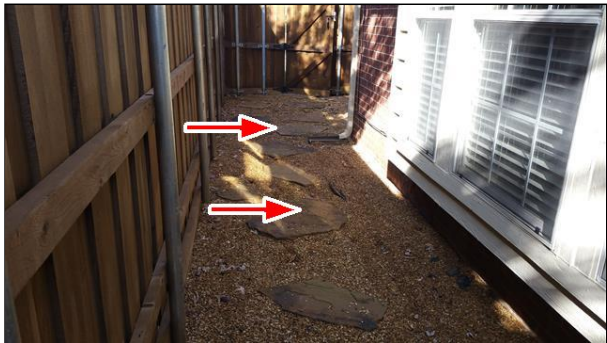
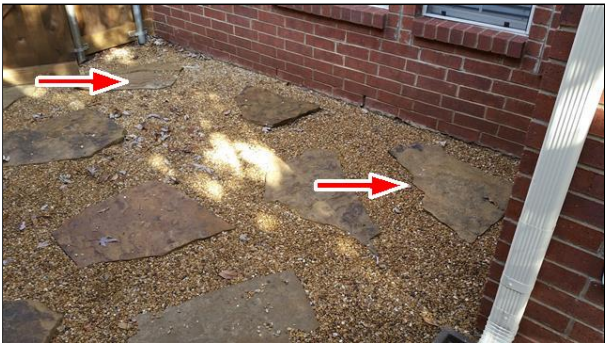
(2) Observed a minor negative slope in the grading towards the house/foundation. These areas do not appear to drain water away from home and may need landscaping and drainage alterations. Locations include but are not limited to: South side of home

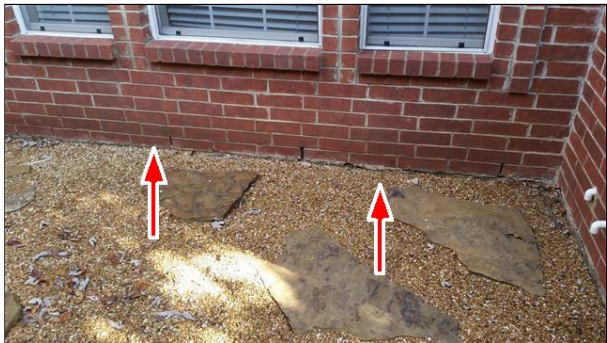
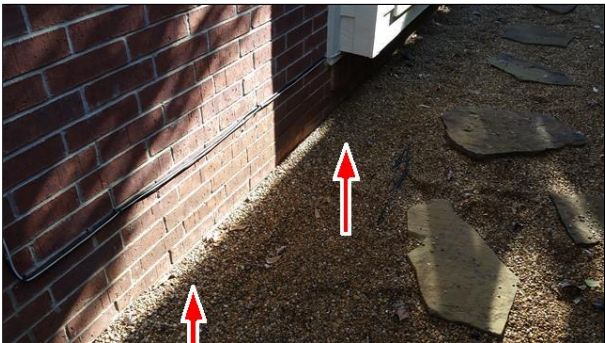
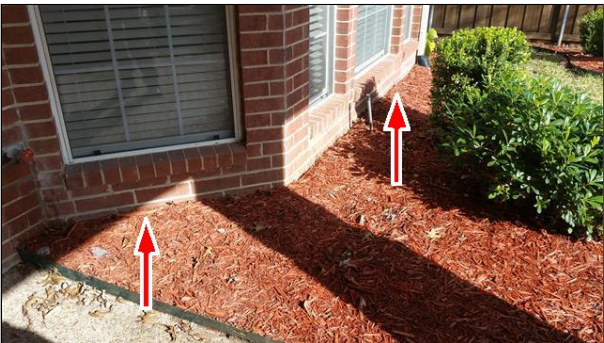
(3) Soil level observed to be too high at various locations around the foundation. Ideally there should be a gap of 4 to 6 inches between the soil and the bottom of the brick / top of foundation. Failure to maintain this gap can lead to moisture penetration in wall and is known to be conducive to termite activity. Recommend modifications to achieve and maintain this spacing. Locations include but are not limited to: South side of home, rear

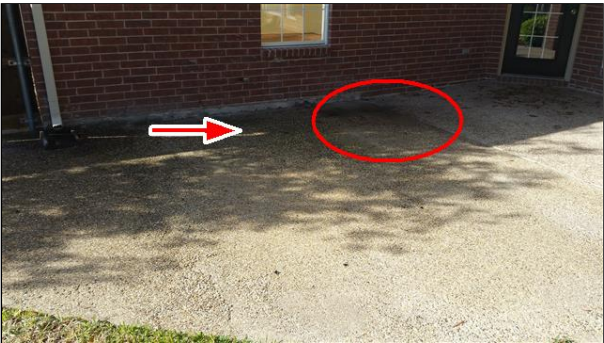
B. Item 6(Picture)

(4) Rear patio addition has improper slope. Does not adequately move water away from home. Observed evidence of pooling water by foundation. Recommend review and repair as needed by a qualified contractor.

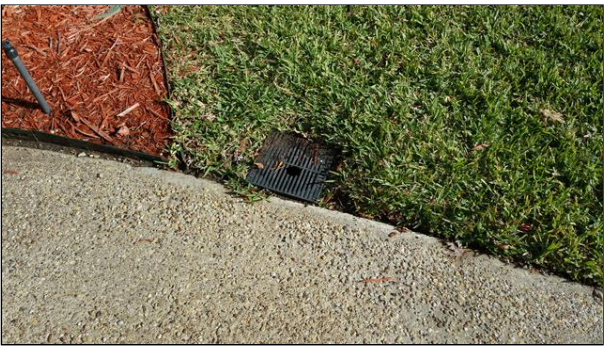
B. Item 7(Picture)

(5) Surface drain system was installed. No inspection of the performance of the system was conducted. Inspection of underground components was not performed so inspector did not verify yard drains operate properly and that there are no collapsed or clogged areas. Recommend periodic maintenance to ensure that the drains are performing as intended.

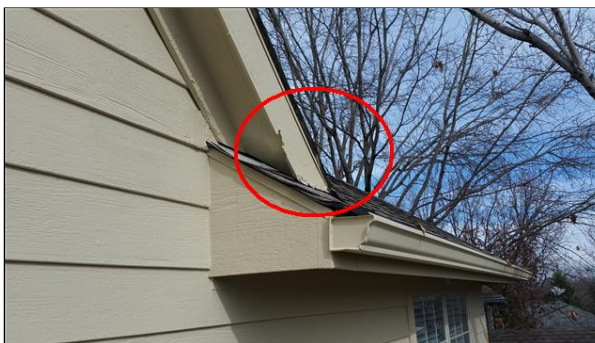
D. Item 2(Picture)

(2) Damaged fascia board observed. Recommend review and repair as needed by a qualified contractor. Locations include but are not limited to : rear second story

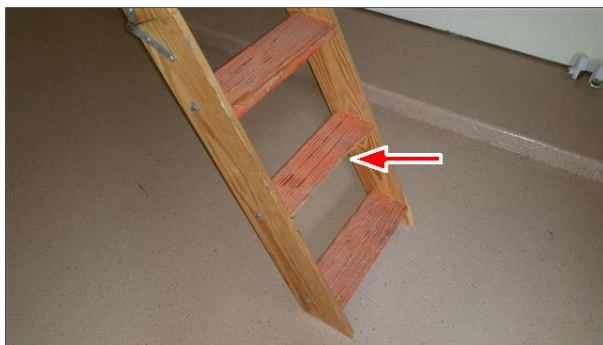
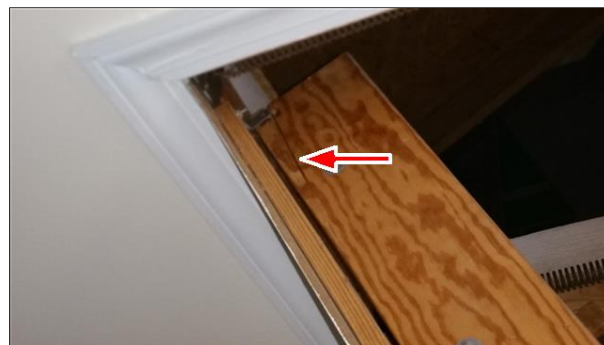
(3) Attic stair unit is in disrepair / has loose hardware / has cracked or damaged wood members. Repair or replacement is needed for safety.

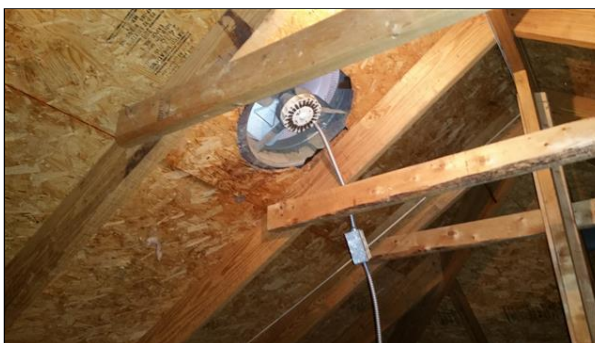
D. Item 5(Picture)

(4) Powered thermostatically controlled attic fans installed. Not operational due to low temperatures. Not inspected. Verify operation when exterior temperature is higher.

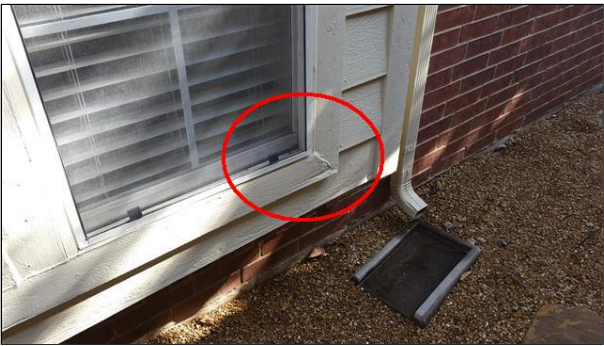
E. Item 1(Picture)

(2) Rotted / damaged trim observed. Recommend review and repair as needed by a qualified contractor. Locations include but are not limited to : breakfast nook window

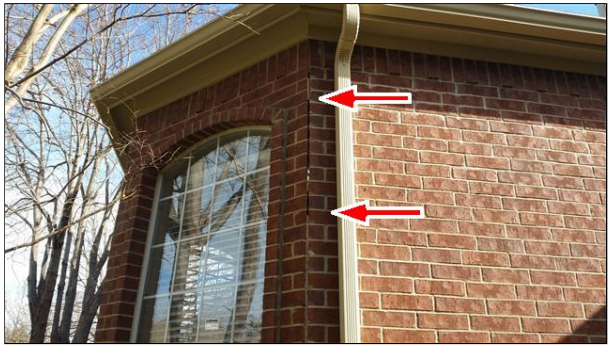
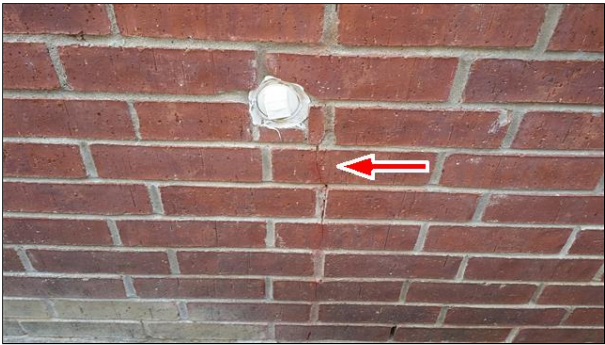
(3) Minor mortar cracking observed. Re-pointing/repair is recommended. Monitor this condition and take further action, including but not limited to evaluation by a structural engineer, if further movement is observed. Locations include but are not limited to: South side of home, North side where expansion joint the was not properly installed

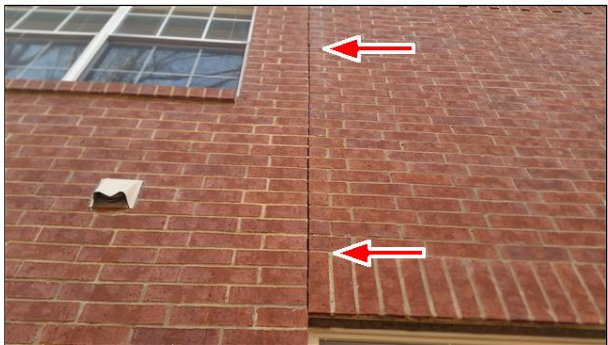
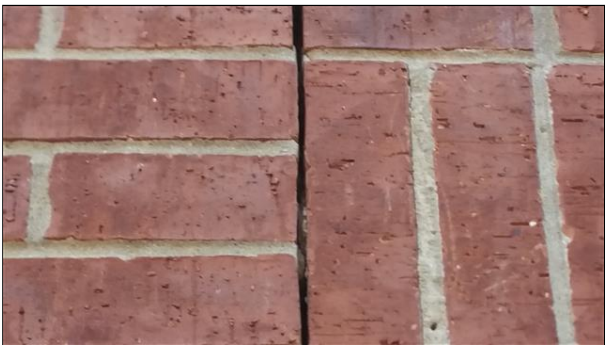
(4) Expansion joint not sealed / completely sealed. Should be sealed with a appropriate elastomer sealant. Locations include but are not limited to : North side

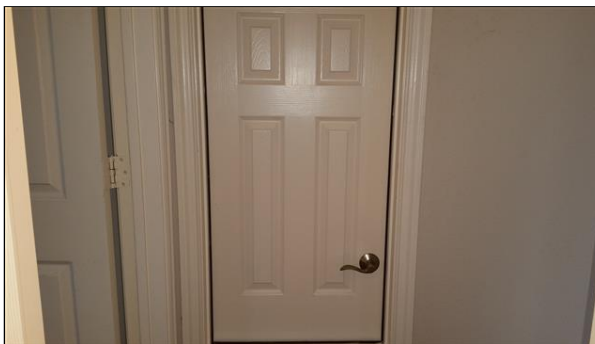
G. Item 1(Picture)

(4) Door to front attic space is improper type. Door slab is hollow core. Attic doors should be exterior grade fire rated doors. Recommend review and repair as needed by a qualified contractor.

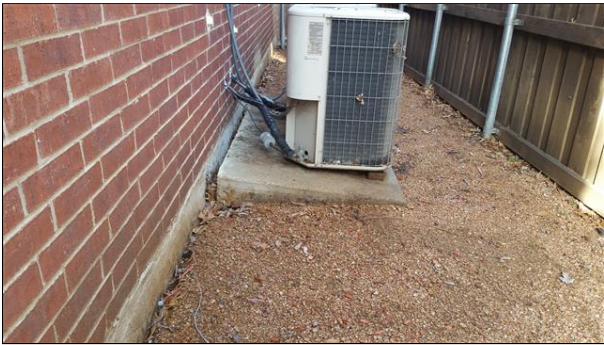
B. Item 1(Picture)

(3) Condenser concrete pad has shifted and sunk. Recommend review and repair as needed by a qualified contractor.

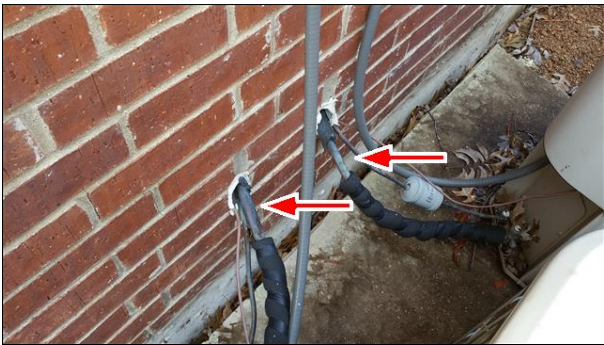
B. Item 2(Picture)

(4) Refrigerant line insulation is damaged/missing. Recommend review and repair as needed by a qualified contractor.

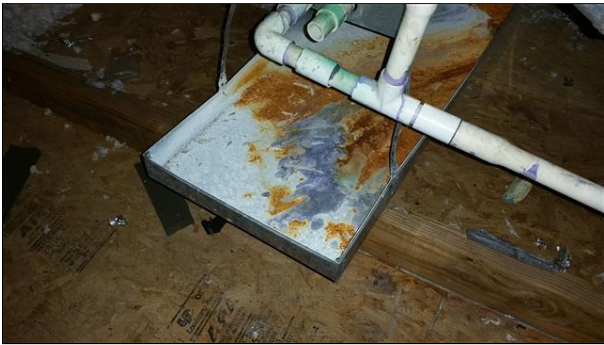
B. Item 5(Picture)

(7) Observed moisture or signs of past water presence (rust and/or mineral build up) in the secondary condensate pan(s). This is a possible indication that the primary drain line is clogged or obstructed or has been. Recommend review by a licensed HVAC contractor should be performed as soon as these units are actively used.

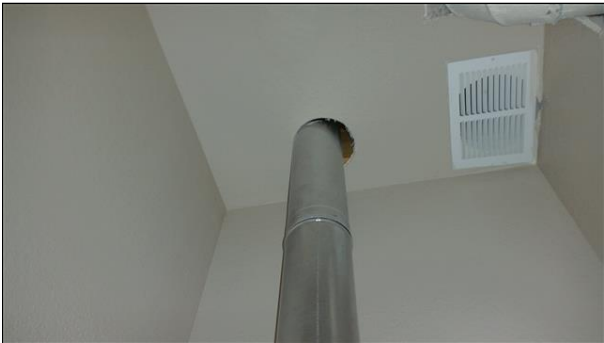
C. Item 2(Picture)

- (4) Water heater vent flue observed to be touching combustible materials. There should be at least a one inch gap between the vent pipe and any combustible materials.
- (5) Water heater closet is not properly vented. Gas powered water heater closets should be vented with supply air from the attic to the floor of the closet and an exit vent to the attic in the ceiling. Recommend repair. Appears that the closet was originally properly ventilated and then modified improperly to remove the bottom vent.

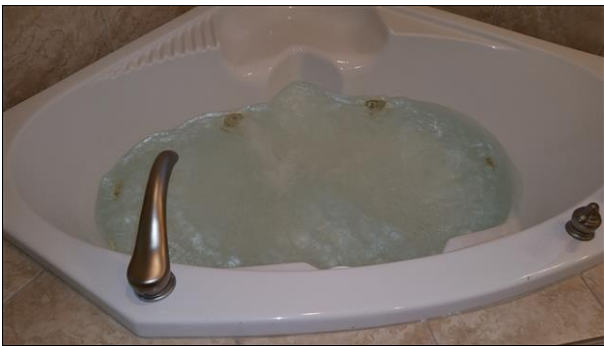
D. Item 1(Picture)

- (1) Was not able to access motor for visual inspection. Does not comply with National Electric Code (NEC 430-14) requiring that motor must be accessible for servicing.

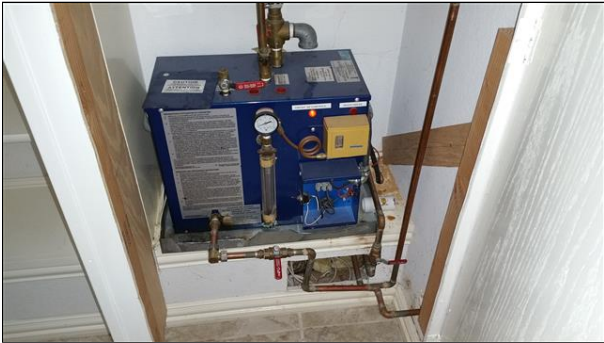
E. Item 1(Picture)

(1) Steam generator appliance present in master closet for master shower. Unit water supply was turned off. Not operated. Recommend reviewing operation with seller or licensed plumbing contractor.

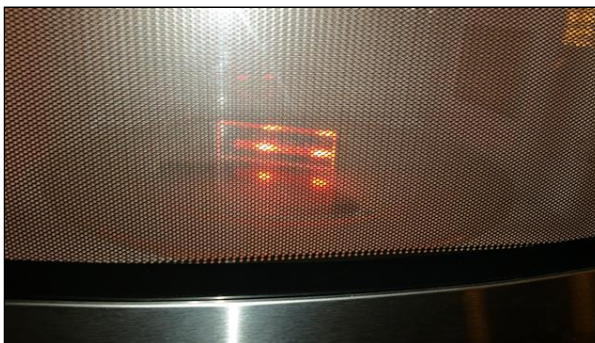
E. Item 1(Picture)

The microwave unit was inspected and appeared to be functioning as intended at the time of the inspection. Inspection of the microwave is for heating ability only. No radiation leak testing was completed.
