# Inspection Report

**Property Address:**  
54321 Older Slab Foundation Home  
Plano TX 75025

# PROPERTY INSPECTION REPORT

**By:** Kevin R. Weiss 7108 / Absolute Inspections, LLC 1/12/2016

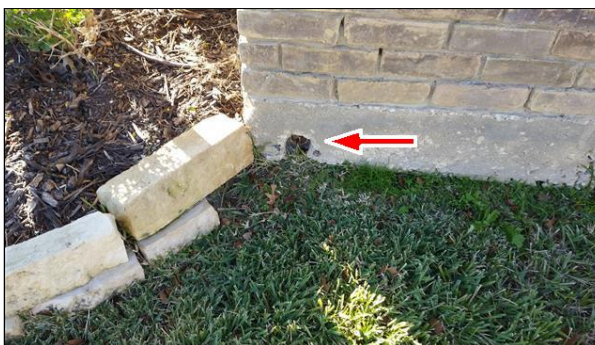
A. Item 1(Picture)

(3) Multiple signs of excessive foundation movement were observed in this home. These signs may include but are not limited to: interior and exterior wall cracks observed that are typically associated with

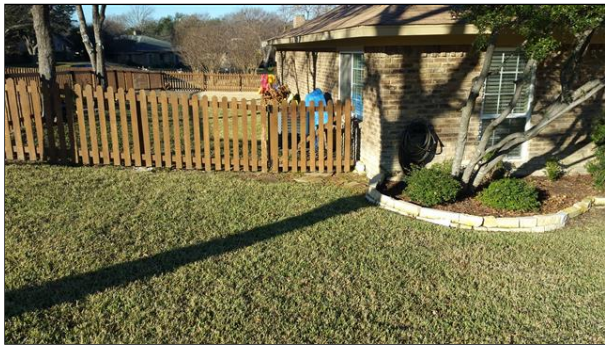
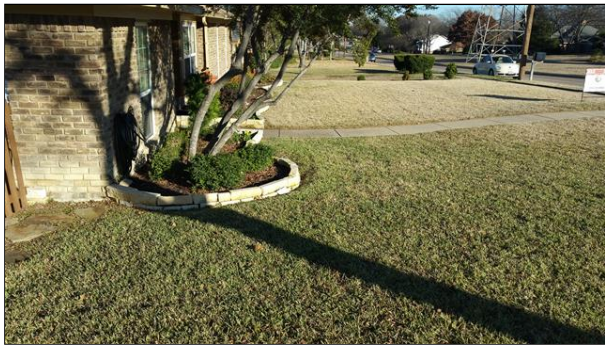
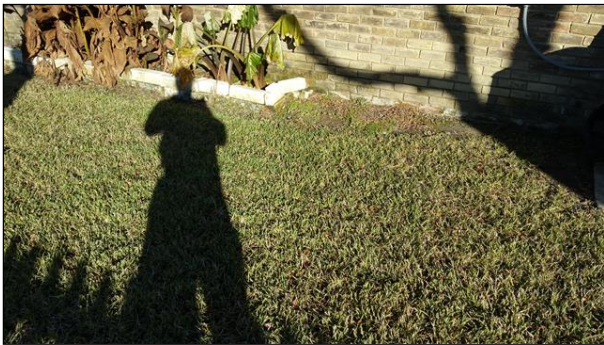
(2) Observed a negative slope toward the house. This area does not appear to drain water away from home and needs landscaping and drainage corrected. Repair may include the addition of underground drainage systems such as french or surface drains or regrading to created proper drainage away from the home to a swale system. Recommend that a drainage/structural specialist (such as a licensed professional engineer) be consulted as to acceptable and affective repair options. Failure to improve this situation could lead to long term foundation issues and/or water penetration. Locations include but are not limited to: South side of home and East side of home

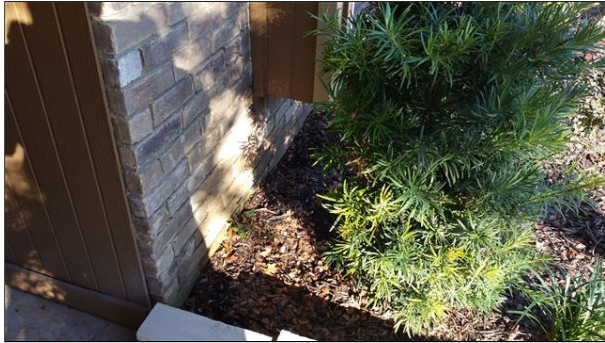
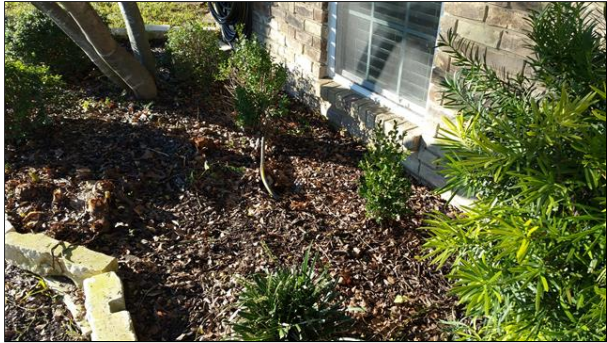
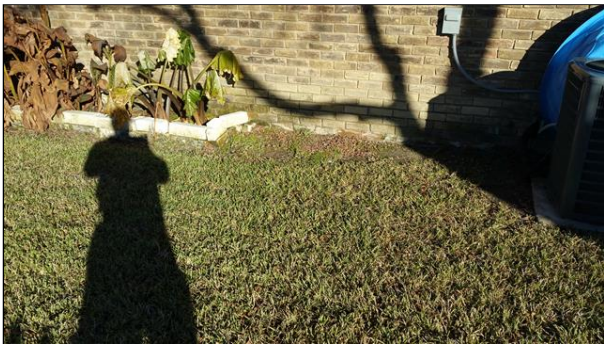
(3) Soil level observed to be too high at various locations around the foundation. Ideally there should be a gap of 4 to 6 inches between the soil and the bottom of the brick / top of foundation. Failure to maintain this gap can lead to moisture penetration in wall and is known to be conducive to termite activity. Recommend modifications to achieve and maintain this spacing. Locations include but are not limited to: front of home, South side

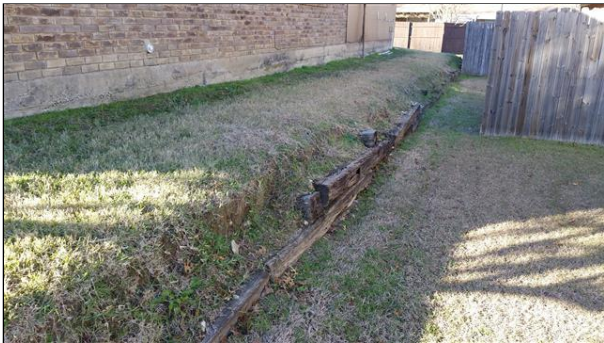
B. Item 7(Picture)

(4) Retaining wall present at North side of home. Ownership details unknown, recommend verification of ownership and maintenance responsibilities. Visual inspection only performed. No structural or engineering surveys performed. No warranties, guaranties are made or implied by this inspection.

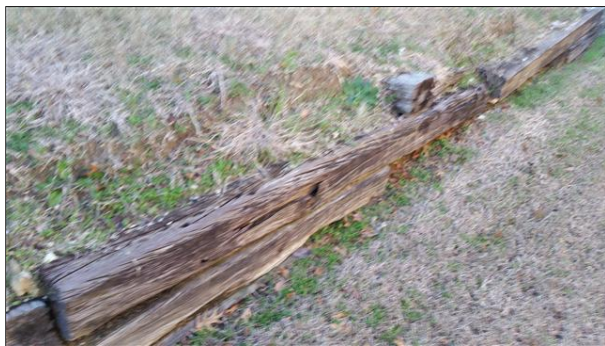
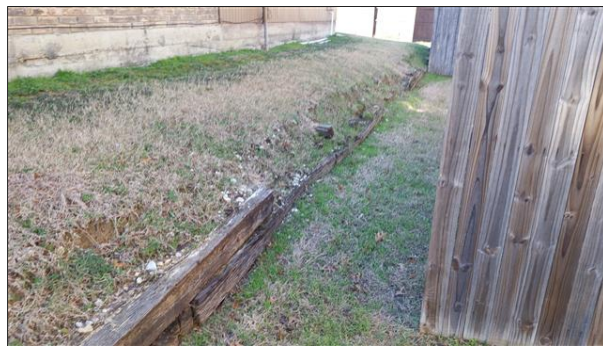
(5) Major shifting and deterioration observed in retaining wall(s). It is virtually impossible for a home inspector to determine whether cracks are caused by structural failure or by some other cause, or, if caused by structural failure, whether the cause is active and ongoing. Recommend further evaluation by a licensed professional engineer or retaining wall specialist licensed by the state of Texas.

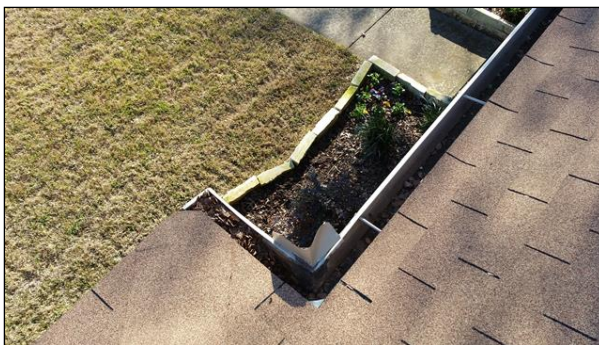
B. Item 11(Picture)

(7) Home is only partially equipped with gutters. We recommend full guttering to manage roof water runoff with the expansive soils in our area. When installed you should make sure that all downspouts extend away from the foundation at least 3 feet.

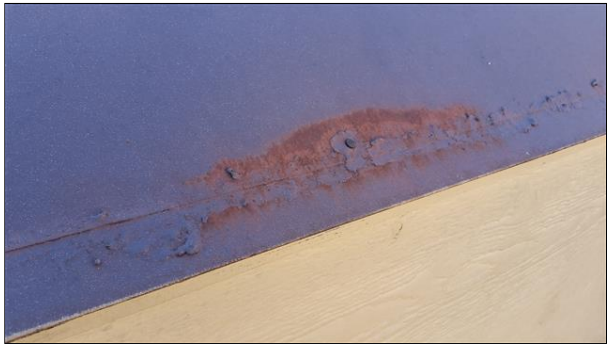
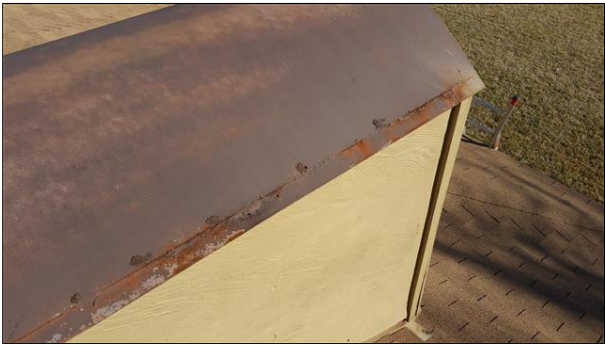
(3) Rust observed at metal roof covering of dormers. Recommend review and repair as needed by a qualified contractor.

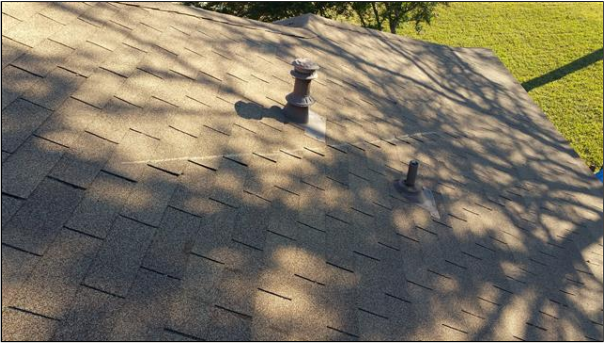
C. Item 7(Picture) Example of loose shingles

(4) Observed multiple areas of loose shingles on the roof. Pictures and caulk marking show examples. These areas had shingles that were slightly out of line and that were not properly adhering to the layer below. This condition leaves the shingles vulnerable to being blown off in high winds. Entire roof surface should be checked by a qualified roofing contractor and repair or replacement conducted as needed.

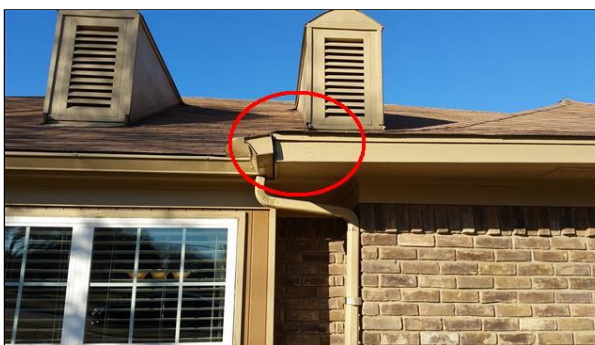
D. Item 1(Picture)

🏠 (2) Facia rot observed. Recommend review and repair as needed by a qualified contractor. Locations include but are not limited to : front

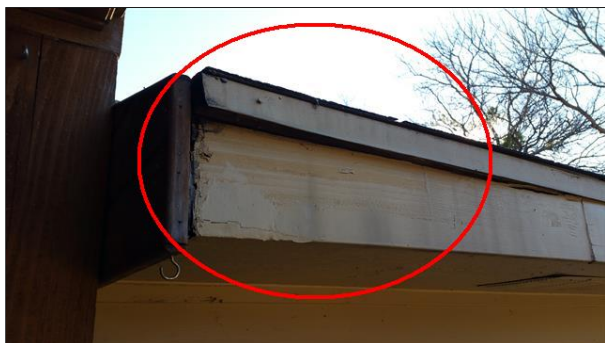
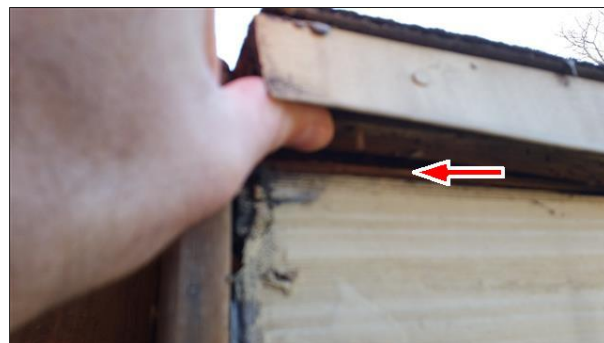
🏠 (3) Observed separation and apparent wood rot and deterioration at rear area fascia and roof decking. Recommend review and repair as needed by a qualified contractor.

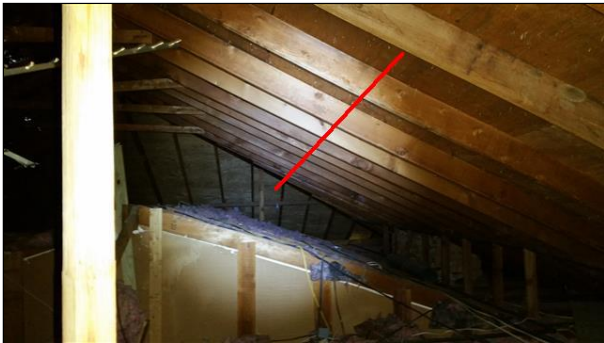
D. Item 5(Picture)

(9) Rear slope of Main roof observed to not have Purlin support. Most likely reason for deflection noted in roof section. Recommend review and repair as needed by a qualified contractor.

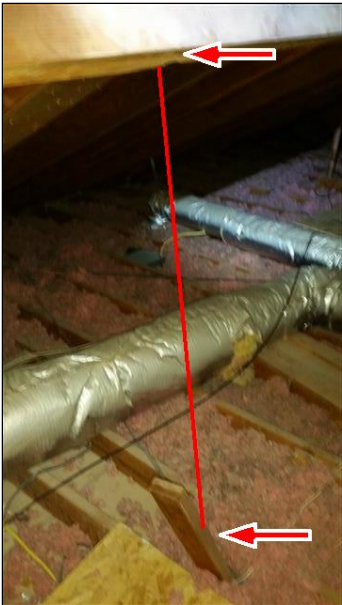
D. Item 6(Picture)

(10) Purlin support vertical support missing at North slope. Recommend review and repair as needed by a qualified contractor.

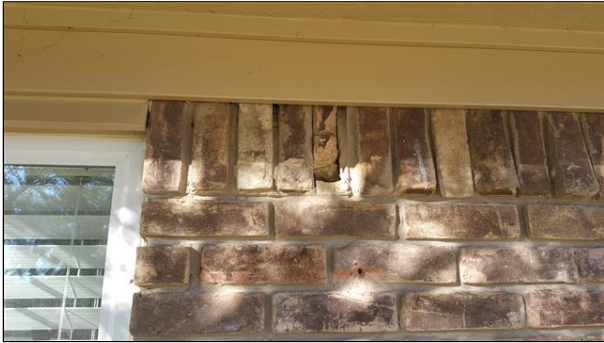
E. Item 1(Picture)

(2) Observed some spelling and deterioration of bricks around home. Does not appear to effect structural integrity of the veneer. Recommend review and repair as needed by a qualified contractor.

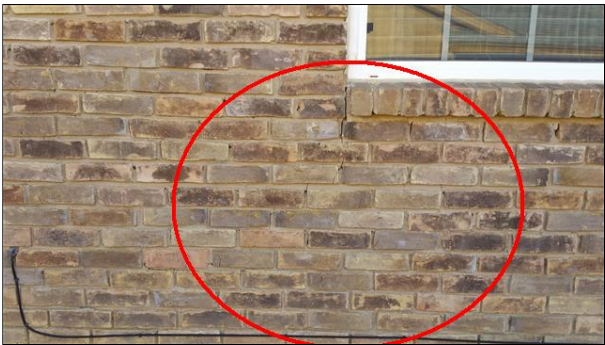
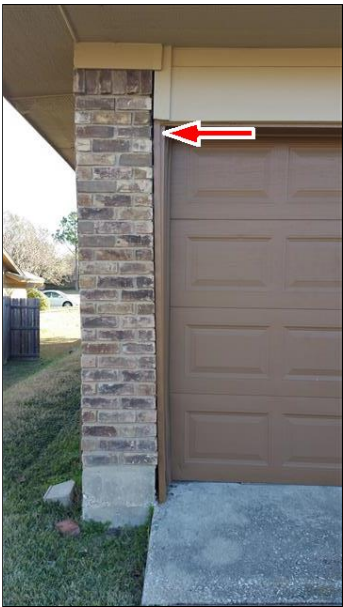
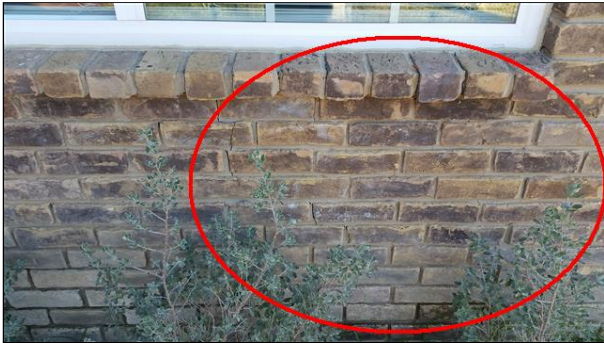
(3) Observed brick/mortar and or separation at window and / or door frames at brick that is consistent with structural deflection or movement. It is beyond the scope of this inspection to determine the extent, severity, or needed remedies related to this movement. I recommend that this be reviewed by a professional engineer licensed by the state of Texas. Locations include but are not limited to: North side, garage door, West side

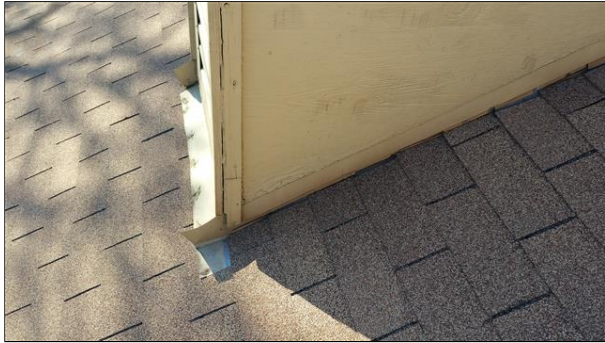
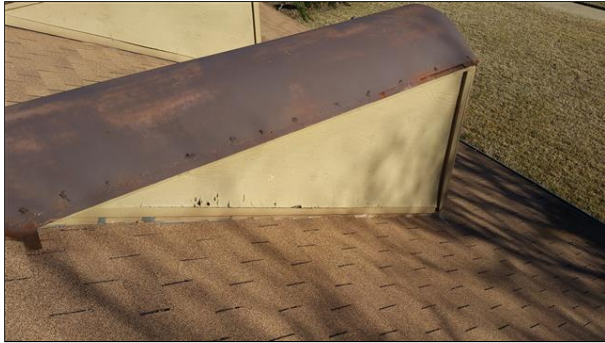
(4) Siding rot and deterioration observed at dormers. Recommend review and repair as needed by a qualified contractor.

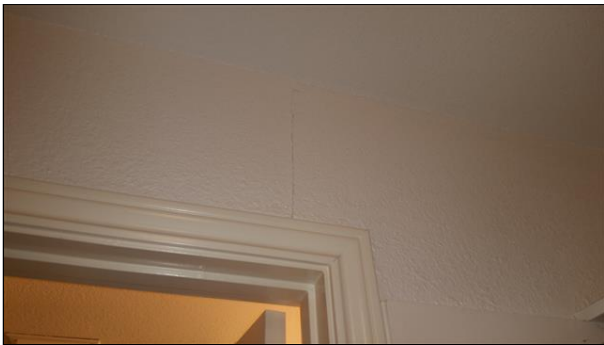
E. Item 7(Picture)

(5) Structural movement type interior cracking observed in multiple self evident location throughout the home. These sheetrock cracks are indications of structural movement that will generally exceed allowed tolerances. Recommend review by a licensed structural engineer. Locations include but are not limited to : master closet

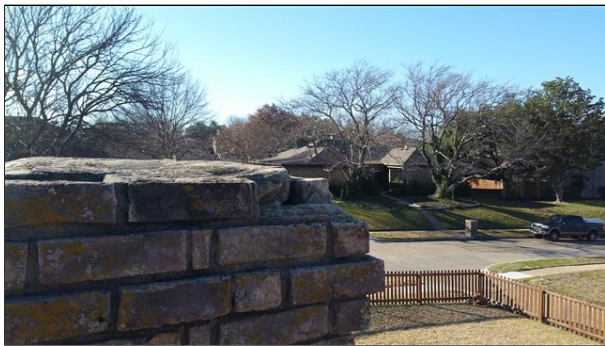
J. Item 2(Picture)

(2) Chimney concrete cap cracking and in disrepair. Repair needed by qualified contractor.

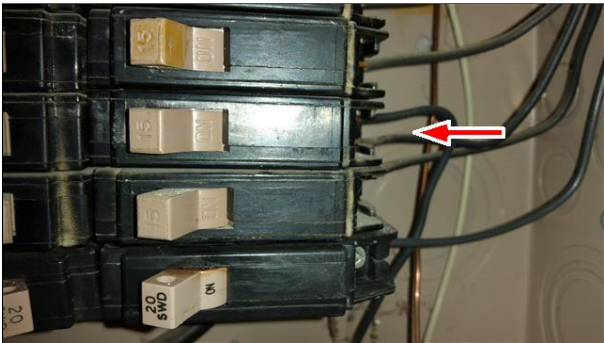
A. Item 4(Picture)

(3) Two circuits improperly joined together and protected with one circuit breaker. Commonly known as "double-lugged." This is not allowed by most breaker manufacturers, although there are a few exceptions. Recommend review and repair by a licensed electrician.

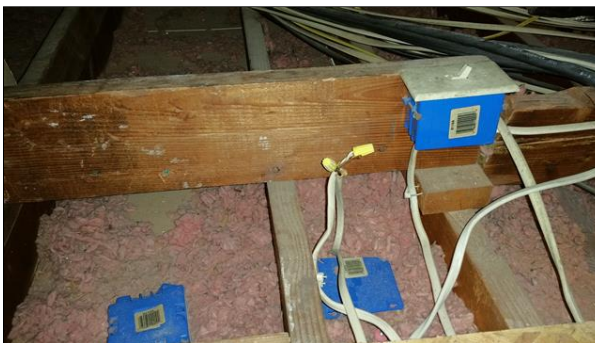
B. Item 1(Picture)

📌 (6) Wire connection not contained in an approved junction box. Recommend review and repair as needed by a qualified contractor.

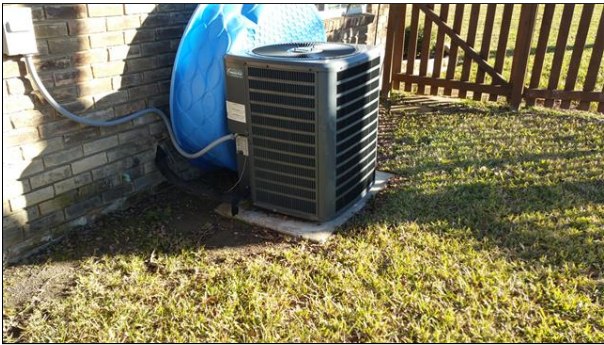
B. Item 1(Picture)

- (3) A/C Condenser pad(s) was/were low. There should be a clearance of approximately 3 inches from the ground to the top of the pad. This helps to prevent dirt and debris from covering the pad and contacting the unit. Recommend review and repair as needed by a qualified contractor.
- (4) A/C Condenser pad(s) was/were not level. Repairs should be made to level the pad(s) and prevent future shifting. Recommend review and repair as needed by a qualified contractor.

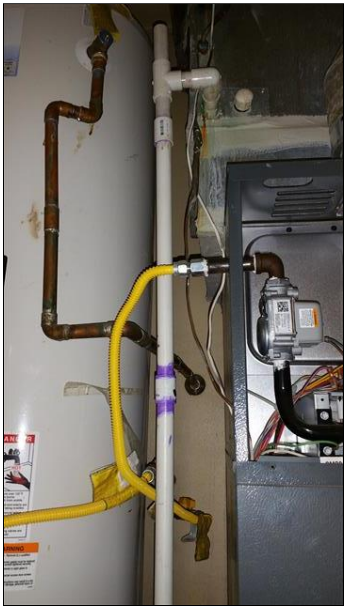
B. Item 2(Picture)

- (5) Primary condensate drain line(s) trap(s) was/were not insulated. The Texas Real Estate Commission requires inspectors to identify the absence of insulation on the air conditioning primary condensate line as an item in need of repair. The insulation prevents condensation from dripping in the home. The first 10 feet of the primary condensation drain line should be insulated.

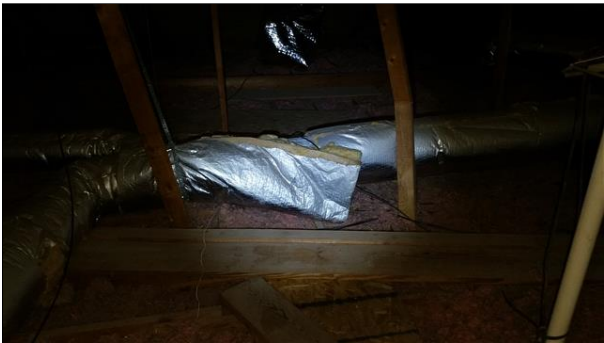
C. Item 1(Picture)

- 🏠 (3) Torn vapor barrier observed on various ducts. Efficiency concern. Repair or Replace.
