Inspection Report

Property Address:
9999 New Construction
Allen TX 75013

PROPERTY INSPECTION REPORT

By: Kevin R. Weiss 7108 / Absolute Inspections, LLC 8/2/2015

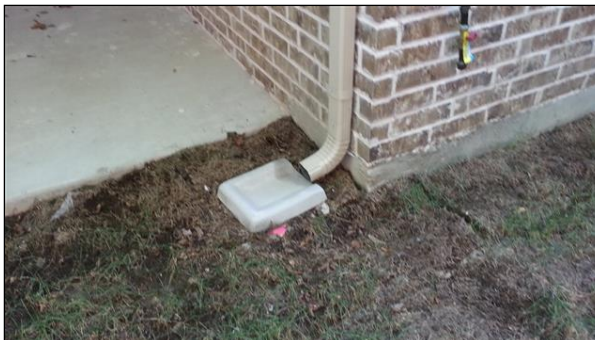
B. Item 1(Picture)

(2) Construction and industry standards recommend gutters terminate three to five feet from the foundation edge, especially in areas where excessive clay soils are prevalent, in order to prevent excessive water from accumulating near the foundation. Excessive water near the foundation can cause foundation related problems. Above ground downspout extensions can make yard care difficult and are often removed by the homeowner, but are functionally acceptable. Below ground extensions are available and should be considered. The absence of extensions may prove acceptable in as long as adequate slope away from the home and splash blocks are provided, but is not recommended. Recommend review and repair as needed by a qualified contractor.

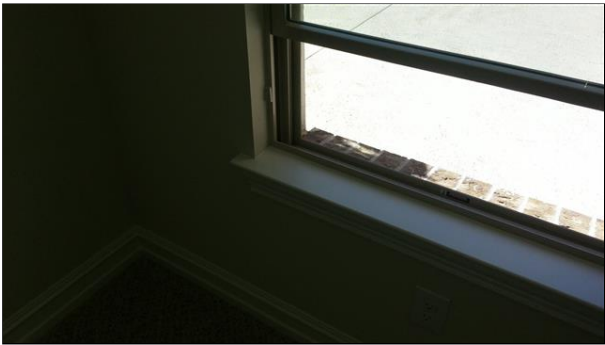
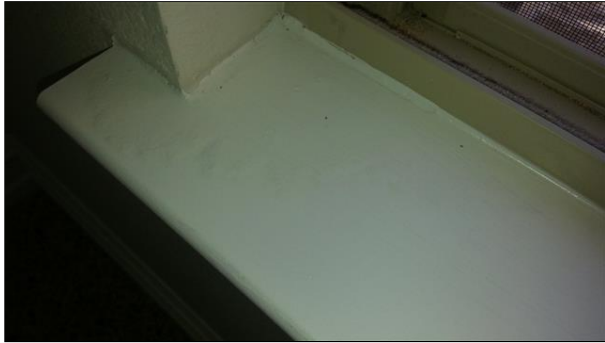
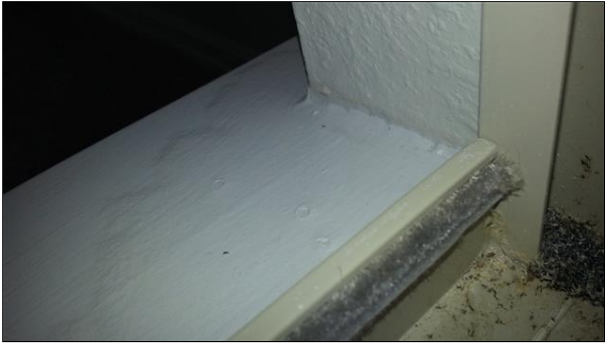
(2) Window seal appears damaged/defective due to marks inside glass at downstairs southeast bedroom. Recommend review and repair as needed by a qualified contractor.

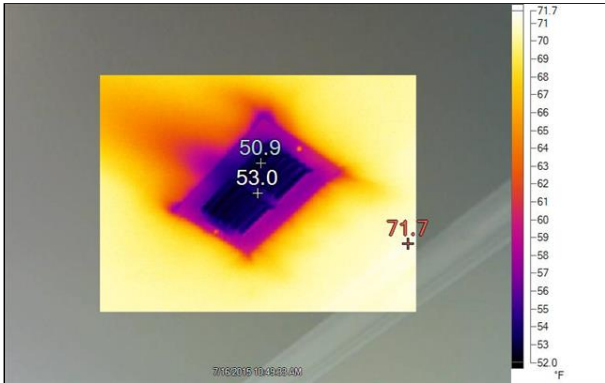
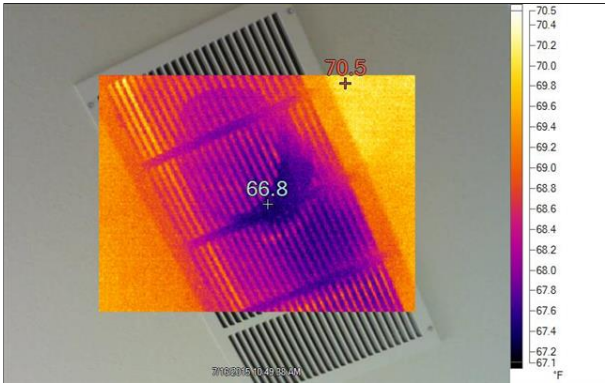
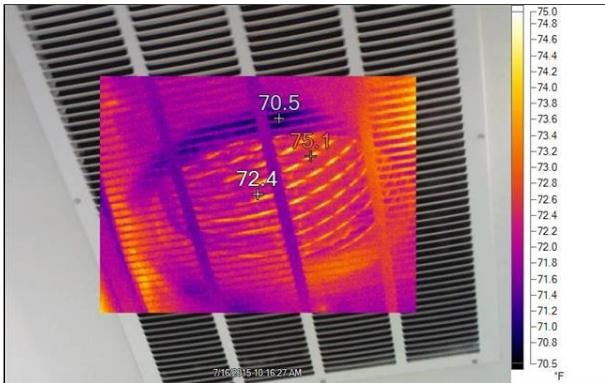
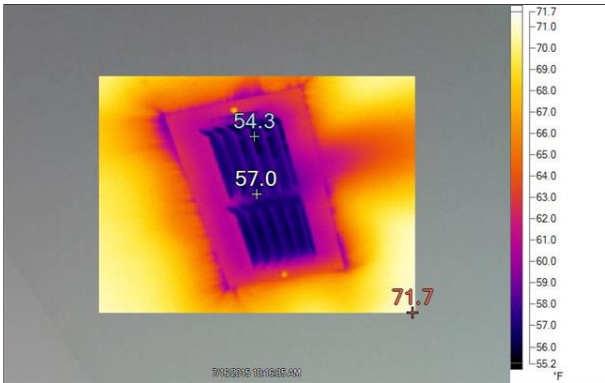
(2) AC unit appears to be functioning properly based on a one time limited inspection. Generally a differential of 14 - 21 degrees is considered normal. These temperature readings were taken at the registers. This testing method very general procedure for determining performance, and is not as accurate as the tests performed by licensed HVAC contractors.

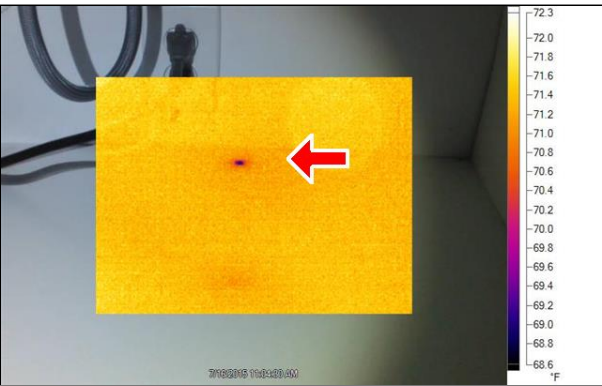
B. Item 1(Picture)

(2) Slow drainage observed. This can indicate various levels of obstruction in the drain plumbing. It can be easily repaired if the blockage is near the fixture, or more difficult if it is further down the in the plumbing. Repair by a qualified contractor is recommended. Locations include but are not limited to : south jack and jill bathroom with sink

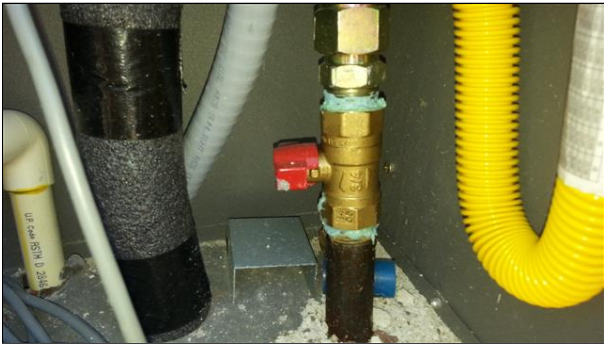
C. Item 4(Picture)

(4) T & P Drain line is improperly routed. End of pipe should be approximately 6" from ground, pointed down, and unobstructed. Repairs are required for safety.

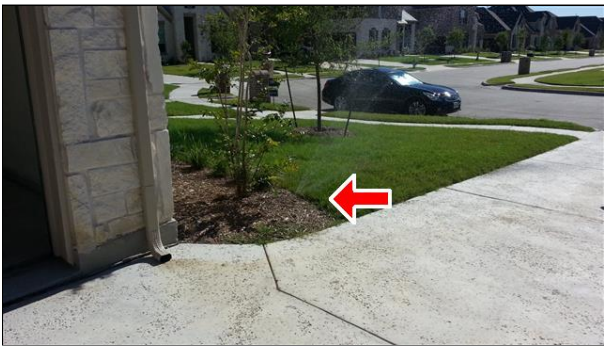
A. Item 1(Picture)

☒ (3) Broken line observed on zone 1 - flowerbed soaker. Repair by licensed irrigation specialist needed.

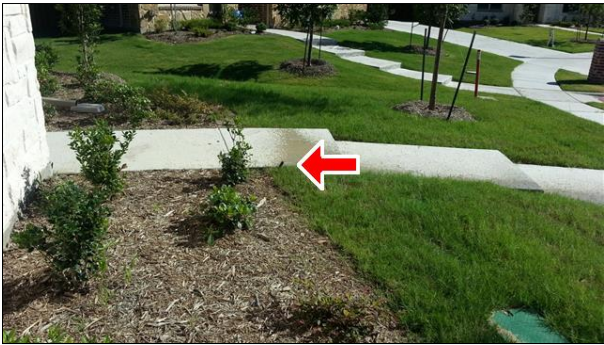
A. Item 2(Picture)

☒ (4) Zone(s) 2 observed to have heads coming up at angles rather than straight. These conditions can cause uneven spray coverage and over saturation leading to excessive runoff and is poor installation. Recommend further evaluation by a licensed irrigation contractor.
