Inspection Report

Property Address:
999 New Construction Home
Frisco TX 75034

PROPERTY INSPECTION REPORT

By: Kevin R. Weiss 7108 / Absolute Inspections, LLC 2/19/2016

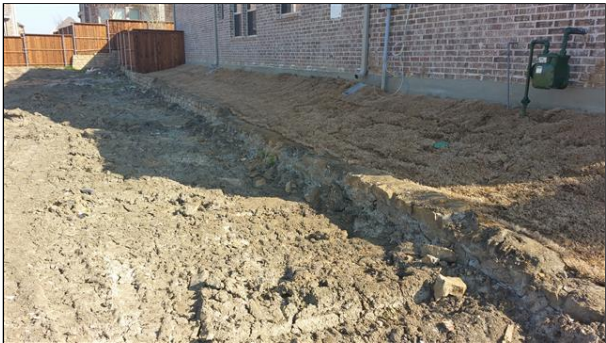
B. Item 1(Picture)

- (4) Retaining wall present at rear and sides of home. Ownership details unknown, recommend verification of ownership and maintenance responsibilities. Visual inspection only performed. No structural or engineering surveys performed. No warranties, guaranties are made or implied by this inspection.

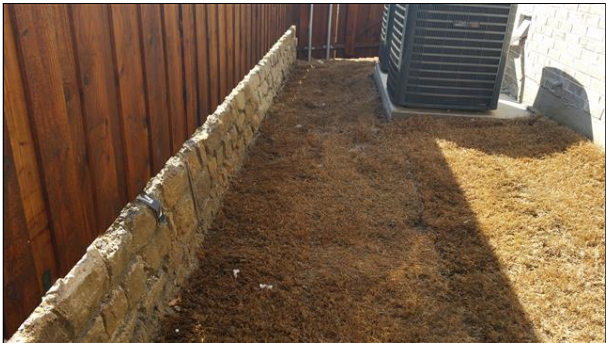
B. Item 2(Picture)

(5) West side retaining wall appears to have been damaged by earth moving equipment. Leaning. Recommend review and repair as needed by a qualified contractor.

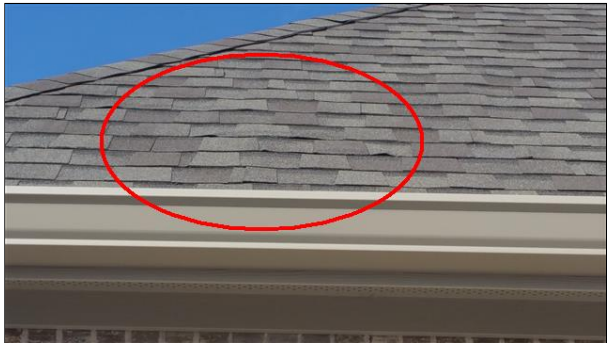
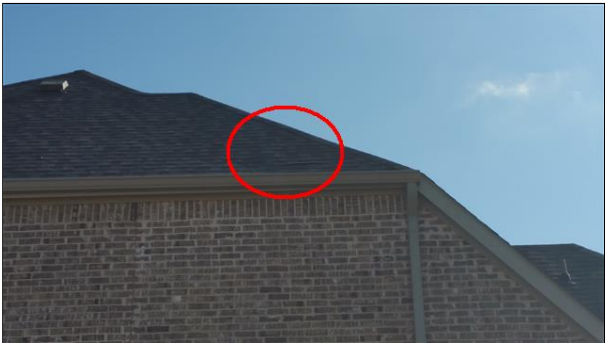
(3) Raised shingle(s) and/or unsealed shingle edges observed. Raised or unsealed shingles can be caused by incompletely driven nails. Other or multiple causes can exist. This condition causes the bottom edge of the shingle to be incompletely sealed to the shingle below it. This can allow high winds to get a "grip" under the shingles and pull them off or cause damage to the roof surface. Recommend review and repair of entire roof area as needed by a qualified roofing contractor. Pictures represent examples, entire roof surface should be carefully checked and repaired as needed at time of repairs.

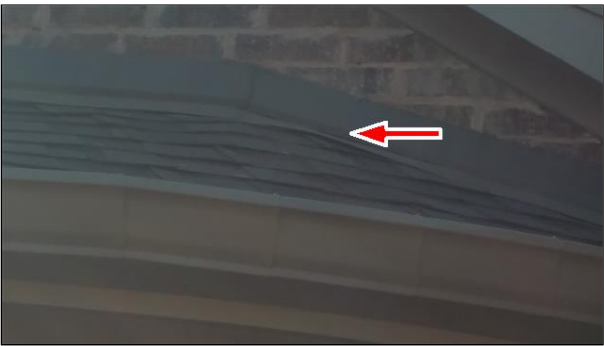
C. Item 7(Picture)

(4) Flashing was observed to be lifted and/or not properly secured. This condition could allow water penetration. Repair by a qualified roofing contractor needed. Locations include but are not limited to: rear of home

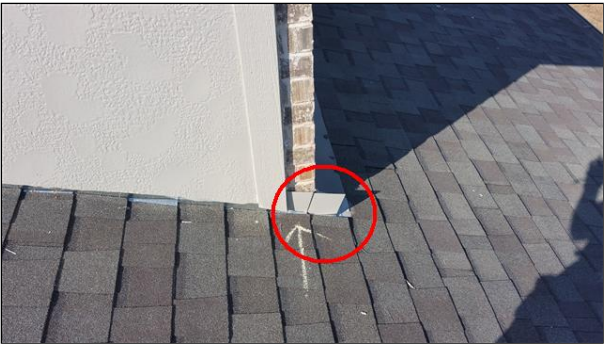
C. Item 8(Picture)

(5) Improper flashing installation observed. Missing counter flashing at brick. Recommend review and repair as needed by a qualified contractor. Locations include but are not limited to : over rear patio

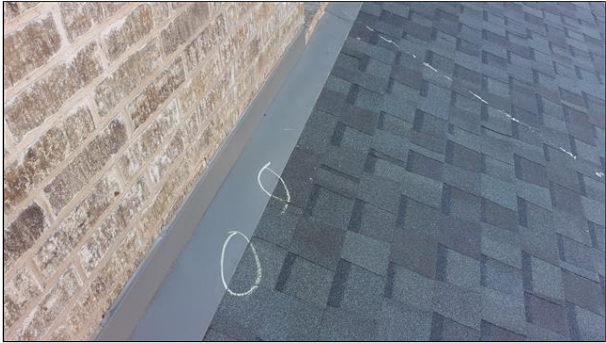
C. Item 9(Picture)

(6) Exposed staples / nail heads / fasteners observed on roof, all exposed fasteners should be sealed with appropriate roofing sealant to prevent water entry. The entire roof surface should be checked and repaired as needed at time of repair.

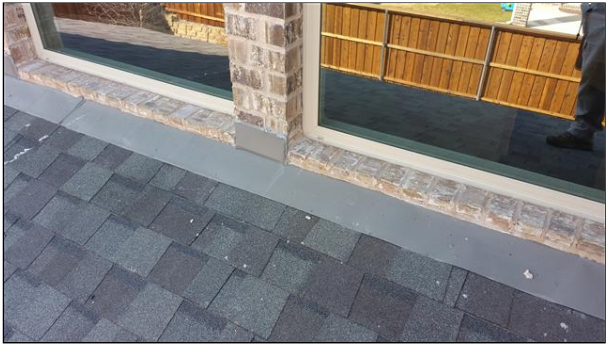
C. Item 10(Picture)

(7) Non standard configuration at patio roof where it meets brick window sills. Confirm that flashing extends under sills. Potential moisture entry point.

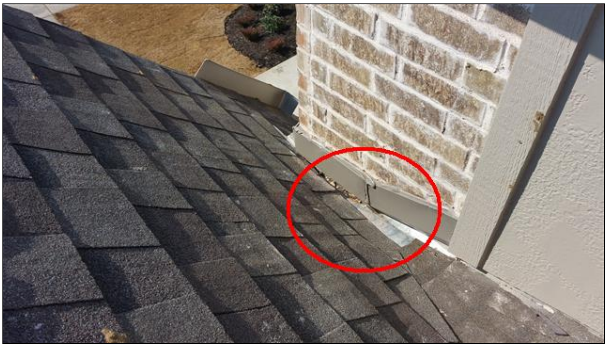
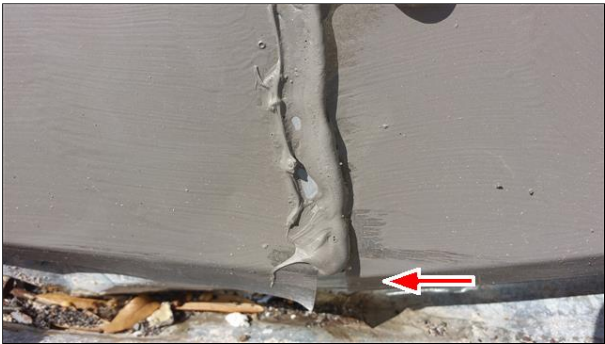
(8) Large Gap in counter flashing sealed with caulk. Poor installation. Recommend review and repair as needed by a qualified contractor.

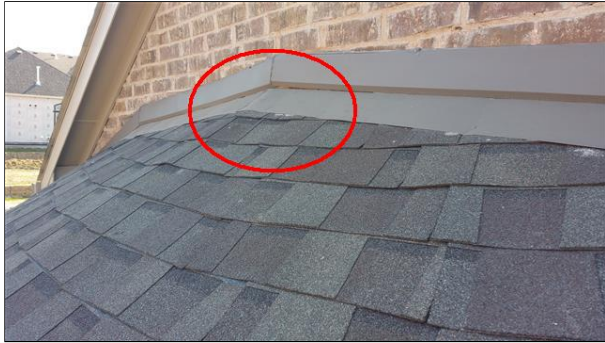
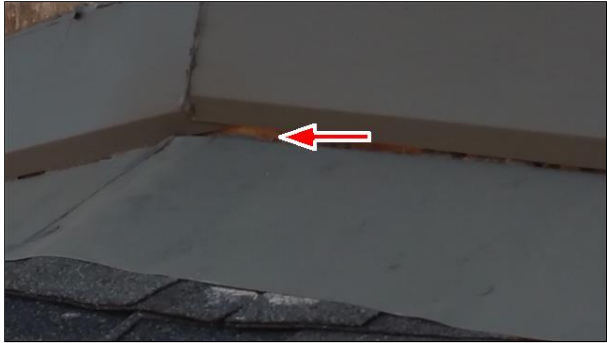
(9) Visible gap noted between bottom of counter flashing and visible roof flashing. Possible leak point. Recommend review and repair as needed by a qualified contractor. Locations include but are not limited to : over master bedroom

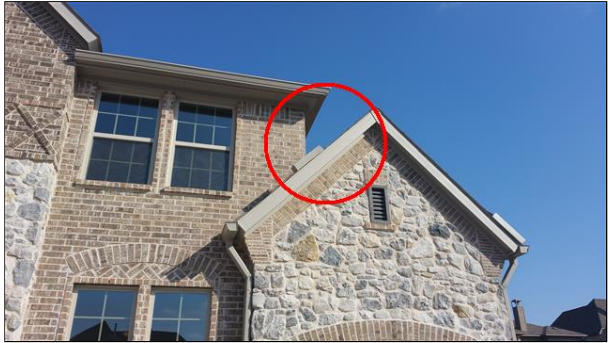
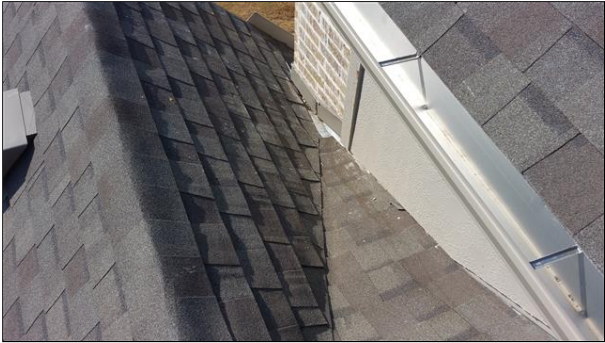
(2) Area of roof structure pictured is by design conducive and prone to leakage. Roof design routes a large amount of roof water to the valley created by the vertical wall. Deterioration / or inadequate installation of caulking and or flashing can lead to leakage. These areas should be monitored regularly and maintained as needed

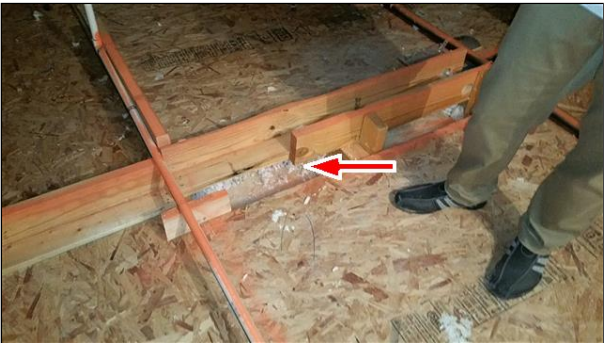
D. Item 3(Picture)

(3) Gap in attic decking should be closed for safety. Recommend review and repair as needed by a qualified contractor.

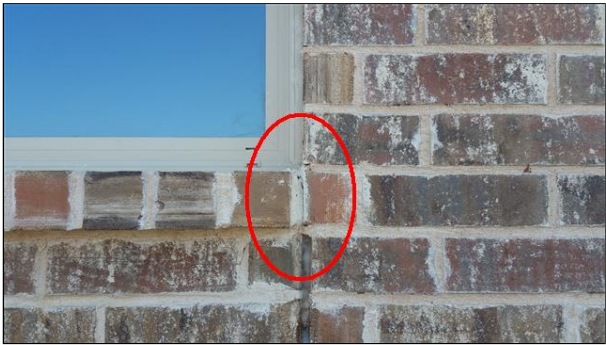
E. Item 1(Picture)

(2) Expansion joints not completely free of rigid mortar materials. By design expansion joints should be completely free of all rigid materials and should extend completely through the brick veneer height. Recommend removal of all rigid materials and reapplication of an appropriate elastomer type sealant in joint.

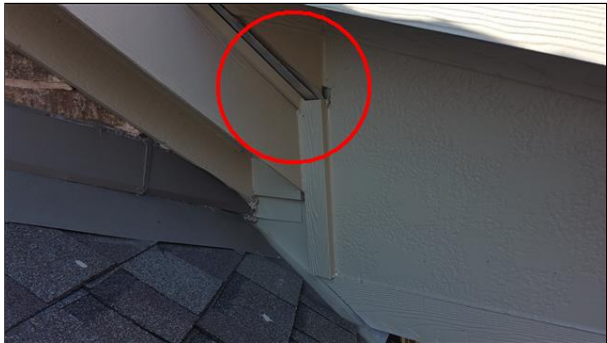
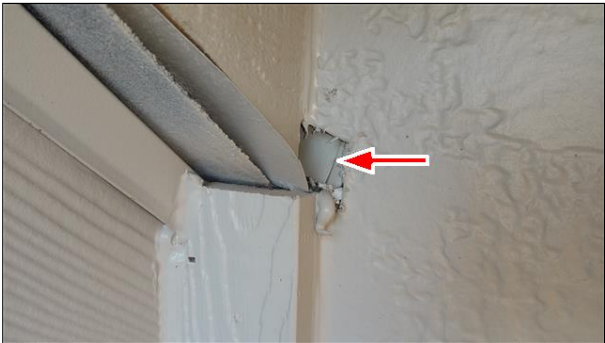
(3) Seal gap at siding. Recommend review and repair as needed by a qualified contractor.

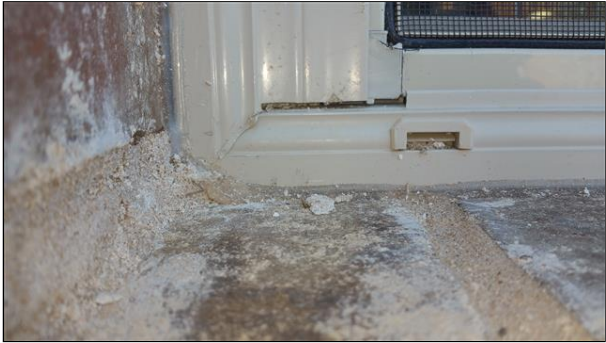
H. Item 1(Picture)

(2) Window frame separated at bottom corner. Does not appear to be separated at the interior. Recommend review and repair as needed by a qualified contractor.

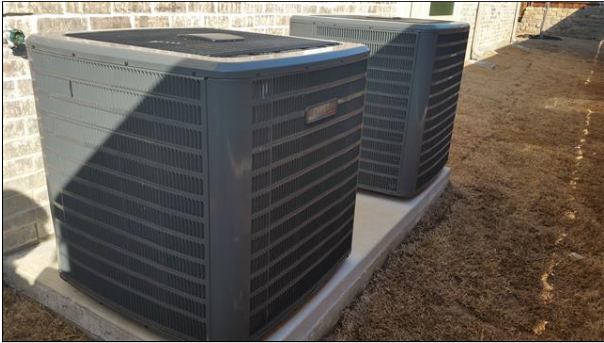
B. Item 1(Picture)

(2) Downstairs / Upstairs air conditioning unit does not appear to be functioning properly. No noticeable cooling was achieved when operated. Multiple possible causes exist. Review and repair by licensed HVAC contractor, including but not limited to compressor amp check, contact check, refrigerant check (look for leaks if refrigerant is added). Inspect and clean all coils as needed and acquire certification of proper function of complete AC system.
