Vincent & Bryte Bellotti
Inspection Address: 1018 Carolyn Ave
San Jose, CA

Inspection Date: 2/1/2021

INSPECTOR: CRAIG MOORHEAD

Craig Moorhead
WellHouse Corporation - Building Inspections

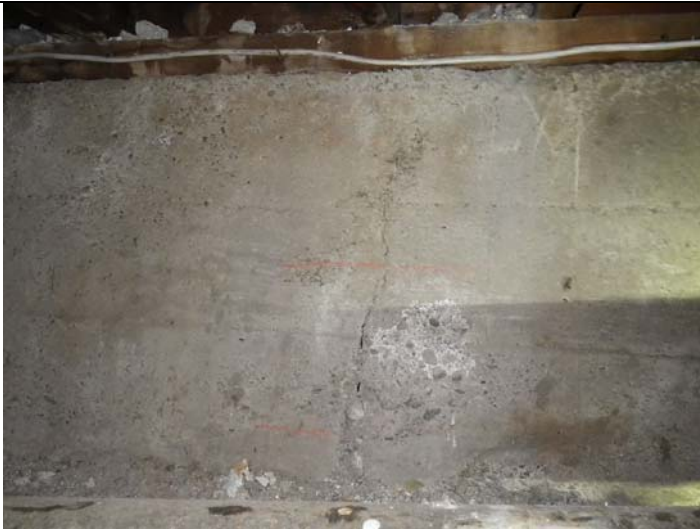
Figure 1(# 1667)

- 4.4. The general condition of the foundation at the front left and left appeared to be serviceable with crack(s) approximately up to an 1/8 inch . Refer to other related foundation comments. (See figure # 1)

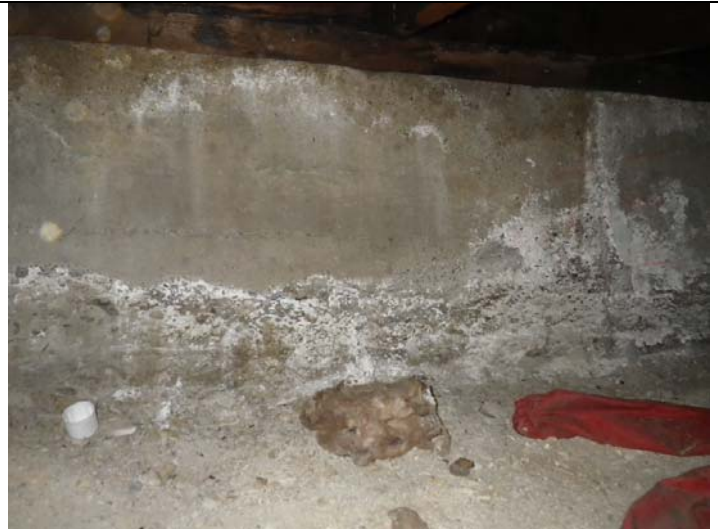
Figure 2(# 1685)

- 4.6. Spalling (deterioration) was noted at the right and right-front surface of the foundation and was affecting up to a 1/2 inch of the surface. While this is a common condition with older concrete foundations and is generally caused by moist conditions and the general aging of the concrete, this appeared to be unusually heavy. Interested parties should refer to a licensed contractor specializing in foundations and/or a civil engineer for more detailed inspection and information. (See figure # 2)

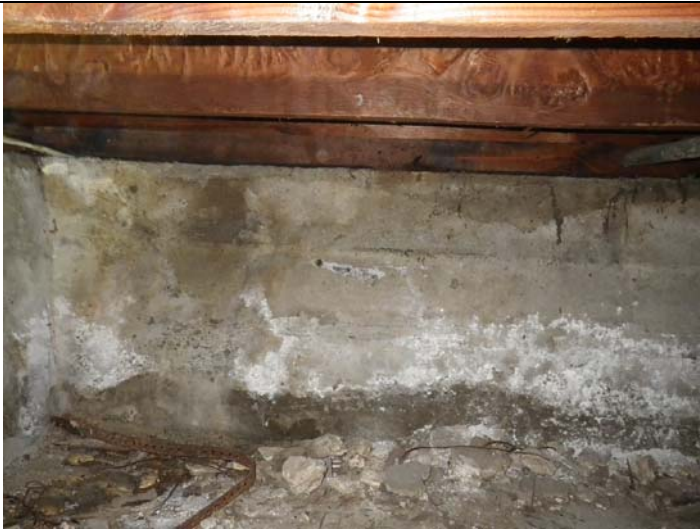
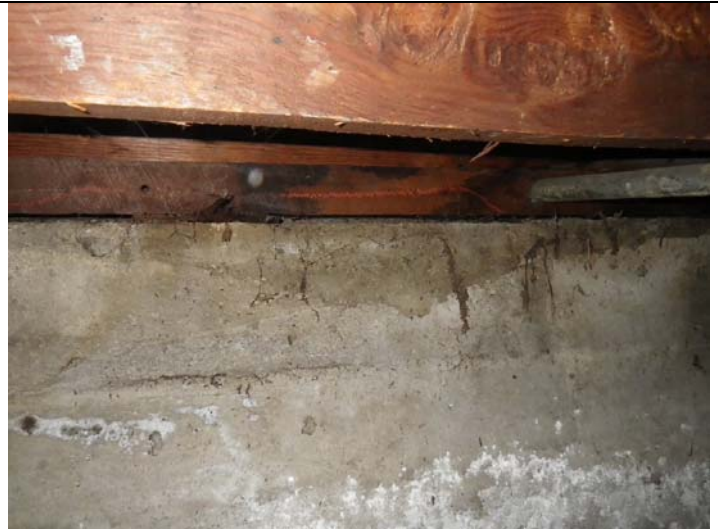
- 4.8. Gaps of up to a 1/16 inch were noted at the back foundation and sill plate juncture(s). Refer to other related comments. (See figures # 3, 4)
- 4.9. Earth / wood contact was noted at the pier/post(s) visible in the sub-area including the fireplace hearth location(s). This condition may promote premature damage and wood destroying insects and should be modified / repaired. Refer to the structural pest control report for possible comments. (See figure # 5)

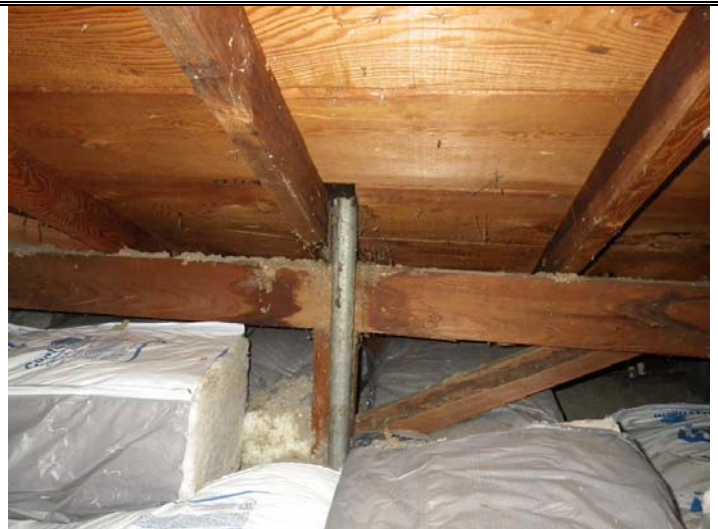
Figure 6(# 1657)

- 4.10. Moisture stains at the roof and/or ceiling framing were noted from the attic and visible at the plumbing vent pipes location(s) when inspected. This appeared to be due to previous roof leakage predating the roof replacement. Interested parties should refer to the current owner for possible related information. (See figure # 6)

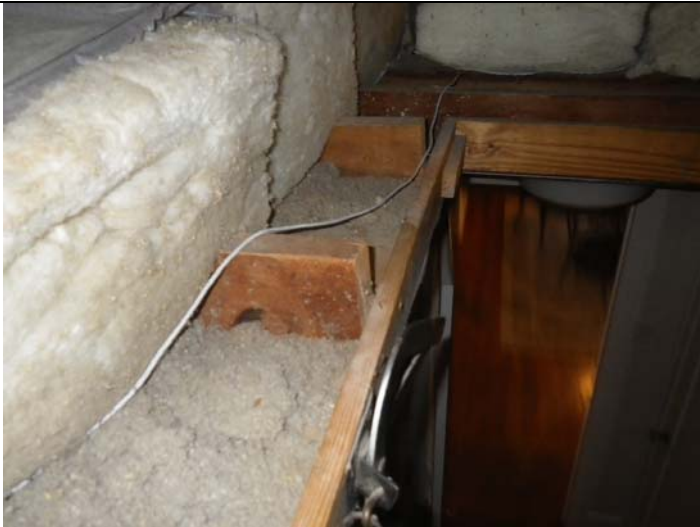
Figure 7(# 1661)

- 4.12. Improperly cut/modified ceiling framing at the pull-down-ladder was noted. This is a substandard condition and in need of attention. (See figure # 7)

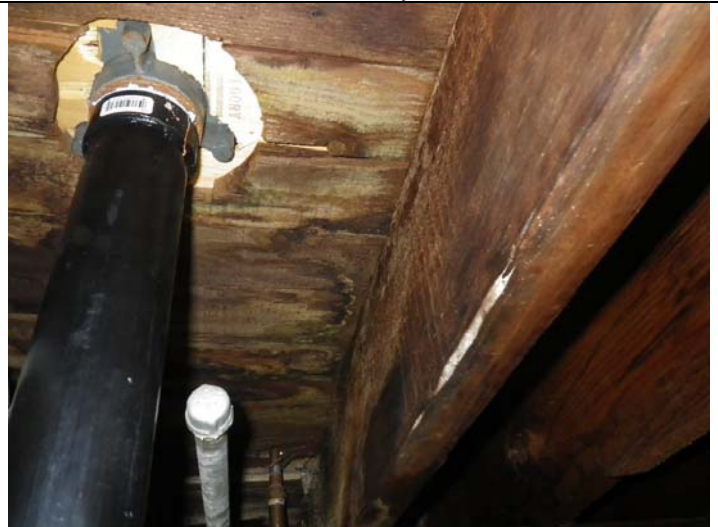
Figure 8(# 1666)

- 4.13. Crawlpace: Moisture stains were noted at the underside of the sub-floor and/or framing including the hall bathroom sub-area(s). This appeared to be due to previous conditions when examined. Interested parties should refer to the current owner for possible historical information regarding the source of the stains. Further evaluation may be needed to determine if this is a current condition. It is recommended to refer to the pest control report for possible related comments. (See figure # 8)

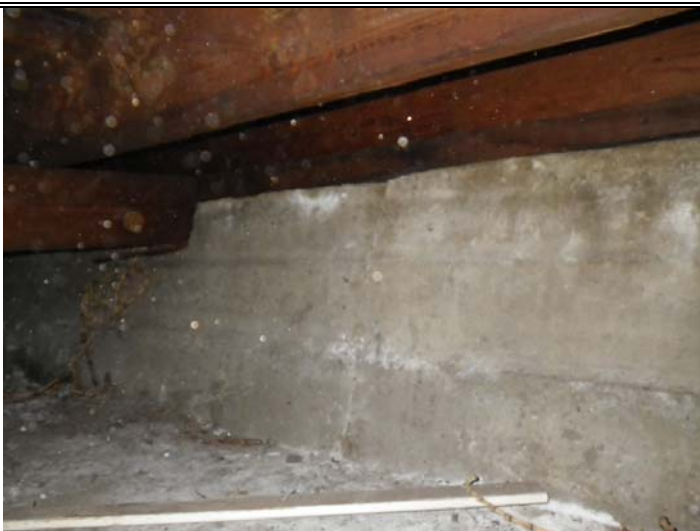
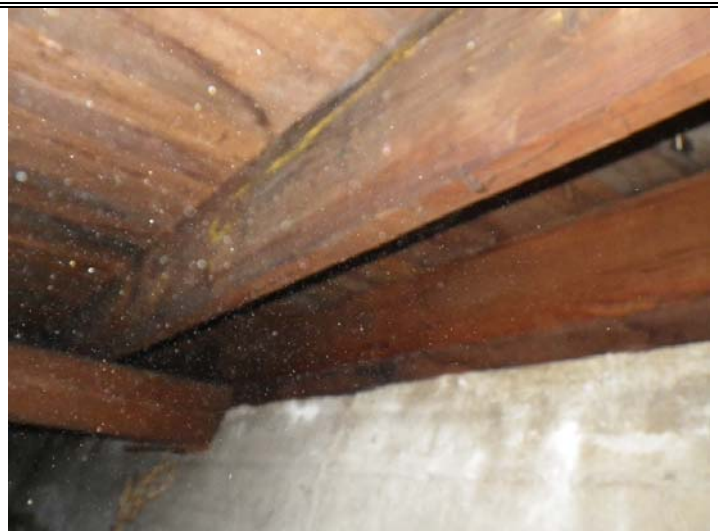
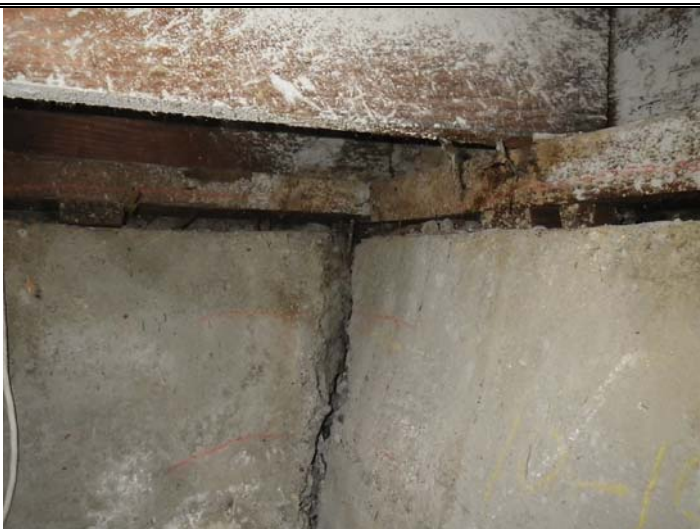
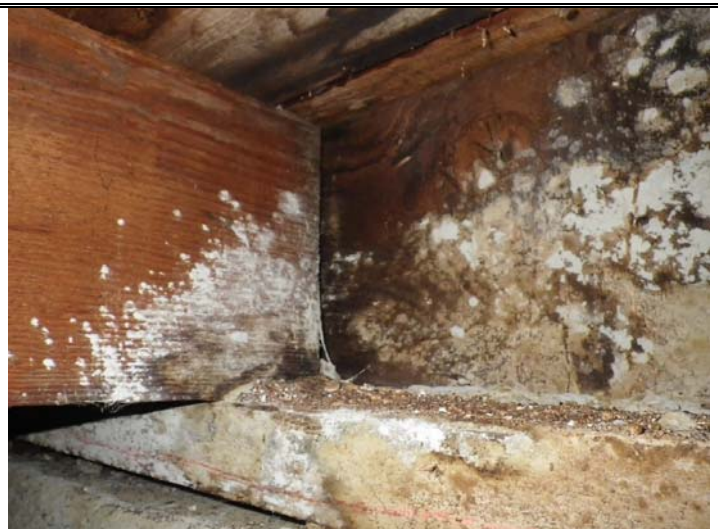
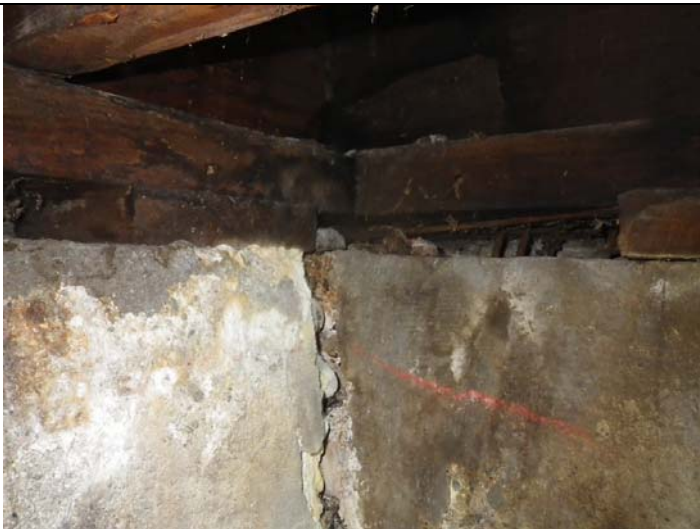
- 4.15. Crawlpace: A crack with differential shifting up to about 1/2 inch was visible at the back-right foundation. Cracks up to 1 1/2 inches were visible at the back right and right front foundations. Gaps up to one or more inches was noted between the foundation and mud sill at the front living room, right, and right-half of the back foundations. Additionally, at these locations the rim joist was angled outward at its lower area. These conditions appeared to be due/related to previous long-term settlement in the foundation that has also caused the foundation to rotate. Further inspection/evaluation by qualified engineer is recommended. (See figures # 9, 10, 11, 12, 13)

4.19. Further inspection of the foundation and framing connection to the foundation by a qualified engineer is recommended.

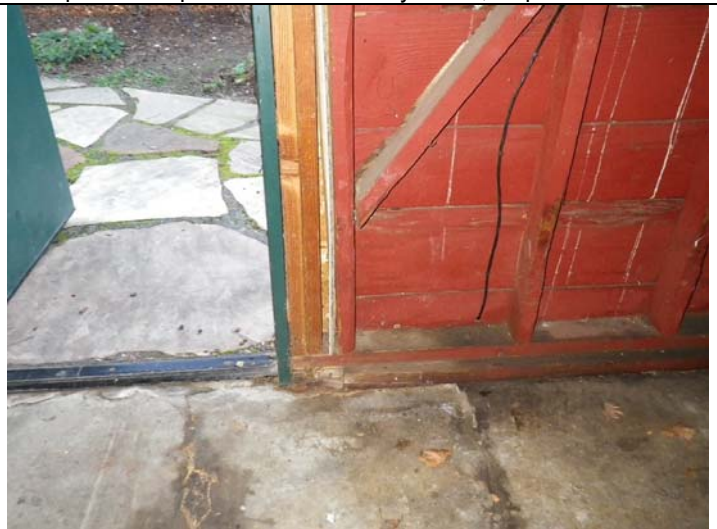
Figure 14(# 1645)

- 4.16. Garage: Diagonal bracing was cut/modified at the back wall for the purpose of adding the secondary man door. There was no visible means of reconnecting or strengthening the diagonal bracing on either side of the door related to the modifications and has resulted in a weakened condition. Further attention/repair is recommended as a preventative measure. (See figure # 14)

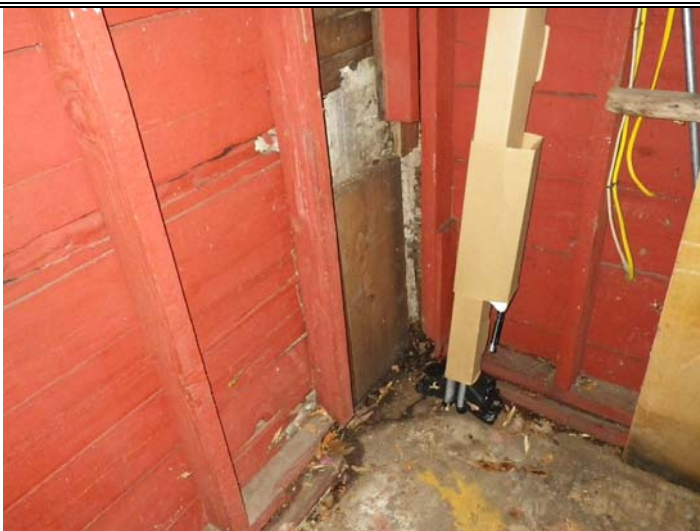
Figure 15(# 1647)

4.17. Garage: Damaged and missing framing components were noted at the back left corner of the garage and included elements at the roof, mid- wall and lower wall areas including missing bottom plates. This appears to be due/related to long-term previous leaking at the roof drain through the parapet. Repair is needed by a qualified contractor and will require coordination with a roofing contractor. Interested parties should refer to the structural pest control report for possible related comments. (See figure # 15)

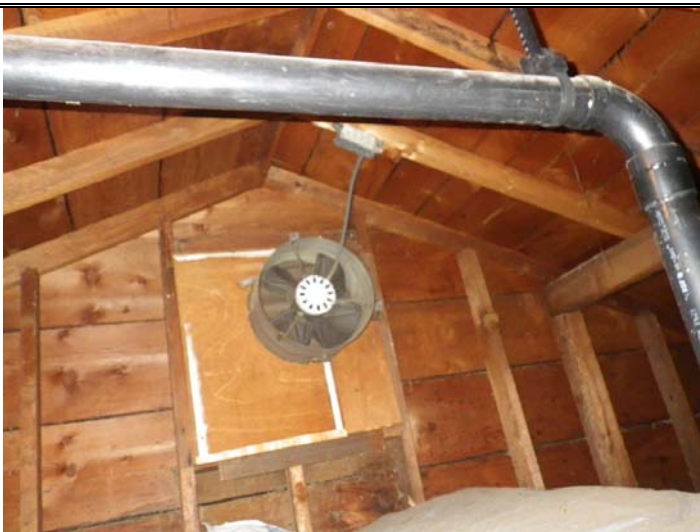
Figure 17(# 1658)

5.1. A thermostatically controlled fan was installed to ventilate the attic. These are generally designed to automatically activate at a preset temperature, and are generally effective for ventilation of the attic. However, these devices will also automatically activate during a fire and could increase the rate of burning. Maintaining a manual disconnect (switch) that is accessible is recommended and should be generally kept in the off position when extended periods of non-use is expected. Interested parties should refer to the current owner for possible information regarding the existence / location of the manual disconnect switch for the attic exhaust fan. (See figure # 17)

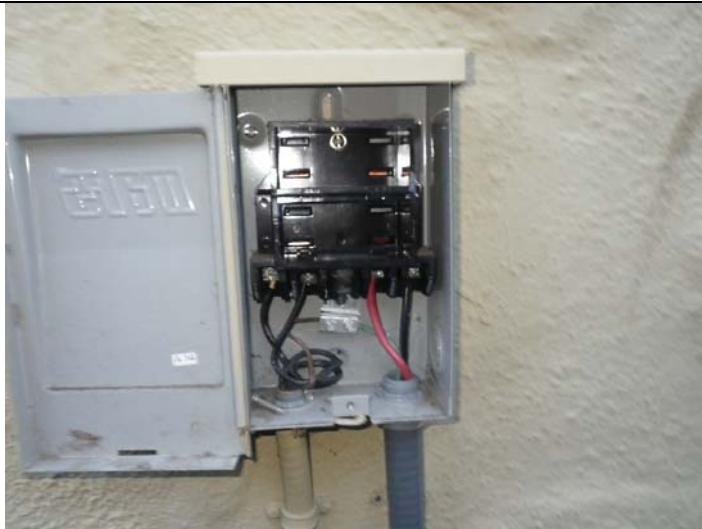
Figure 19(# 1653)

An electrical disconnect panel was installed at the back and was servicing the nearby air-conditioning equipment. (See figure # 19)
