Inspection Report

Property Address:
9876 Sloppy Construction
Plano TX 75074

PROPERTY INSPECTION REPORT

By: Kevin R. Weiss 7108 / Absolute Inspections, LLC 1/21/2016

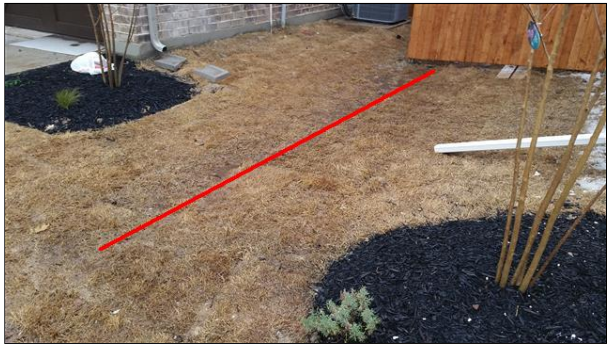
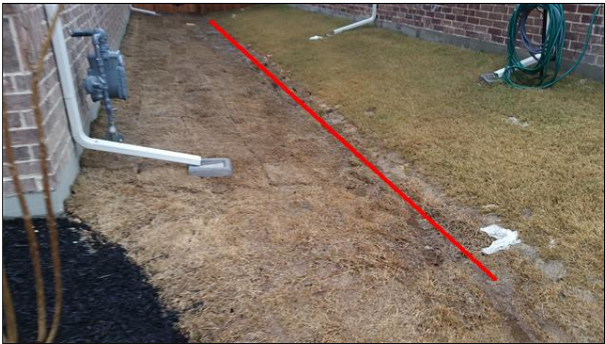
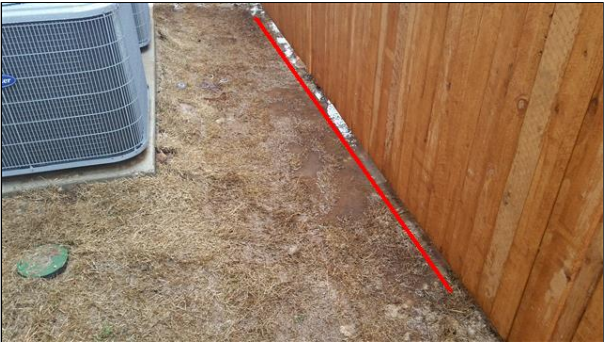
(2) Sod is newly installed. It is difficult in these conditions to accurately determine how the drainage of the property will perform. Adjustments to the drainage may be needed. Monitor the drainage and make requests under your warranty if needed. Sod is uneven in some areas. Recommend that the sod/yard be rolled and leveled before closing. Uneven sod or ground will not "self level" over time.
-

(3) Sod installation is uneven in some areas. This condition will not "self correct" over time. Recommend repair by qualified landscaping contractor. Typical repair involves "rolling" the sod to make it more even, but other remedies may exist.

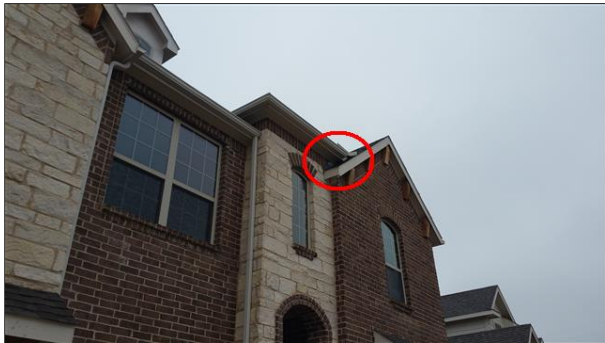
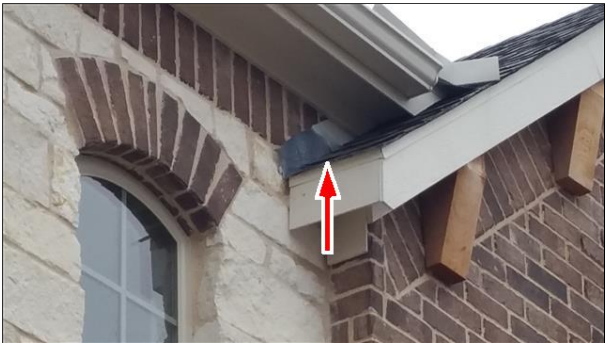
(2) Roof observed from ground with binoculars due to wet conditions and /or the height and/or pitch of the roof making it unsafe for the inspector to walk. Because the roof was observed from the ground and roof edge some areas may not be visible and are not inspected. Any areas not visible from the ground are disclaimed and excluded from the inspection. You should consult a licensed roofing contractor if you desire to have a professional actually walk this roof.

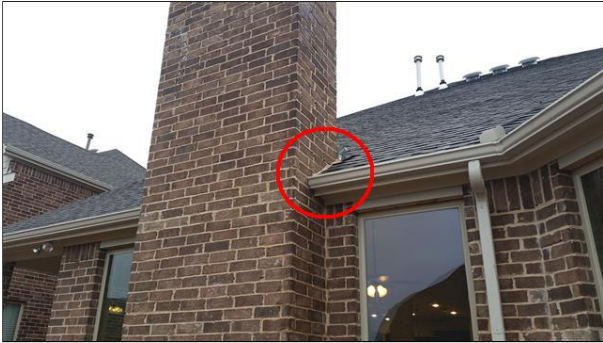
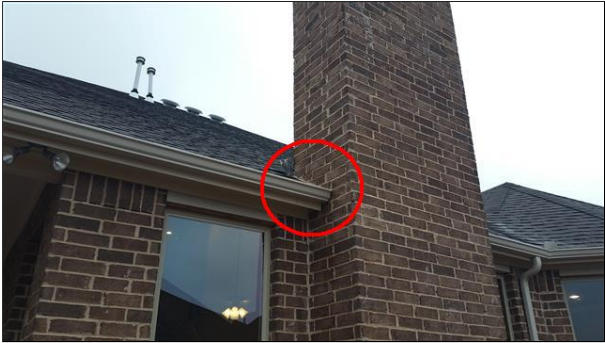
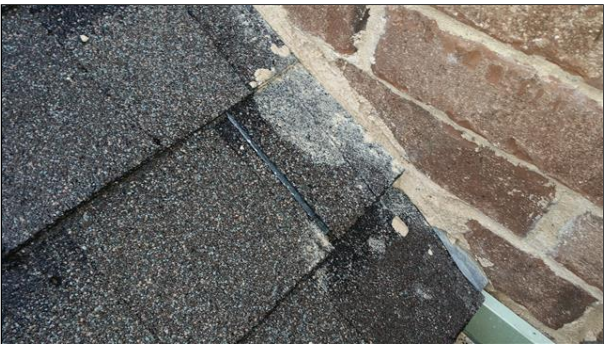
(3) Improper flashing installation observed at area pictured. No counter flashing installed. Potential moisture entry point. Recommend review and repair as needed by a qualified contractor.

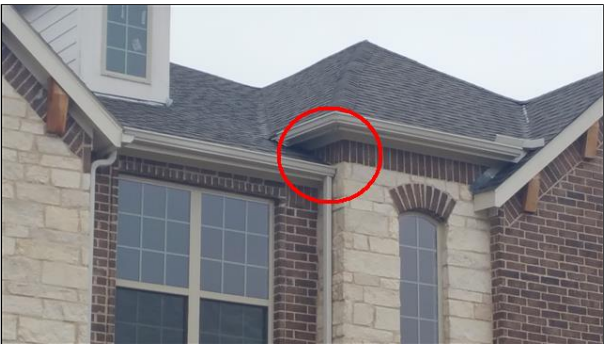
C. Item 6(Picture)

(4) Chimney is not properly flashed. Not counter flashing observed. Recommend review and repair as needed by a qualified contractor.

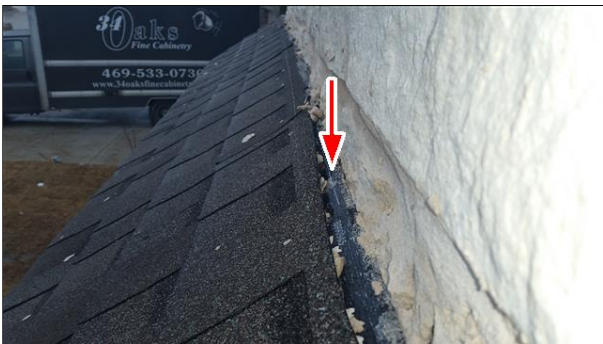
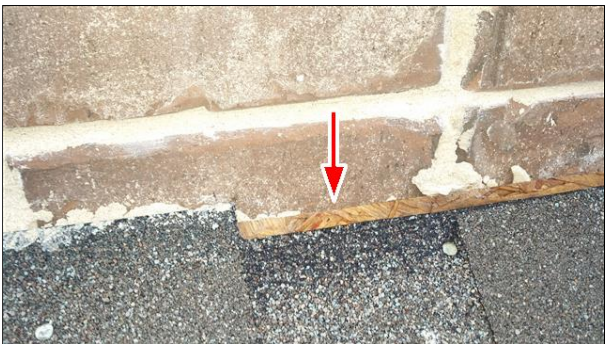
(5) Roof step flashing and counter flashing not installed at front area pictured. Recommend review and repair as needed by a qualified contractor.

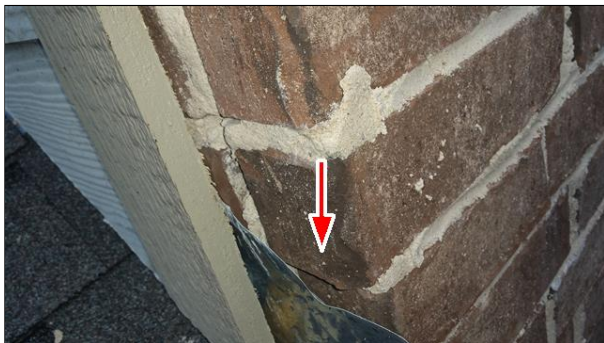
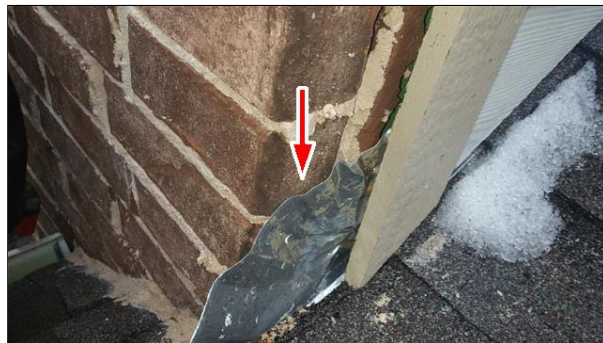
(6) Front lower roofs have no flashing. Completely improper. Recommend review and repair as needed by a qualified contractor.

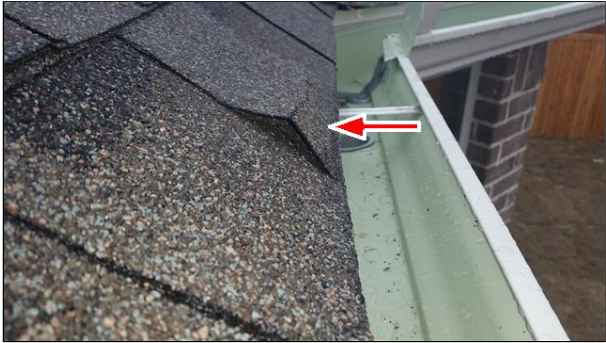
C. Item 14(Picture)

(9) Unsealed nail holes, probably left from roofer toe board nails, observed on roof. These should penetrations should be sealed with appropriate roofing sealant. Pictures represent examples, entire roof surface should be carefully checked and repaired as needed.

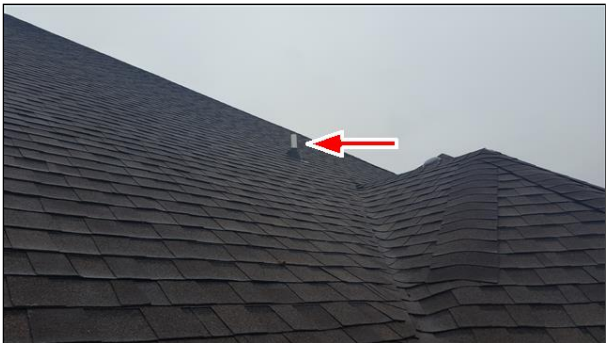
C. Item 15(Picture) Example of unpainted pipe

(11) PVC plumbing vent pipe not painted. Recommend painting exposed PVC to prevent possible UV damage to the material of the pipe.

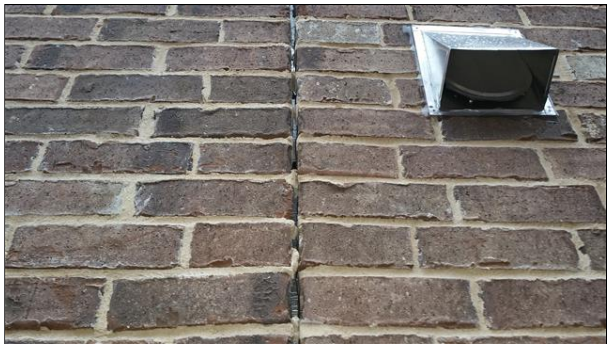
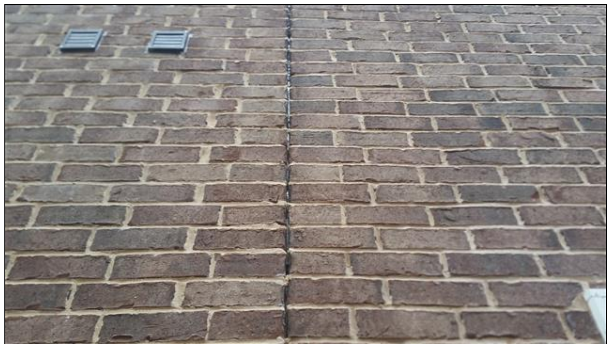
- (2) Expansion joints not completely free of rigid mortar materials. By design expansion joints should be completely free of all rigid materials and should extend completely through the brick veneer height. Recommend removal of all rigid materials and reapplication of an appropriate elastomer type sealant in joint.
- (3) Expansion joint not sealed / completely sealed. Should be sealed with a appropriate elastomer sealant.

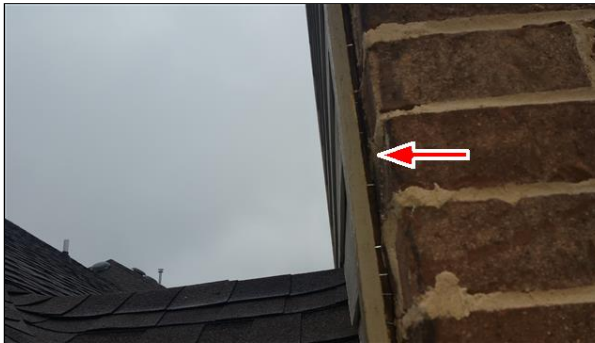
E. Item 3(Picture)

(4) Vertical trim pieces were observed to not be caulked at intersection with brick veneer. Recommend the addition of caulk s in these locations.

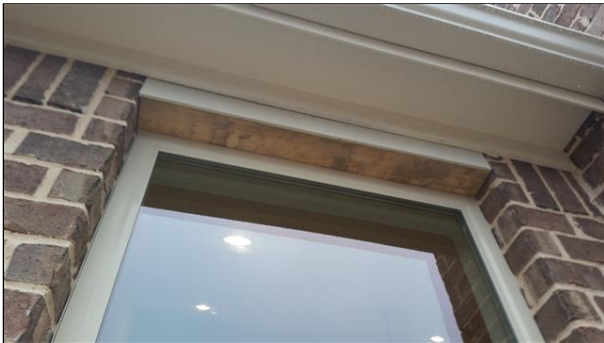
H. Item 2(Picture)

(3) Window exteriors have not been caulked. Recommend review and repair as needed by a qualified contractor.

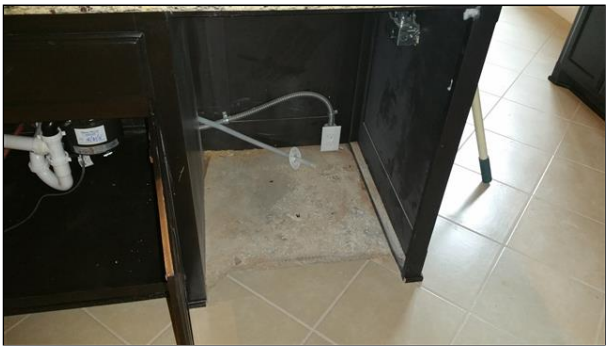
A. Item 1(Picture)

☒ (2) Unit not present. Appears to have been stolen.

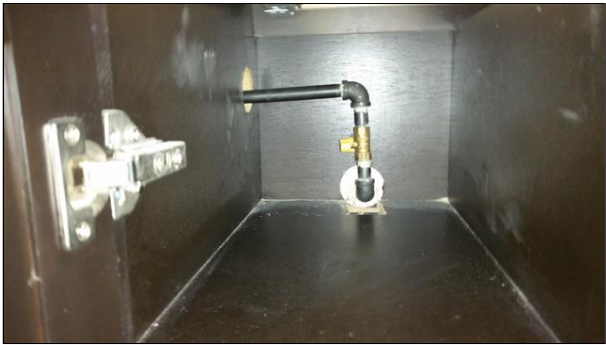
D. Item 1(Picture)

- (1) Gas turned off at valve. Inspector does not turn on valves found in the off position. Not inspected.
- (2) Top oven heated to 370 degrees when set at 350 degrees. This is within the TREC accepted range of +/- 25.
- (3) Bottom oven heated to 365 degrees when set at 350 degrees. This is within the TREC accepted range of +/- 25.
