PRE-DRYWALL

1234 Main St. Colleyville Texas 76034

Buyer Name
07/20/2020 9:00AM

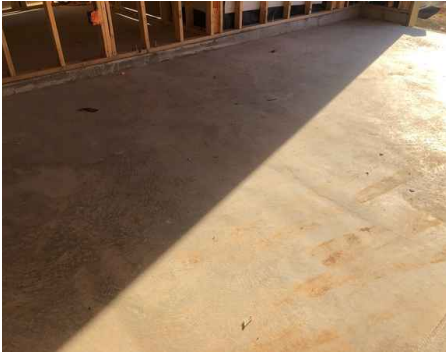
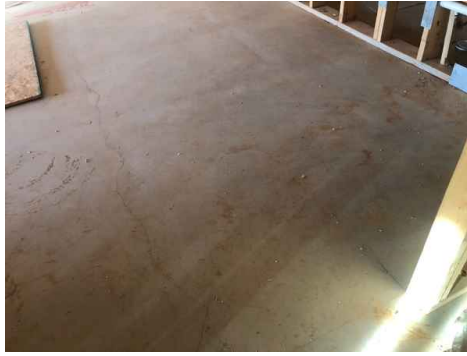
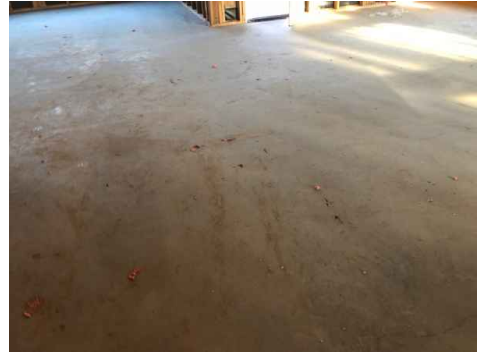
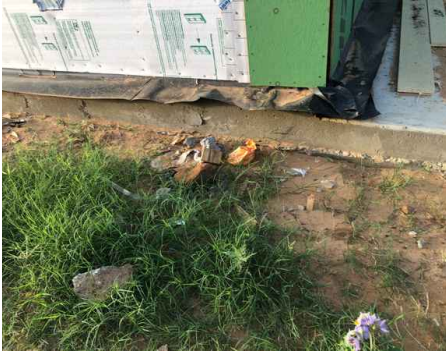
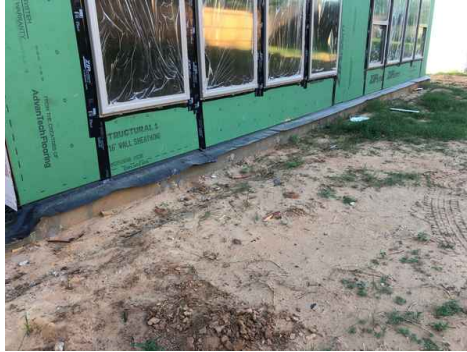
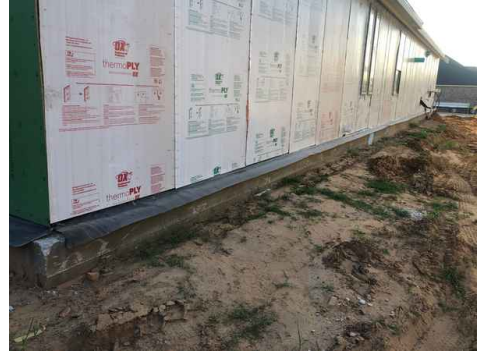
Foundation appeared to be properly finished.

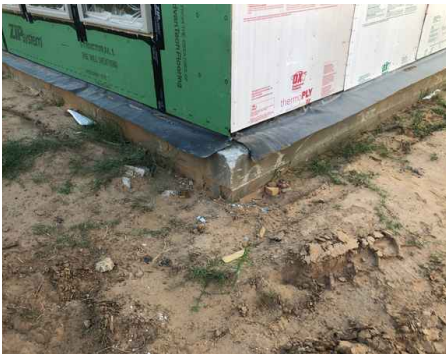
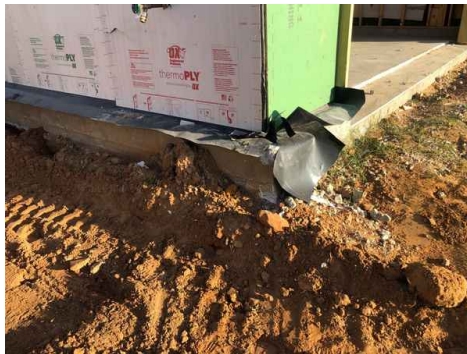
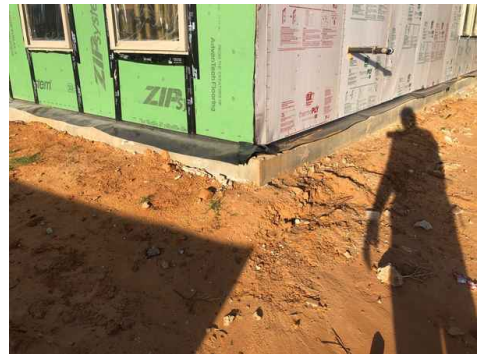
Form Boards have been removed.

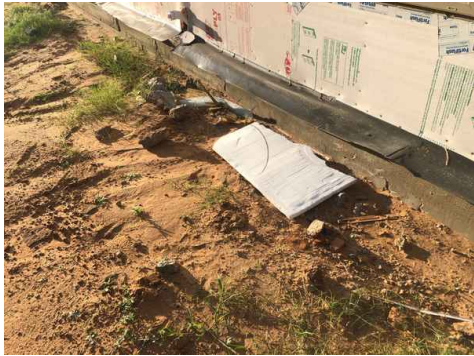
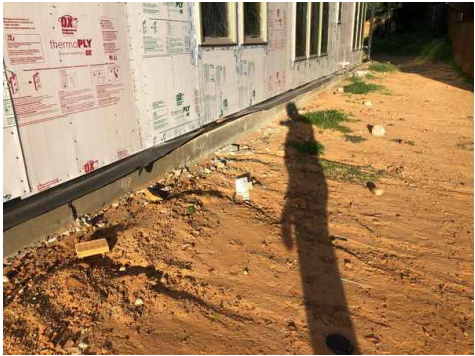
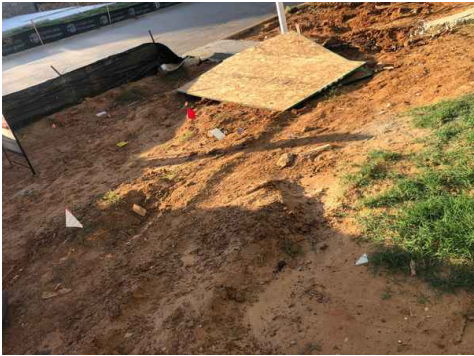
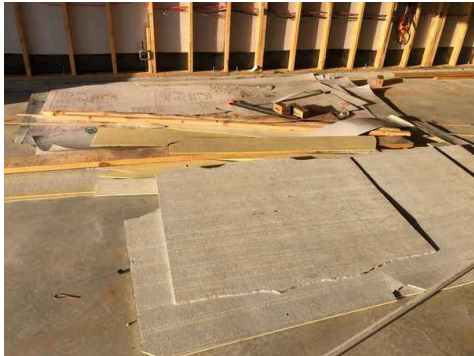
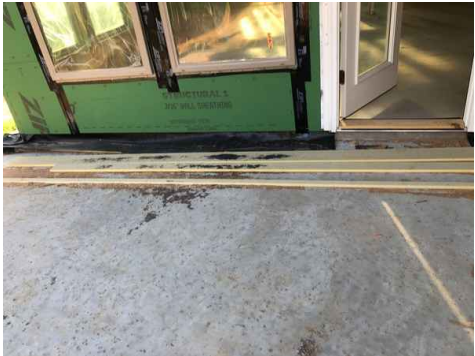
3.2.1 Job Site Clean

JOBSITE DIRTY

The Jobsite was dirty and had extra material laying around.

Contact your builder.

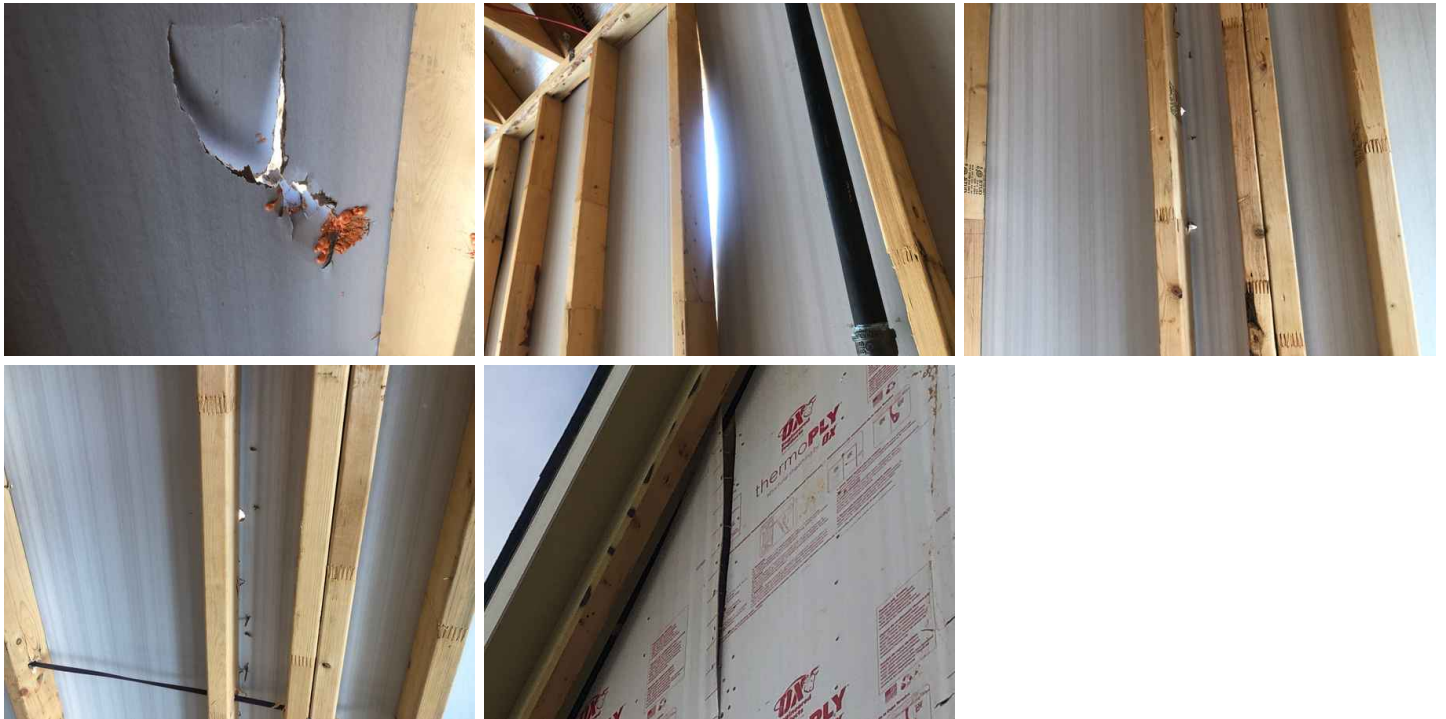
6.1.1 Wall Sheathing

EXTERIOR WALL PENETRATIONS

The Pipes/Vents were not taped around the perimeter as per manufacturer requirements. We recommend to inspect and tape.

Contact your builder.

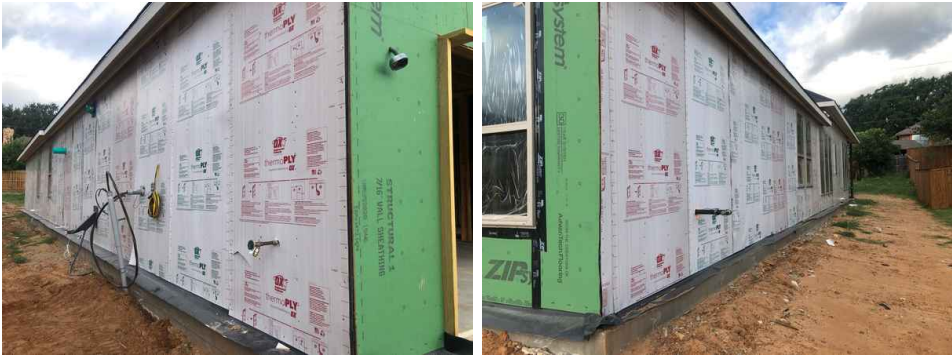
6.2.1 House Wrap & Metal Lath

MISSING HOUSE WRAP

The House Wrap has not been completed. We recommend to inspect and install.

Contact your builder.

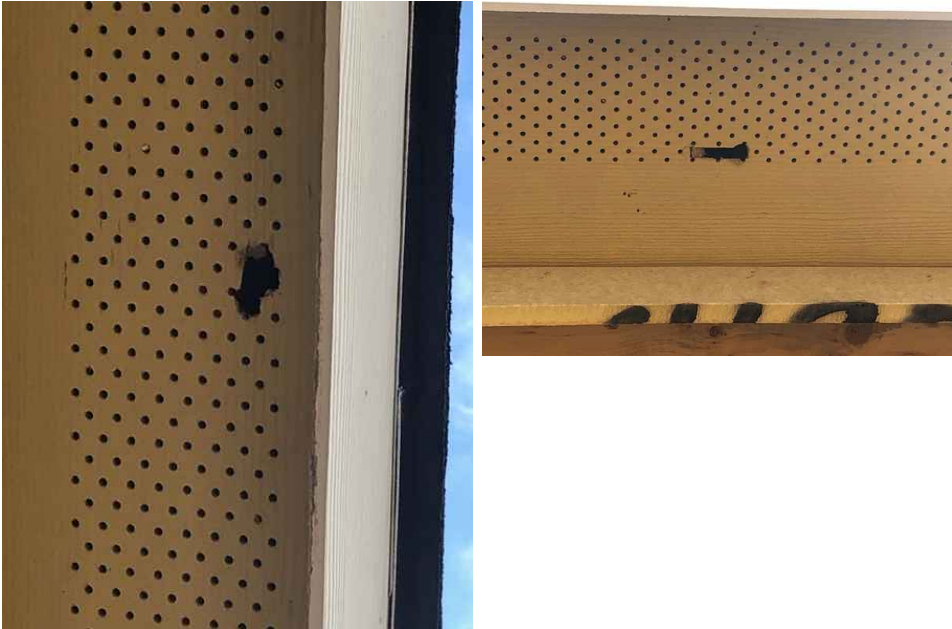
6.3.1 Sub Fascia & Soffit

SOFFIT

The soffit at the left side damaged at the time of the inspection.

Contact a qualified professional.

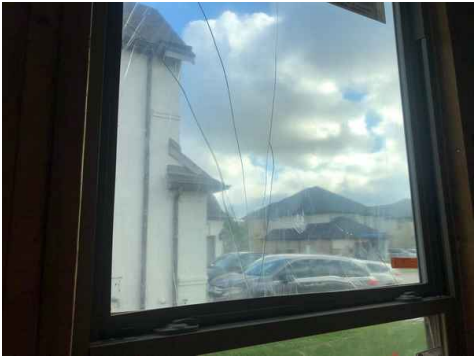
6.4.1 Windows

BROKEN WINDOW GLASS

RIGHT SIDE FRONT WINDOW TOP SASH

The Window Pane was damaged at the time of inspection. We recommend to have a Qualified Person to inspect and replace.

Contact a qualified professional.

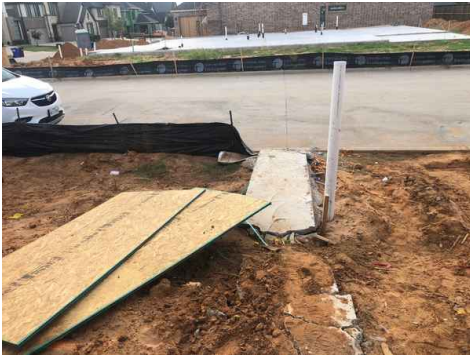
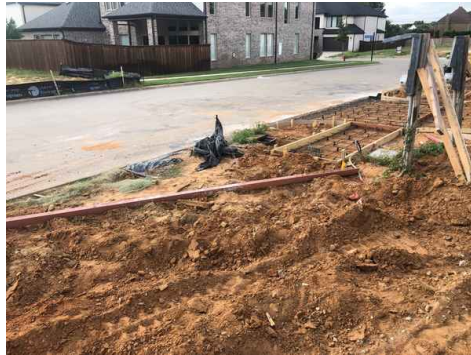
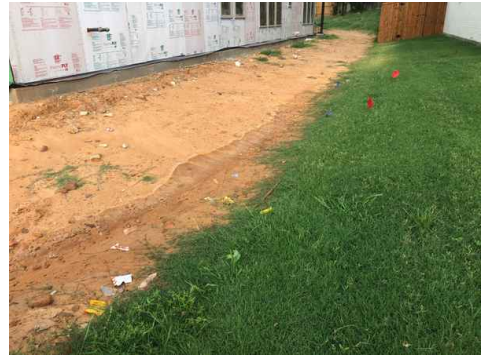
6.7.1 Surface Drainage, Retaining Walls & Grading

SILT FENCE DOWN

The Silt Fence was done at the time of inspection. We recommend to inspect and repair.

Contact your builder.

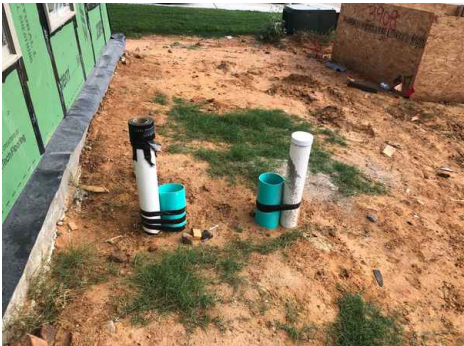
Water Supply For Home Public	Plumbing Water Distribution (Inside Home) CPVC, PEX, PVC	Sewage Disposal Public
Plumbing Waste PVC	Water Heater Power Source Gas (Quick Recovery)	Clean Out Present and Capped: Visible Clean Out The Clean Out was visible and capped. This is for your information.
