EGA HOME INSPECTION

EGA SEWER SCOPE REPORT

1234 Main St. Rocklin Ca 95765

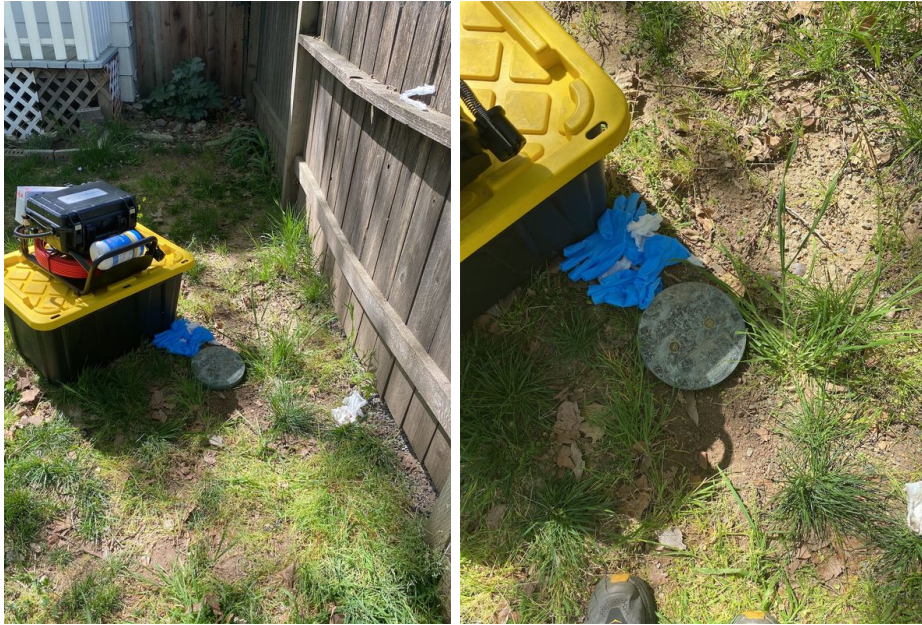
Access Point: Single Outside Clean-Out

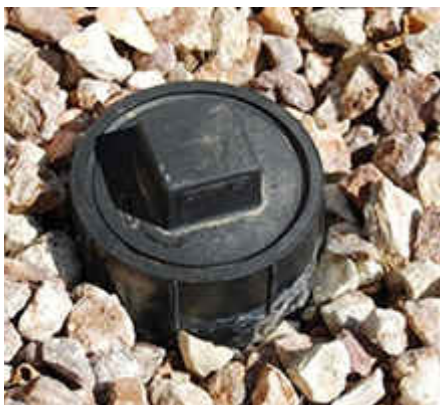
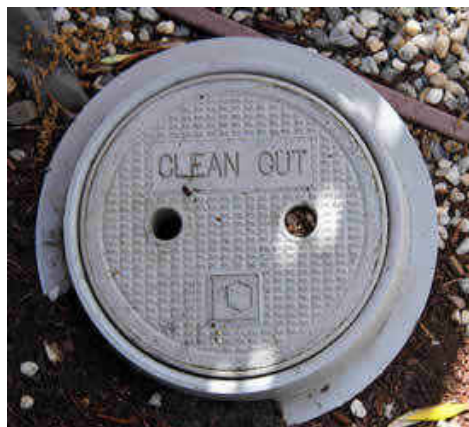
Material: ABS

Sections of the lateral sewer line appeared to be ABS, which is a modern plastic-like material used for constructing residential sewer lines. It is a low maintenance, smooth wall material. We recommend avoiding putting kitchen grease down the home's drains, avoiding the use of chemicals to "repair" clogs, and also avoid flushing wet wipes (even the "flushable" wet wipes).

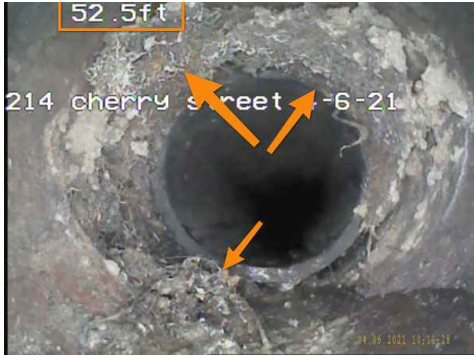
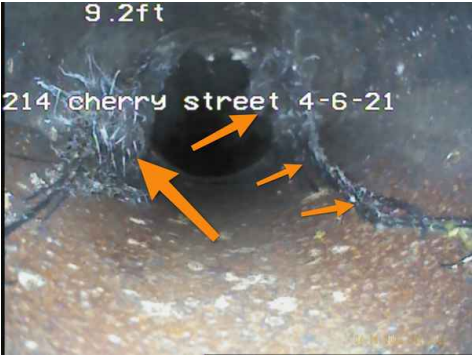
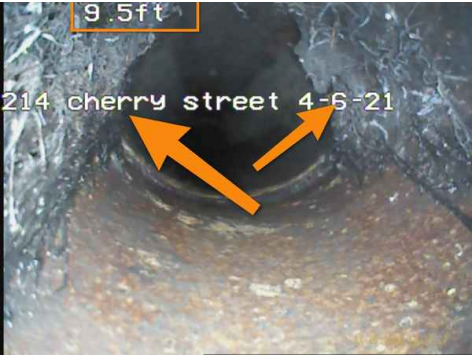
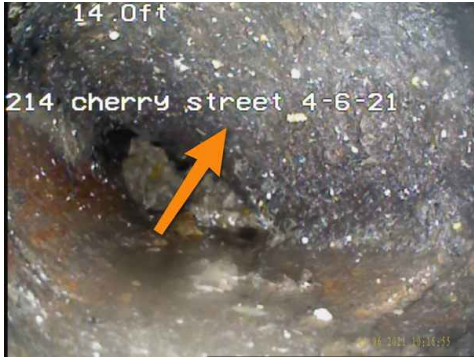
Towards the street

ROOT INTRUSION

Root intrusion was observed inside the lateral sewer line. Root intrusion will collect debris, which will prevent proper flow. In order to allow proper flow, I recommend having the lateral sewer line cleaned by a qualified contractor and then re-inspected prior to closing.

I recommend having the line cleaned, then re-inspected by a qualified sewer professional prior to closing.

Contact a qualified professional.
