Pait Home Inspections of North Carolina, LLC

Home Inspection Report

123 New Home Rd

Thank you for the opportunity to conduct a pre-drywall inspection on your new home. We understand that the function of this report is to assist you in understanding the condition of the property and assist you in ensuring that your contractor is providing you with the quality product that you expect.

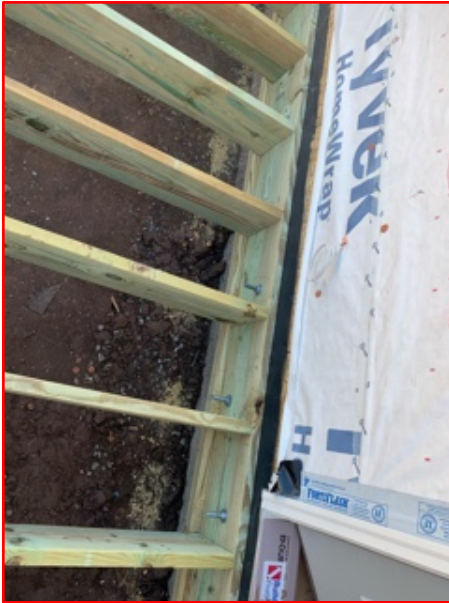
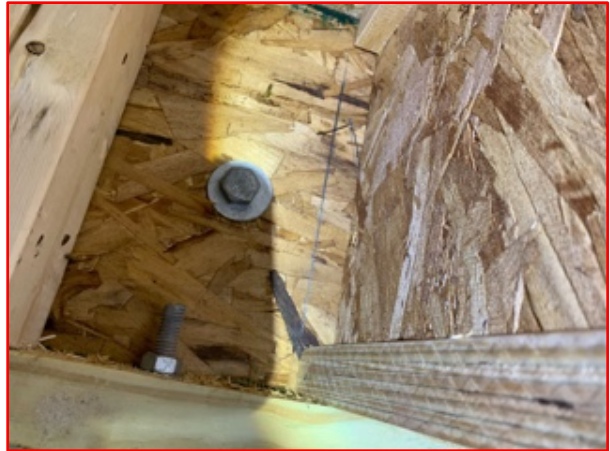
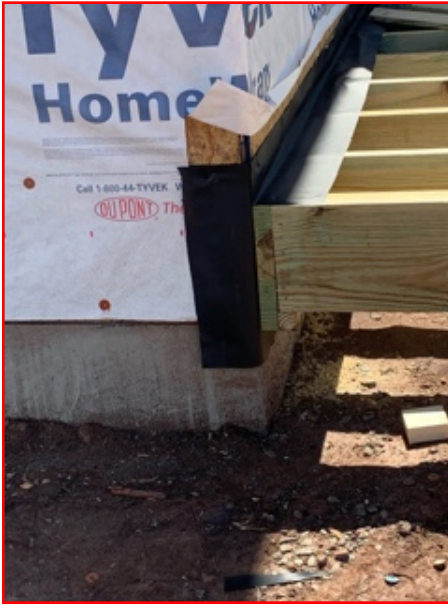
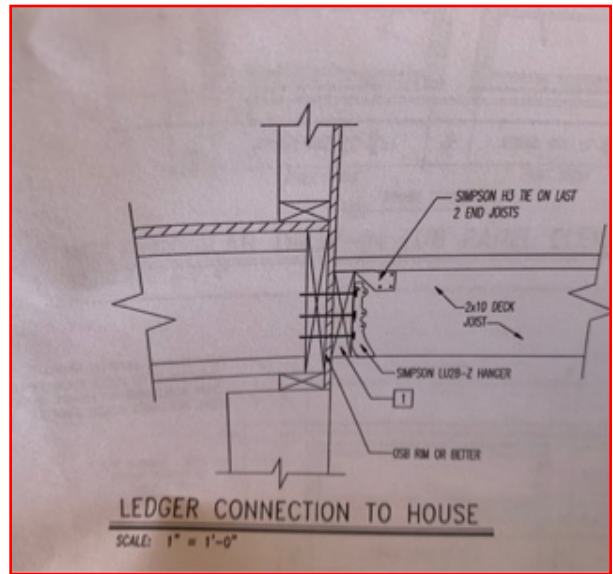
1) The rear deck was not being installed according to sealed building plans. The joists lacked joist hangers, and the ledger was attached only through half-inch OSB sheathing. The plans called for two by blocking to be on the interior side of the OSB sheathing and the ledger bolted through both the two by blocking and the sheathing.

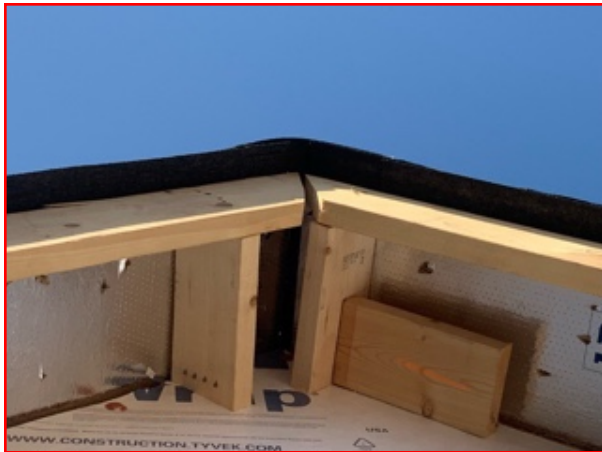
Figure 3-1

2) Gable barge/fly rafters have been cut too short. Over time, this will cause roof decking to sag and rafters to close together. It is recommended to add some blocking behind each fly rafter where they meet at the ridge to reduce this effect in the future.

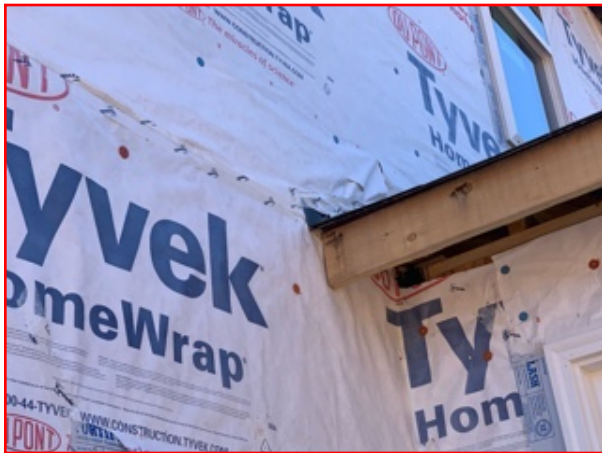
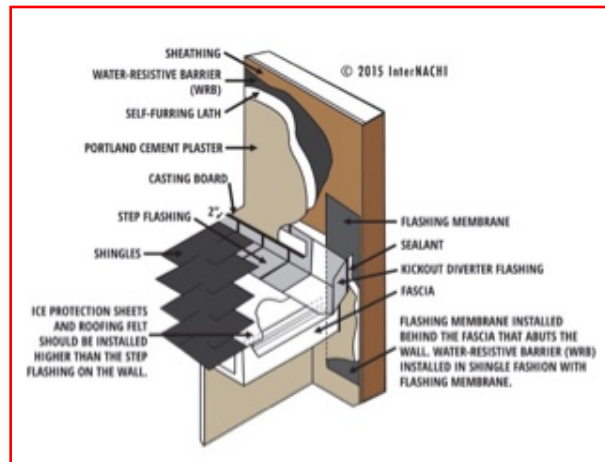
3) Proper kick out flashing is missing. Kick out flashing should be present at all roof and wall intersecting locations to divert water from entering behind the siding. This could lead to water damage of framing materials located behind the exterior cladding. It is recommended that kick out flashing be installed at all similar locations.

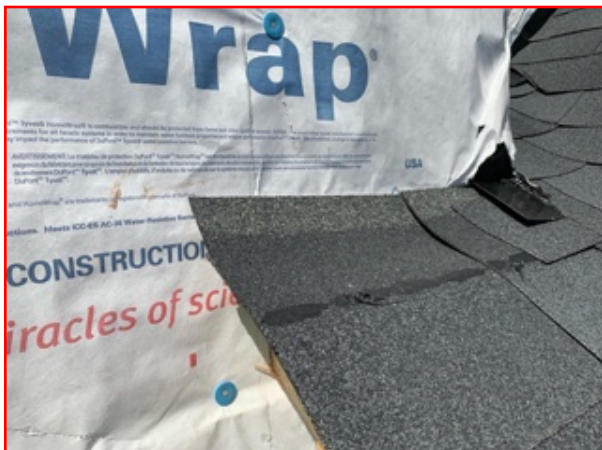
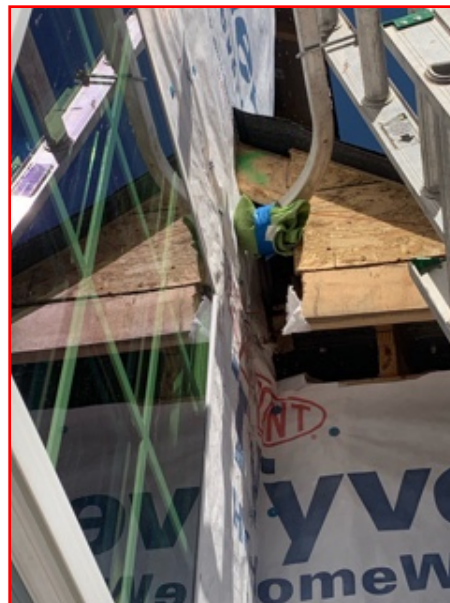
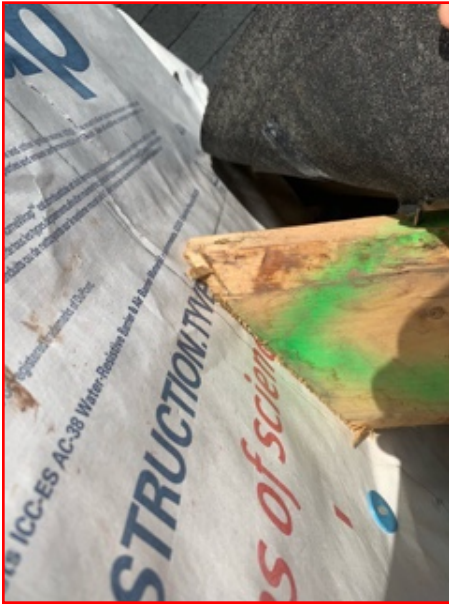
4) The bottom section on the left gable of the garage lacks headwall flashing. In addition, the roof sheathing did not extend all the way up the roof rafter to the wall framing. This caused the shingles to collapse downward. Lack of headwall flashing and lack of sheathing will ultimately result in water intrusion in this location.

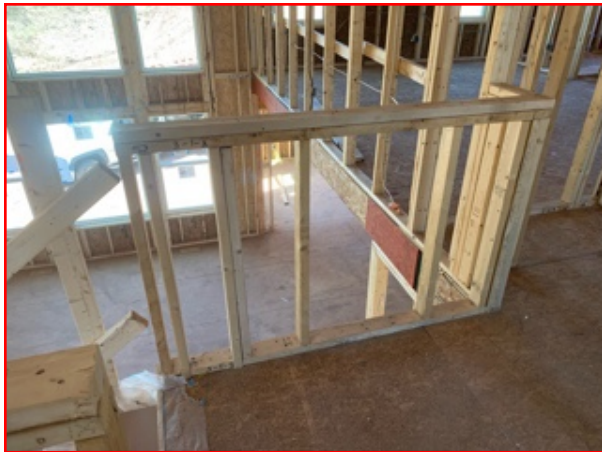
Figure 10-1

5) The knee wall located on the left side of the upstairs landing has been requested to be a stained handrail with iron spindles per the customer.

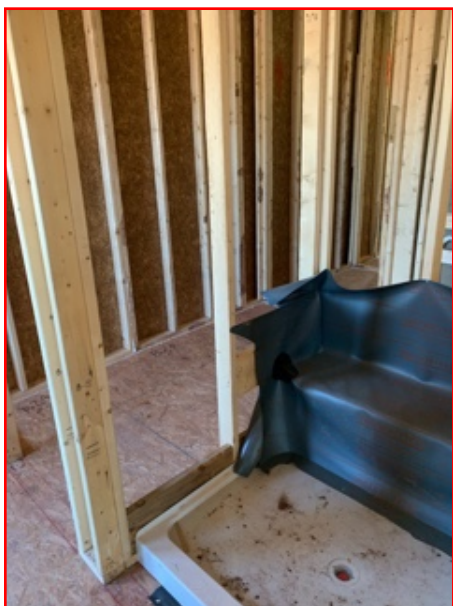
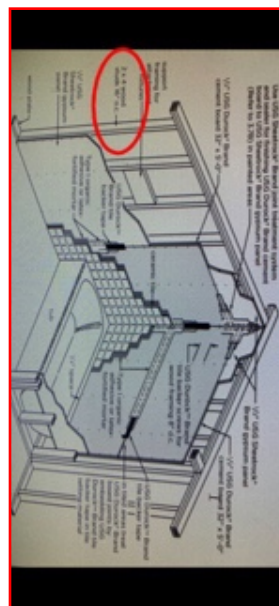
6) The stud spacing at the master shower is too great to allow for proper tile backer strength. Spacing should be a maximum of 16" OC to give the tile back proper support for a long lasting shower surround.

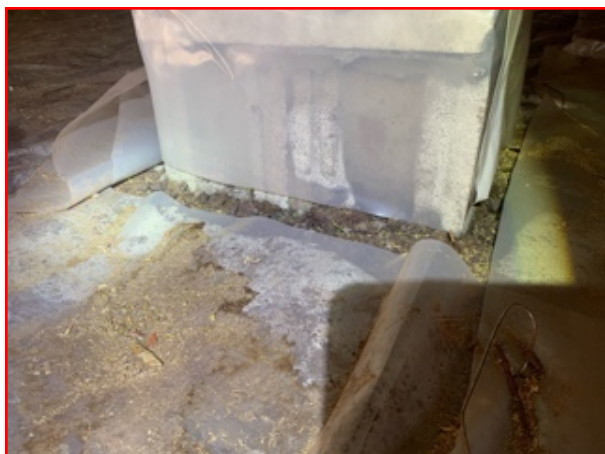
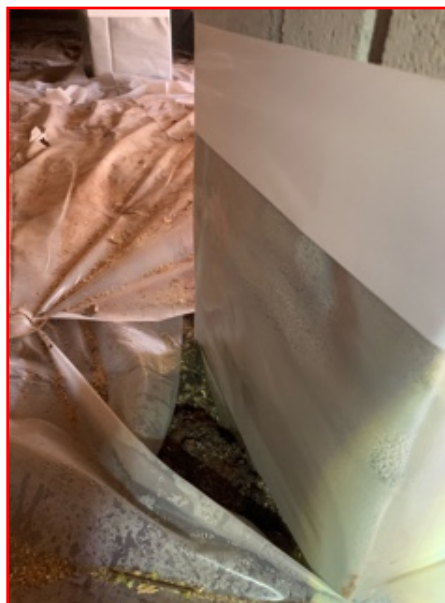
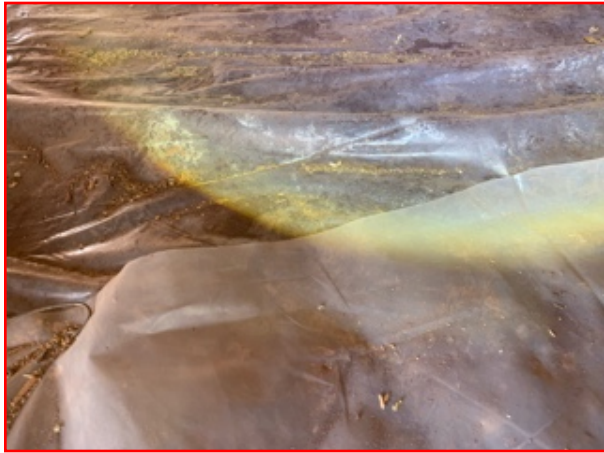
7) Sealed basement criteria has not been met. The vapor retarder seams are not taped, the vapor retarder does not extend up the concrete block pier walls.

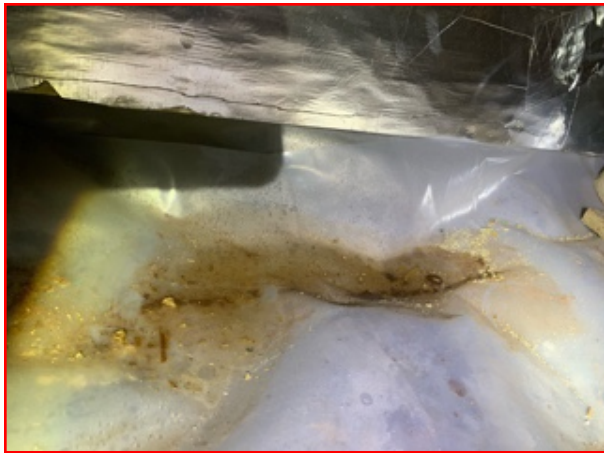
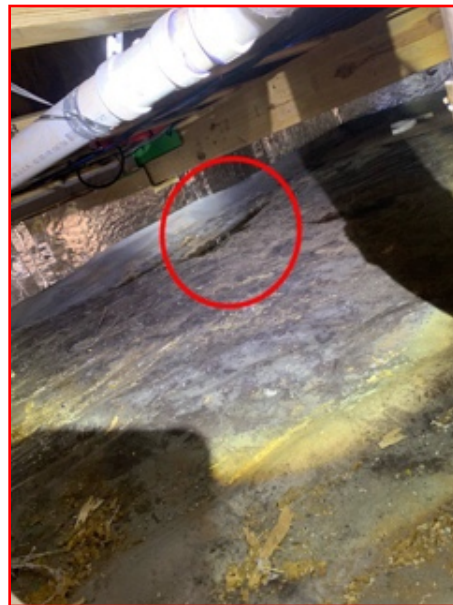
8) Significant amounts of standing water was observed in multiple areas of the crawlspace.

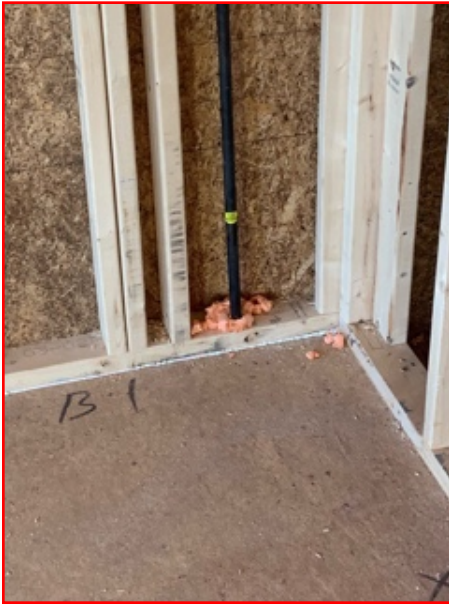
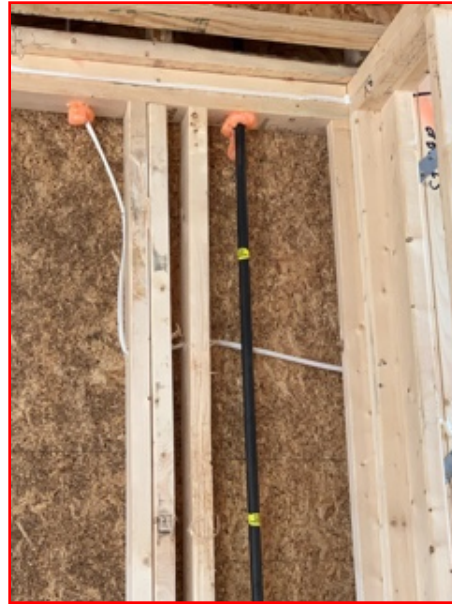
9) Nail plates should be installed where the gas pipe protrudes through sole plates and top plates to prevent accidental fastener penetration. Needed on first and second floors in the "study" and "game room". While fastener penetration is unlikely, for precaution, nail plates are recommended.

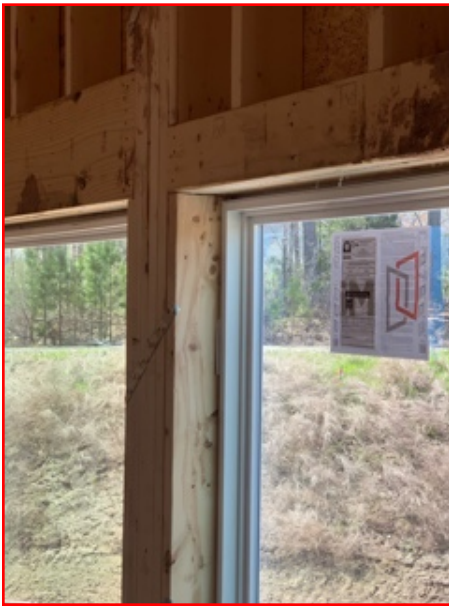
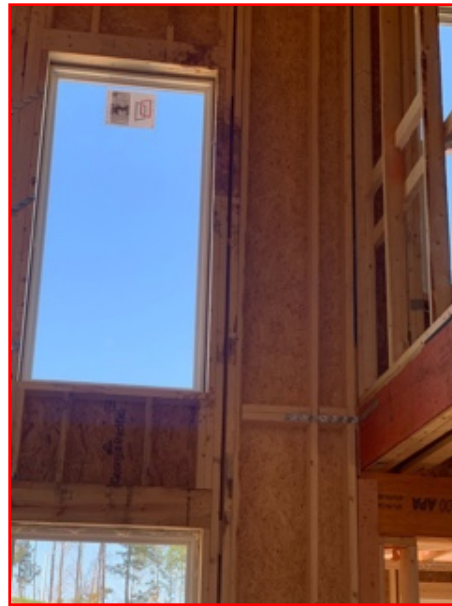
11) Upper windows on the rear family room have not been foam sealed around the edges.

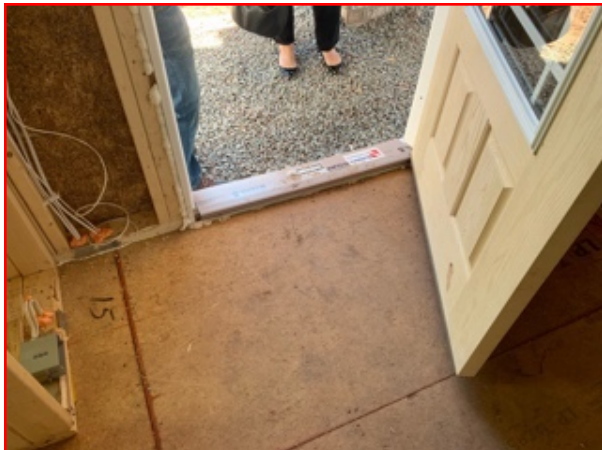
Figure 20-1

12) Install construction adhesive under all exterior door thresholds to prevent movement.

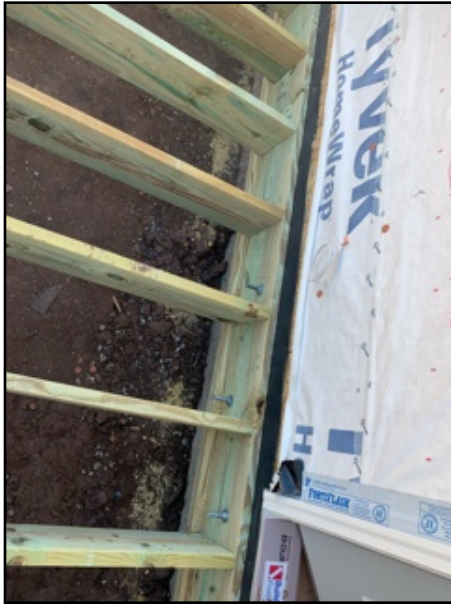
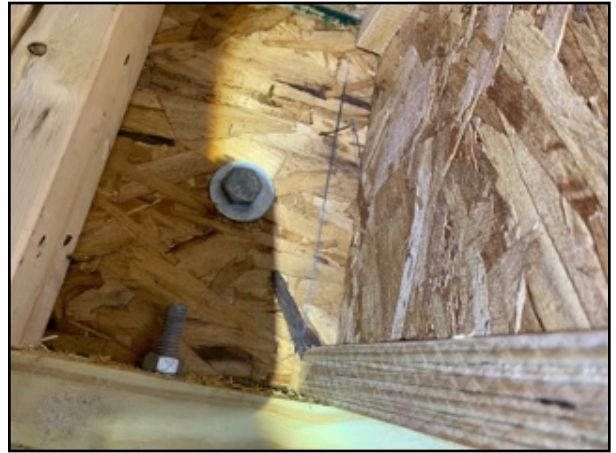
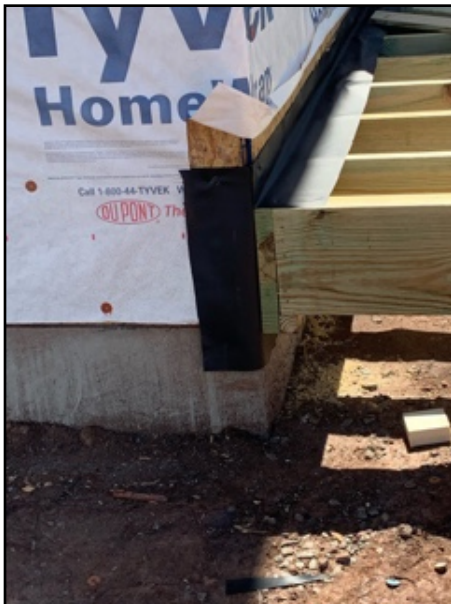
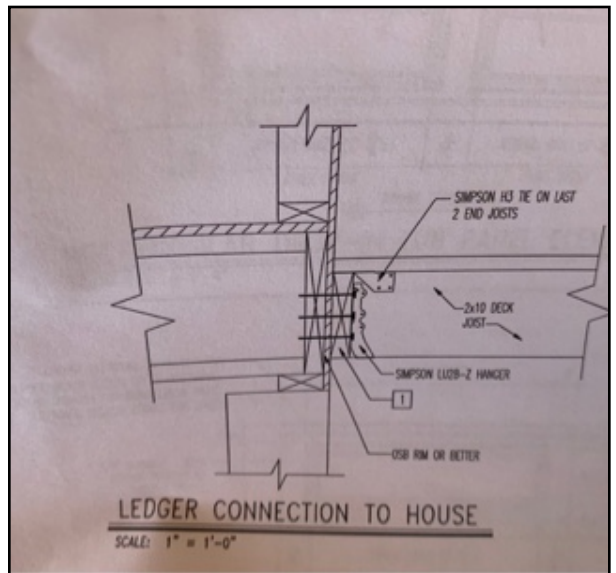
The rear deck was not being installed according to sealed building plans. The joists lacked joist hangers, and the ledger was attached only through half-inch OSB sheathing. The plans called for two by blocking to be on the interior side of the OSB sheathing and the ledger bolted through both the two by blocking and the sheathing.

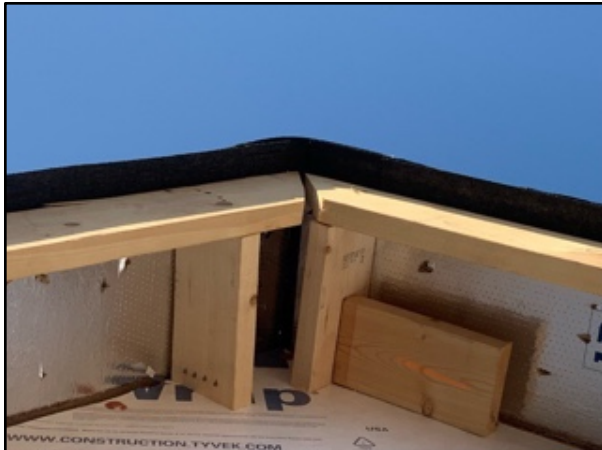
Figure 3-1

Gable barge/fly rafters have been cut too short. Over time, this will cause roof decking to sag and rafters to close together. It is recommended to add some blocking behind each fly rafter where they meet at the ridge to reduce this effect in the future.

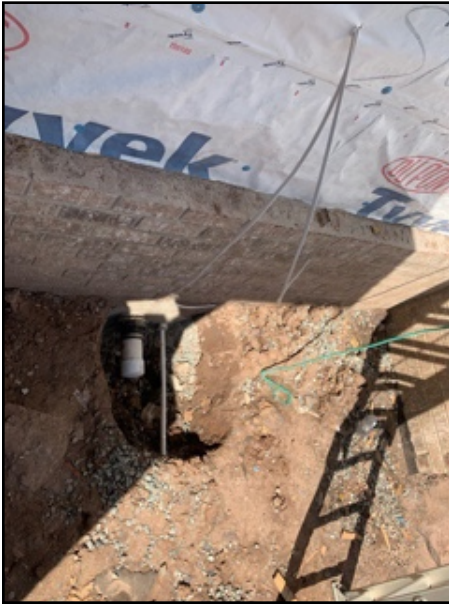
Figure 4-1

Flashing should be installed above the masonry wainscoting on the exterior to ensure no water intrusion.

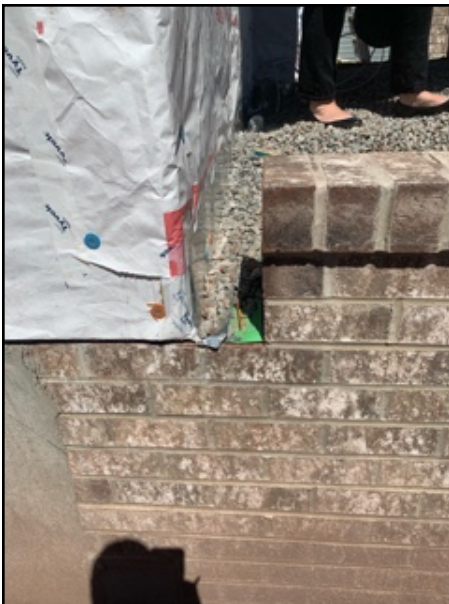
Figure 5-1

Comment 5:
Explanation of masonry gap needed .

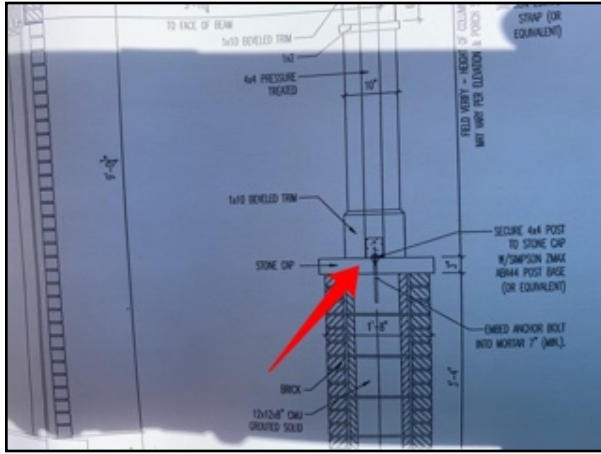
Figure 6-1

i Comment 6:
Ensure proper post base anchors are installed per plans on front porch.

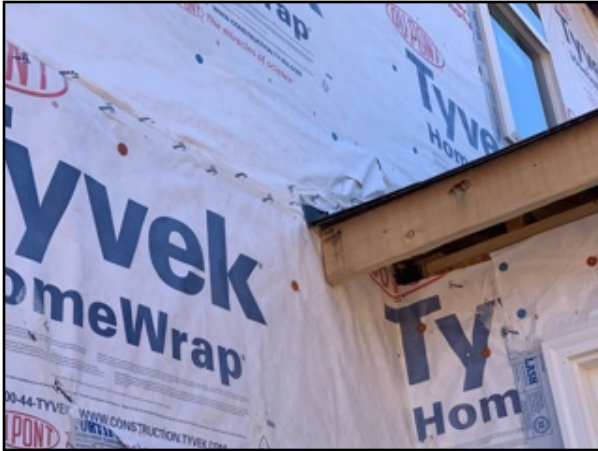
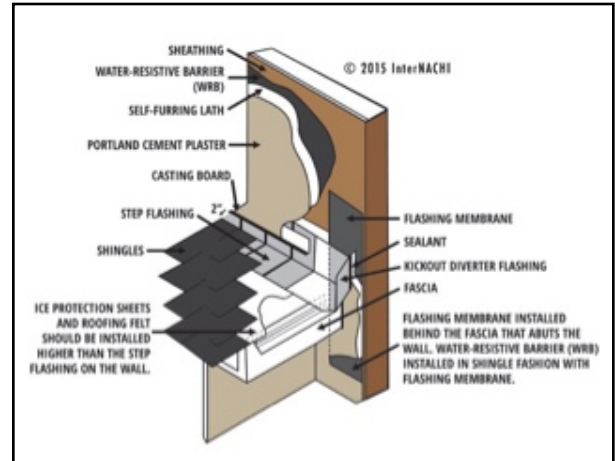
Proper kick out flashing is missing. Kick out flashing should be present at all roof and wall intersecting locations to divert water from entering behind the siding. This could lead to water damage of framing materials located behind the exterior cladding. It is recommended that kick out flashing be installed at all similar locations.

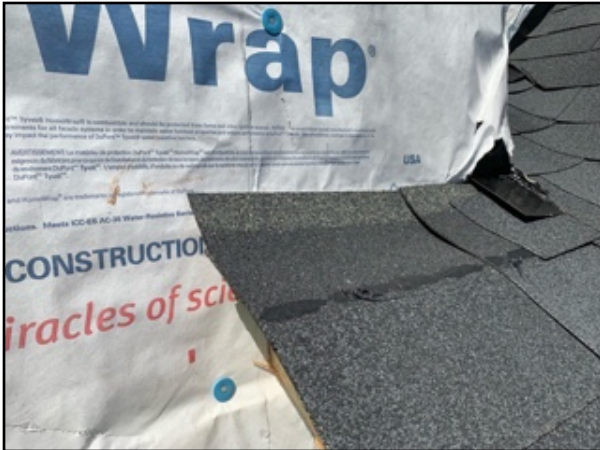
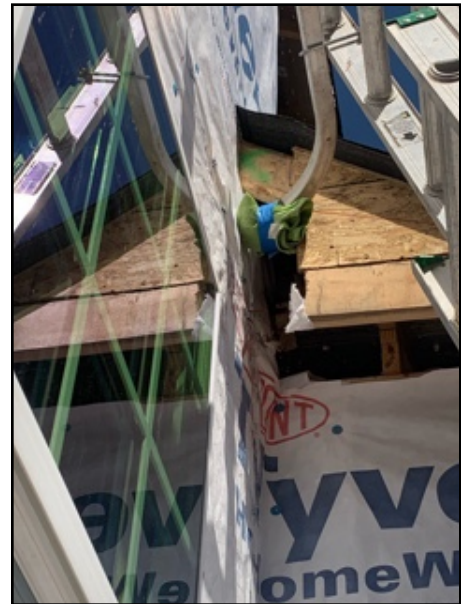
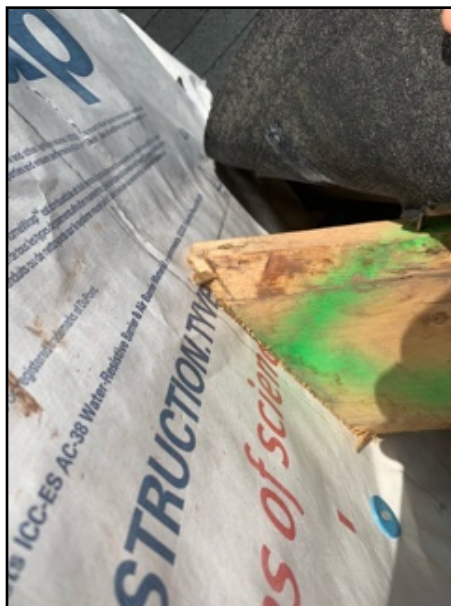
The bottom section on the left gable of the garage lacks headwall flashing. In addition, the roof sheathing did not extend all the way up the roof rafter to the wall framing. This caused the shingles to collapse downward. Lack of headwall flashing and lack of sheathing will ultimately result in water intrusion in this location.

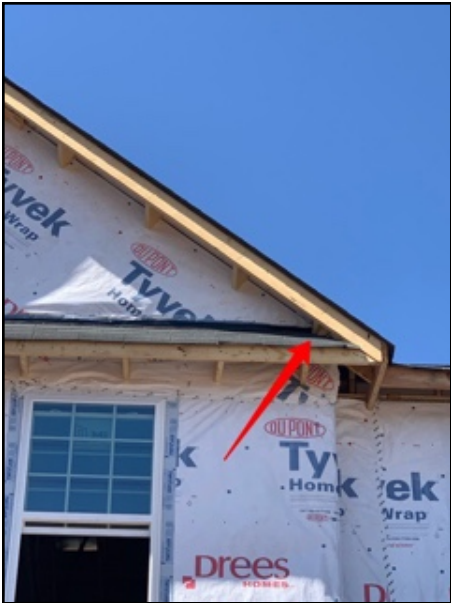
Figure 9-1

Comment 9:
Ensure proper flashing in this location and all similar locations.

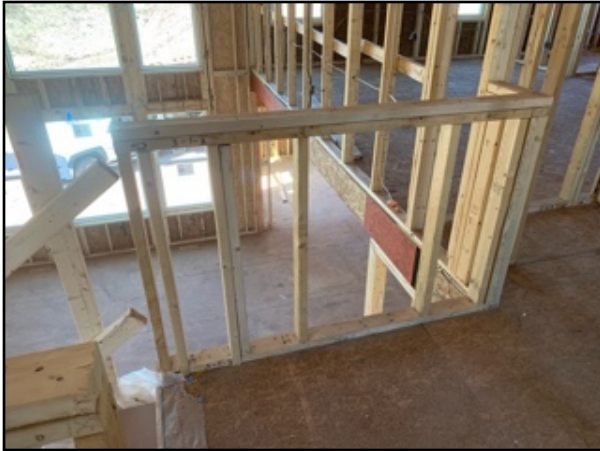
Figure 10-1

The knee wall located on the left side of the upstairs landing has been requested to be a stained handrail with iron spindles per the customer.

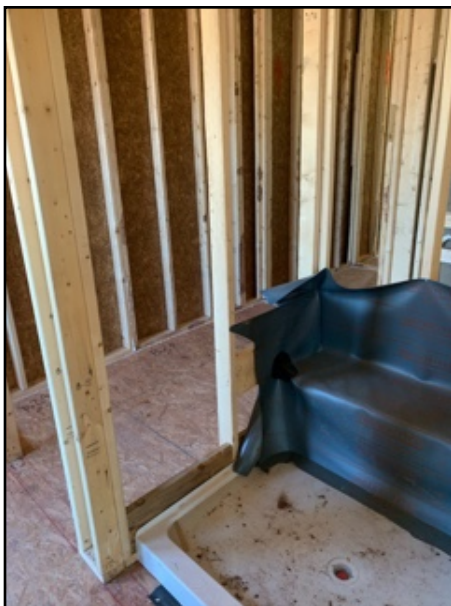
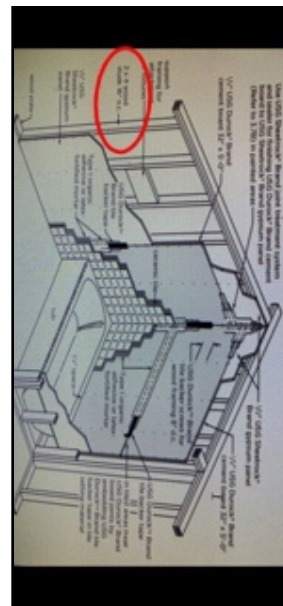
The stud spacing at the master shower is too great to allow for proper tile backer strength. Spacing should be a maximum of 16" OC to give the tile back proper support for a long lasting shower surround.

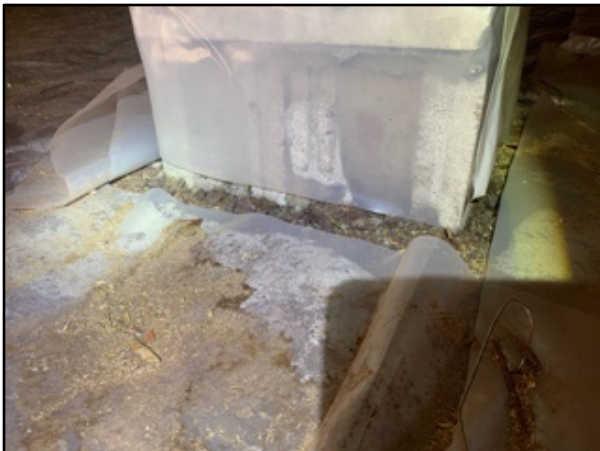
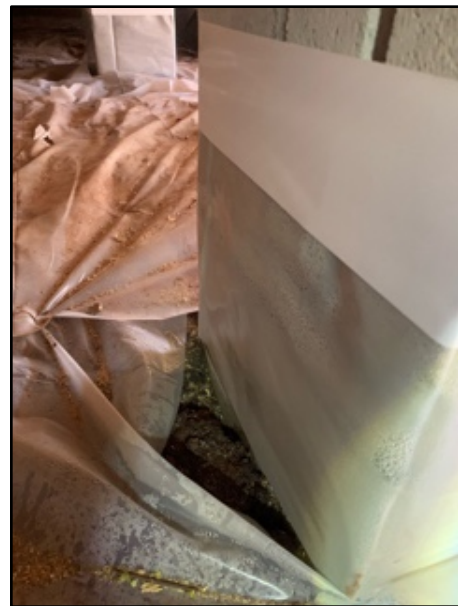
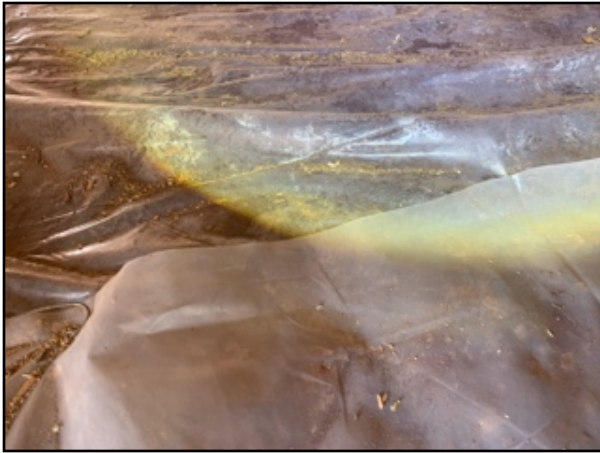
Sealed basement criteria has not been met. The vapor retarder seams are not taped, the vapor retarder does not extend up the concrete block pier walls.

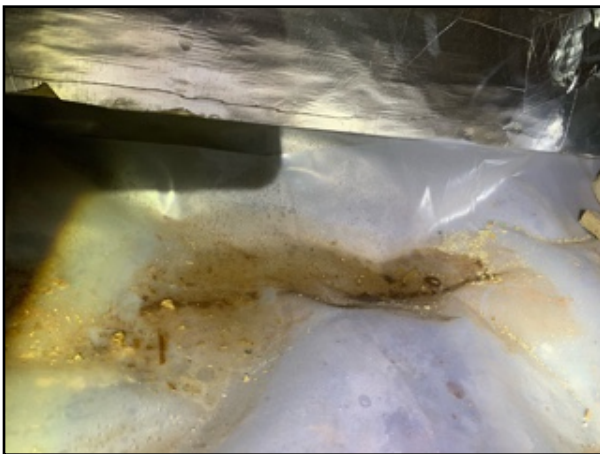
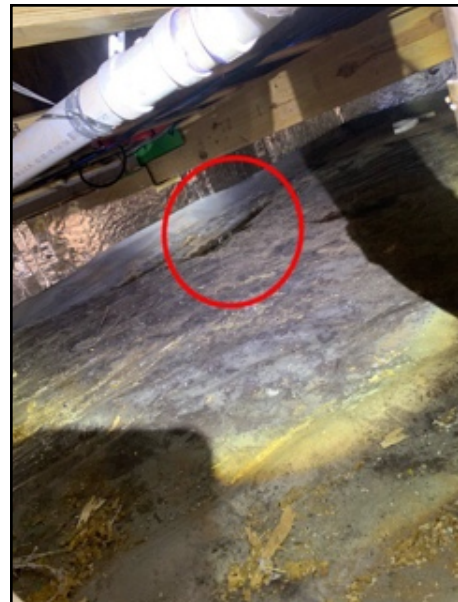
Comment 13:
Significant amounts of standing water was observed in multiple areas of the crawlspace.

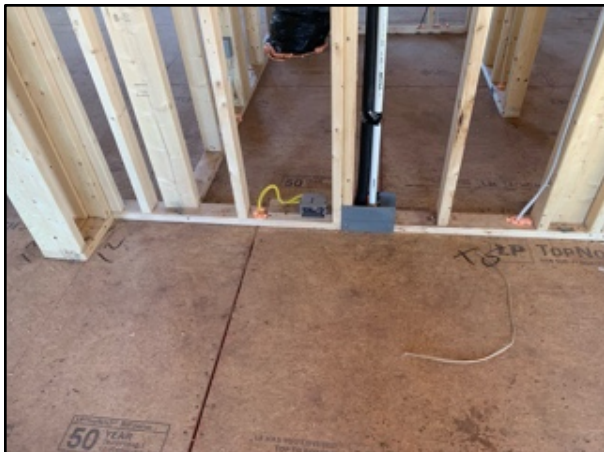
Figure 14-1

Receptacles in the front dining room are located at baseboard height. This is inconsistent with the remainder of the home. Consult the builder if the movement of the outlet location is requested.

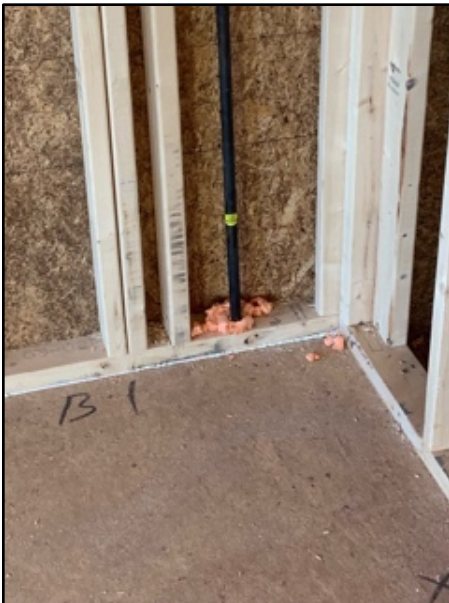
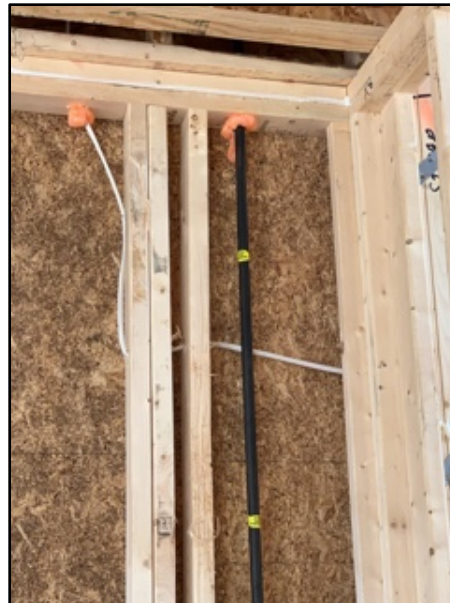
Nail plates should be installed where the gas pipe protrudes through sole plates and top plates to prevent accidental fastener penetration. Needed on first and second floors in the "study" and "game room". While fastener penetration is unlikely, for precaution, nail plates are recommended.

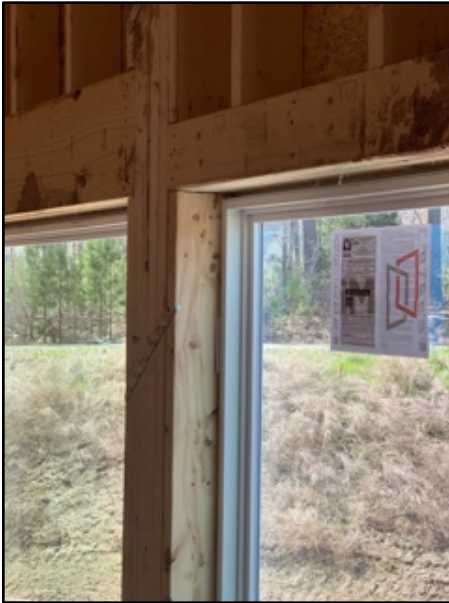
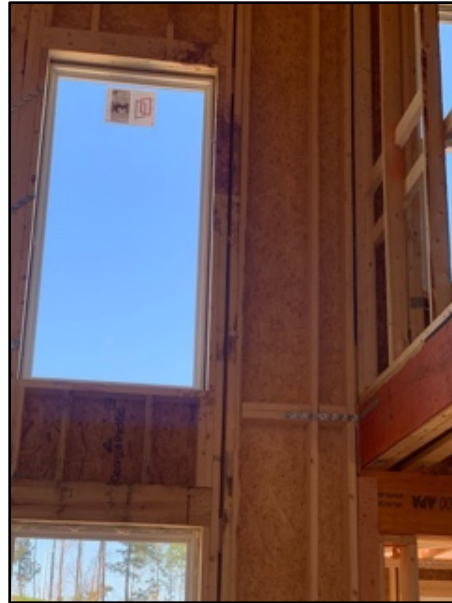
Upper windows on the rear family room have not been foam sealed around the edges.

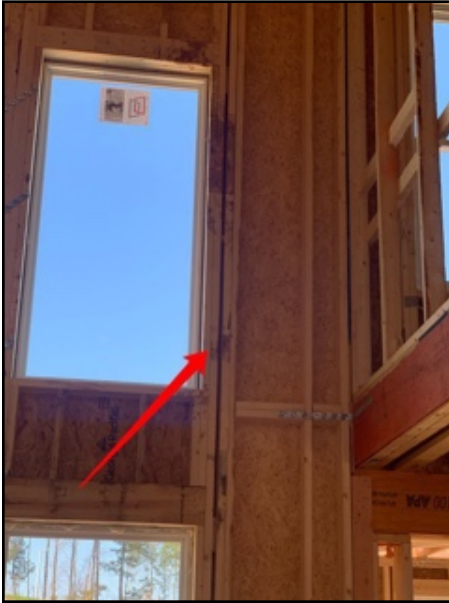
Figure 19-1

**Comment 19:**
Insulation should be installed between the stud gaps in the family room.

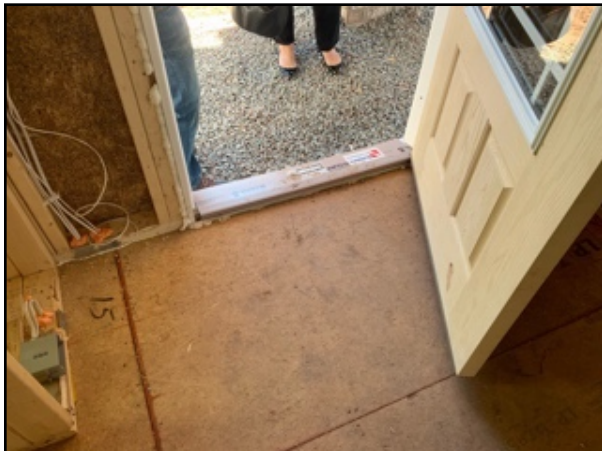
Figure 20-1

**Comment 20:**
Install construction adhesive under all exterior door thresholds to prevent movement.
