SDC HOME INSPECTIONS

INSPECTION REPORT

1234 Main St.
Bend OR 97702

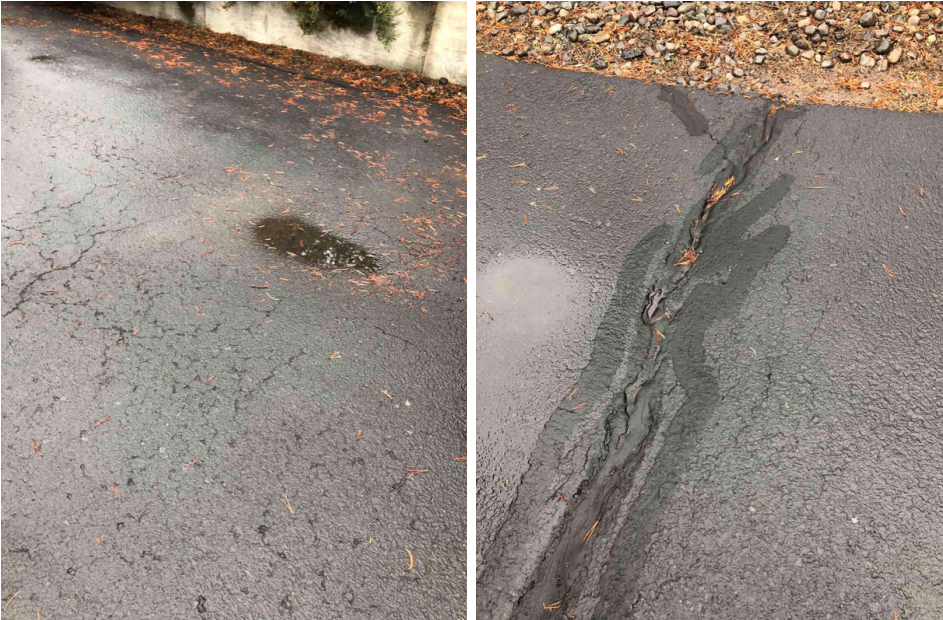
2.2.1 Driveway & Parking

NORMAL CRACKS

Cracks of the surface materials are present, considered normal and typical and should be periodically sealed.

Contact a qualified concrete contractor.

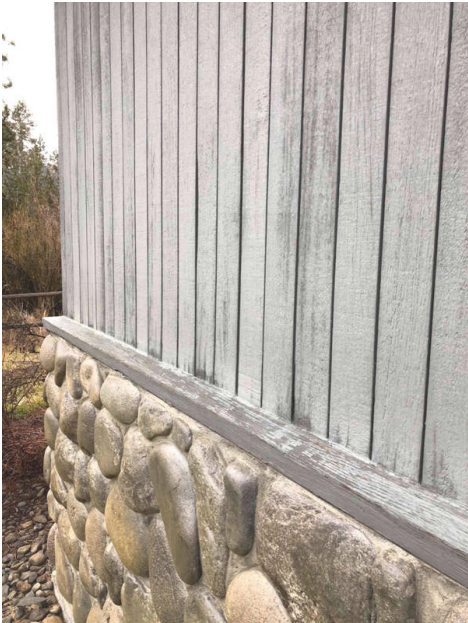
3.4.1 Paint / Caulking

PAINT NEEDED

SOUTH SIDE OF HOUSE

The house is in need of painting. Typical maintenance.

Contact a qualified painter.

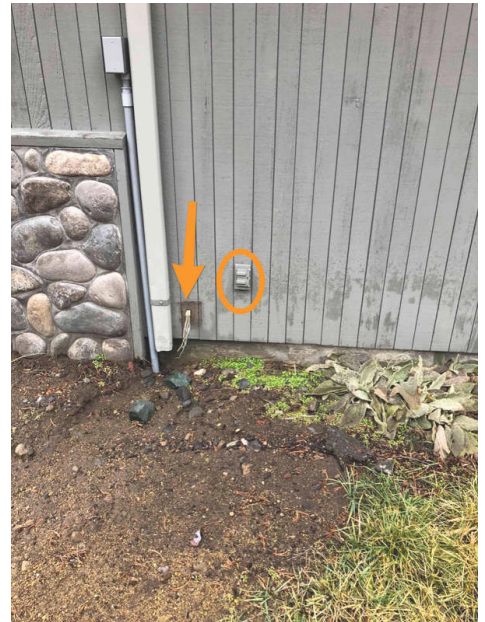
3.6.1 Outlets

LOOSE OUTLET

EAST SIDE OF HOUSE

Electrical receptacle is loose in its junction box and should be properly secured. There are also some exposed wires that need to be corrected

Contact a qualified electrical contractor.

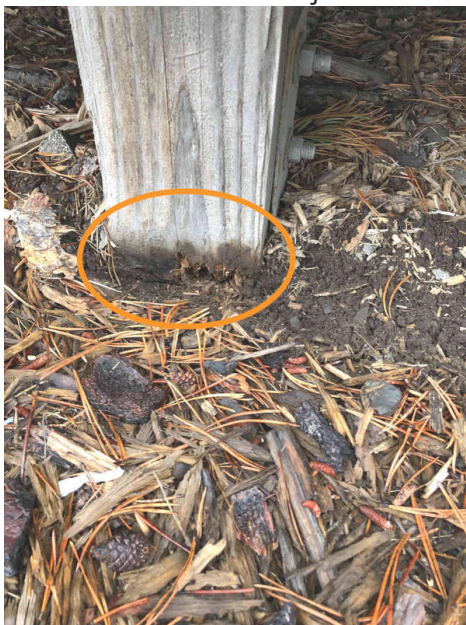
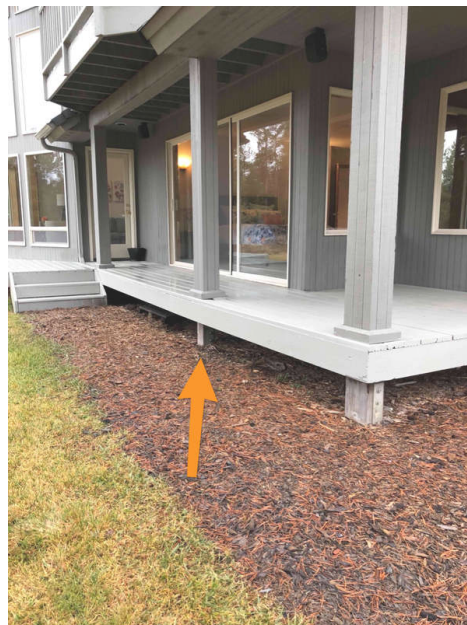
3.7.1 Decks / Balconies

SOIL TO WOOD CONTACT

BACK OF HOUSE

Soil to wood contact was present. It is suggested that all soils be cleared away at least 4" from any wood surface, (even if it is Cedar) as this is a condition that is conducive to wood rot and or pest infestation. Small amount of wood rot noted.

Recommended DIY Project

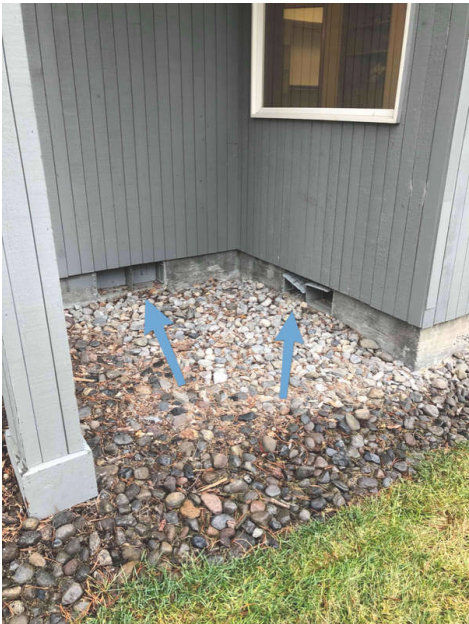
4.1.1 Foundation

INSTALL VENT WELLS

BACK OF HOUSE

Some of the foundation vents are below grade or just above it. Foundation vents close to grade or below can allow water intrusion. We recommend vent wells, and that they be about 2" or so above grade as a preventative measure against water intrusion.

Recommendation
Recommended DIY Project

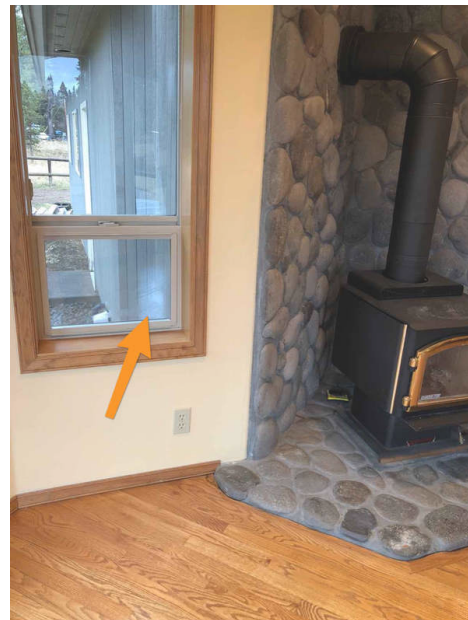
4.6.1 Windows

BROKEN SEAL

DINING NOOK

Broken seal noted. This condition is caused from the vacuum between the panes of glass escaping due to its seal being compromised. Cosmetic, but most people ask to have them replaced

Contact a qualified window repair/installation contractor.

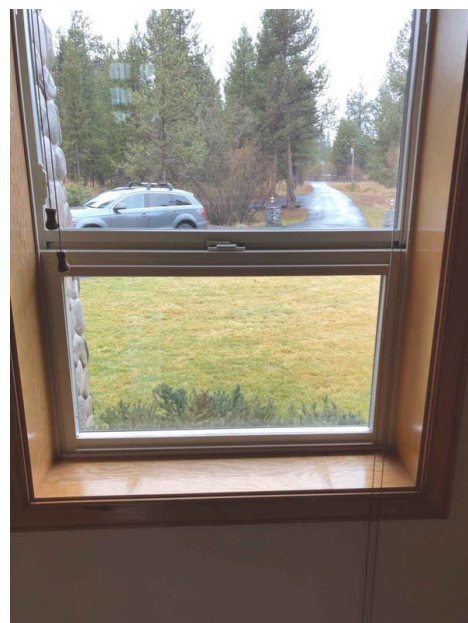
4.7.1 Screens

MISSING WINDOW SCREENS

Some of the window screens were missing and you may choose to ask the seller of their whereabouts.

Contact a qualified window repair/installation contractor.

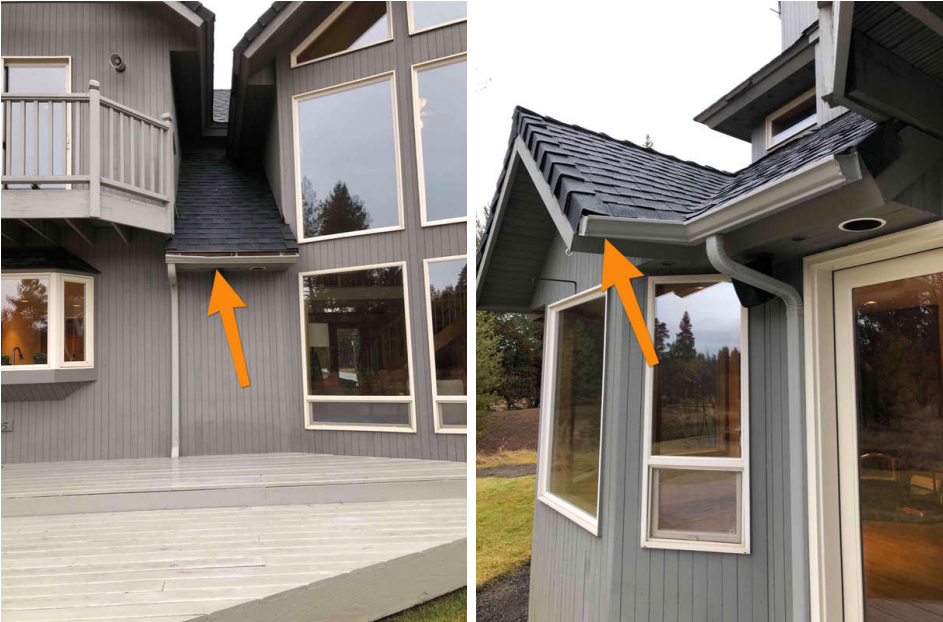
5.3.1 Gutters

LOW SPOT

BACK OF HOUSE

There is a low spot in the gutters that inhibits the proper drainage of water. Suggest it be corrected to allow proper flow of water to the downspout

Contact a qualified professional.

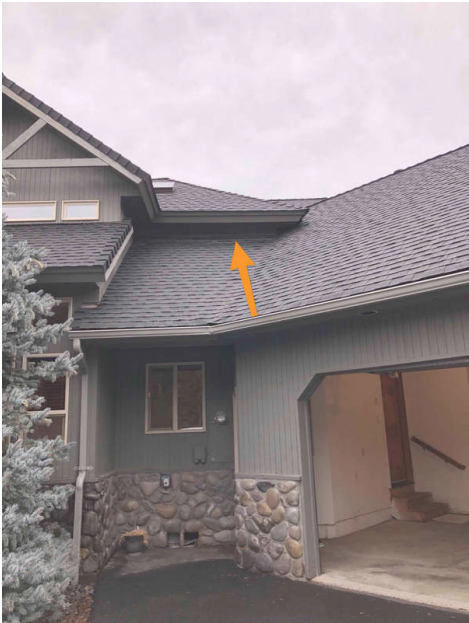
5.4.1 Flashings

FLASHING PULLING UP

FRONT OF HOUSE

Flashing was coming loose and should be better secured.

Contact a qualified roofing professional.

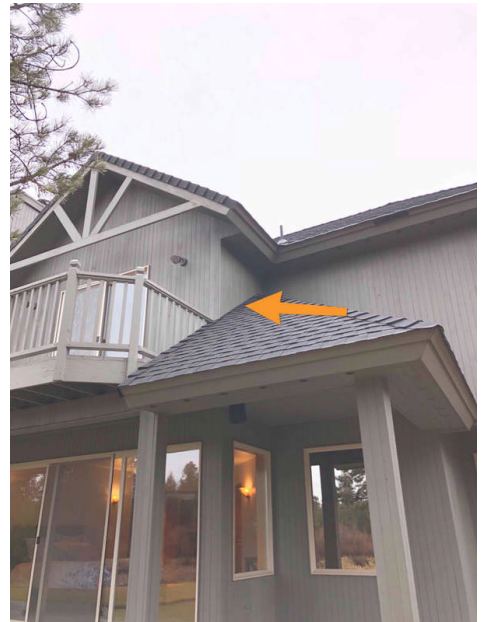
5.6.1 Siding Cut

GAP

VARIOUS AREAS

The gap between the bottom of the siding where it meets the roof is less than 1". Recommended to be between 1" and 2". Water and snow melt can damage the bottom drip edge over time if there is not adequate clearance. Cutting the siding up to the recommended distance (gap) will eliminate this potential condition.

Back of the house

Contact a qualified handyman.

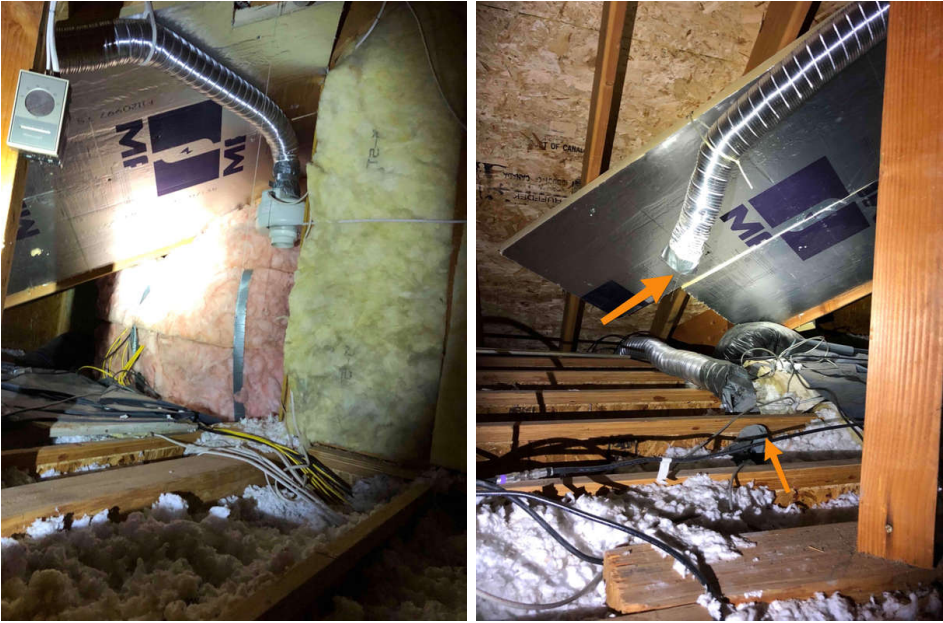
6.4.1 Exhaust Ducts / Flues

SEPARATED DUCT

ATTIC OVER MASTER BATHROOM

An exhaust duct is separated, and should be repaired. This may be an exhaust duct tied to a Thermostat or humidistat but I cannot confirm that

Recommendation
Contact a qualified professional.

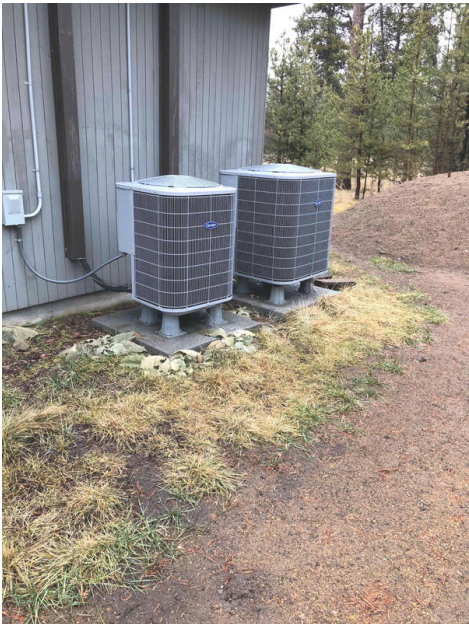
Heat pumps were not fully inspected. The disconnect was removed on one and was too cold to run the other. A limited inspection. They do look “newer” however. Recommend further inspection by an HVAC technician.

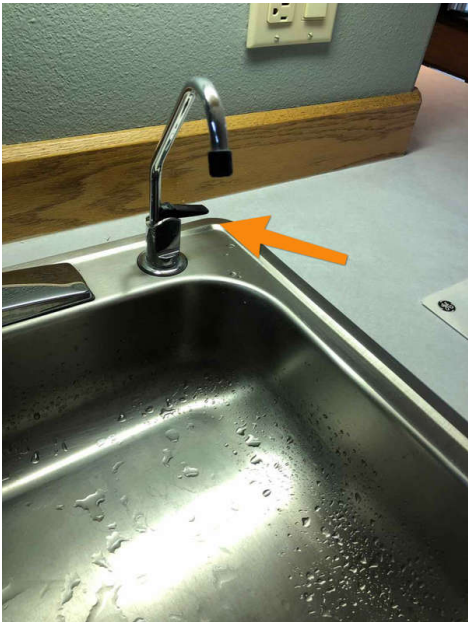
10.1.1 Interior Rooms	<div><div></div>Recommendations</div>
BROKEN FAUCET UPSTAIRS BONUS ROOM The fresh water faucet will not shut off and needs repair or replacement. The valve is currently turned off under the sink. Recommendation Contact a qualified plumbing contractor.

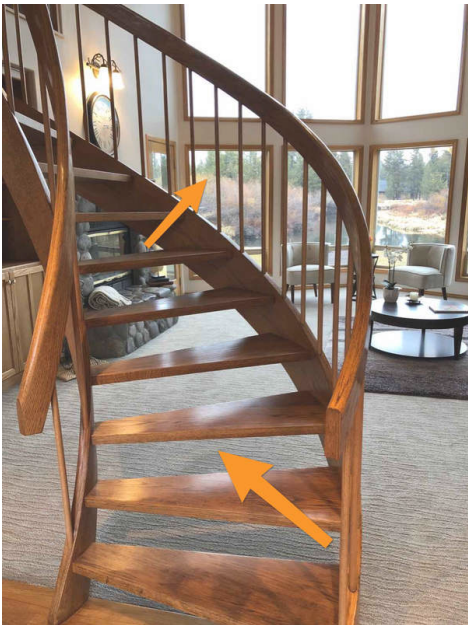
10.2.1 Stairs

BALUSTERS TOO WIDE

The balusters in the stair handrails are more than four-inches apart and based on today's building standards are too wide. This was acceptable at the time of construction however and is not required to be altered or changed. If small children are present this area should be used with caution, and you may choose to install additional posts or balusters as a preventative measure.

Recommendation
Contact a qualified professional.

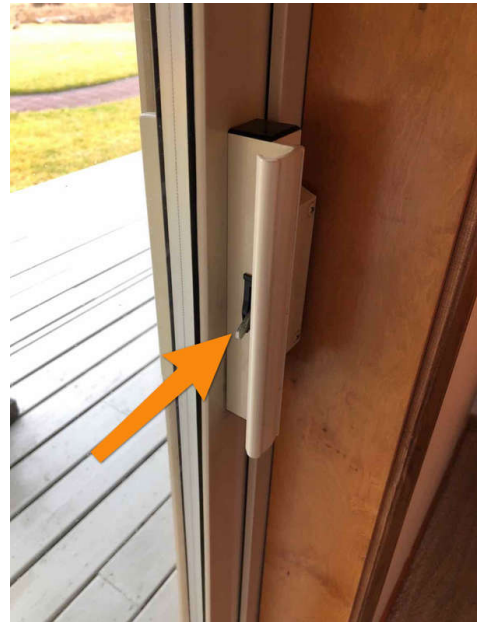
10.5.1 Doors

DOOR LOCK / LATCH

MASTER BEDROOM

Door needs adjusting / repair. This was very hard to open and close the latch

Very hard to lock/unlock

Recommendation
Contact a qualified professional.

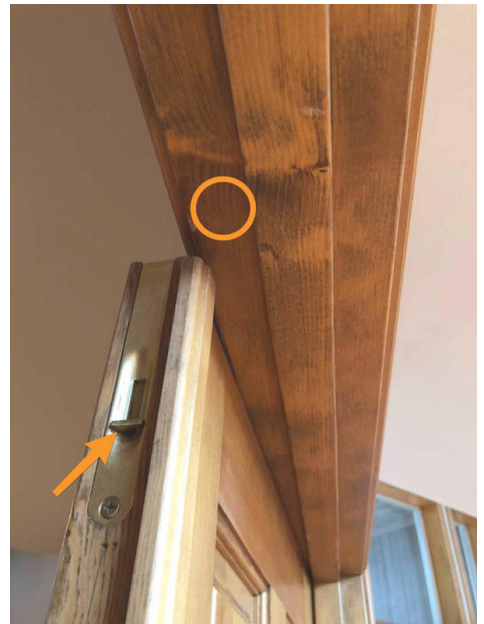
10.5.2 Doors

MISSING HARDWARE

DOWNSTAIRS OFFICE

A door is missing some hardware and needs correction. There is no hole in the top door jamb for the lock pin at the top of the door to "lock the door".

Contact a qualified handyman.

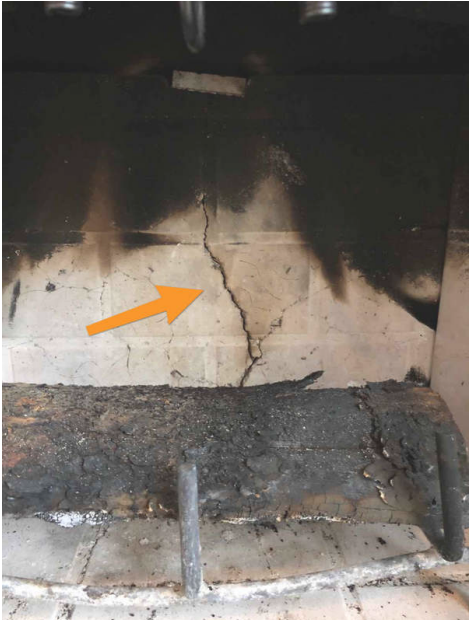
12.1.1 Fireplace

CRACKED BRICKS IN FIREBOX

Cracks of the refractory bricks in the firebox were noted. We suggest they be sealed with the proper heat caulking and replaced if necessary. This condition can pose a potential fire hazard if left unattended.

Contact a qualified chimney contractor.

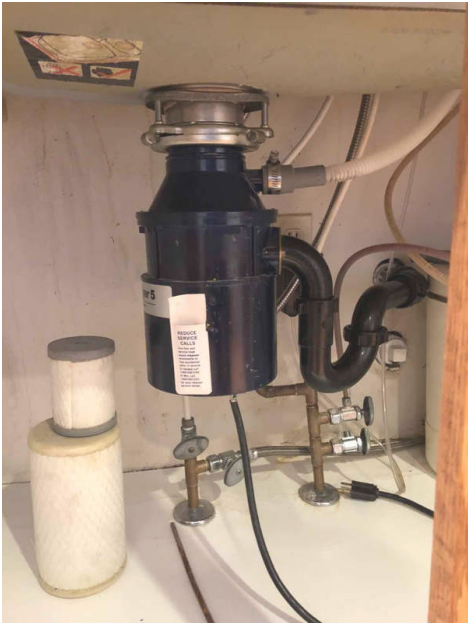
The garbage disposal did not work using normal controls and will need to be repaired or replaced. I tried to reset it but I still could not get it to work

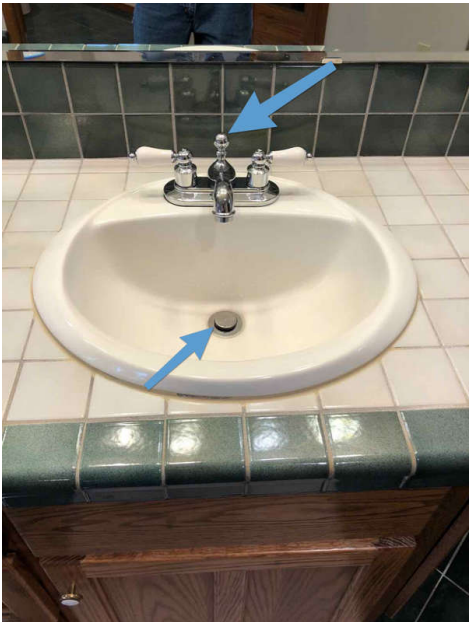
14.3.1 Sinks

The mechanical sink stopper will need to be adjusted or replaced to engage.

Recommended DIY Project

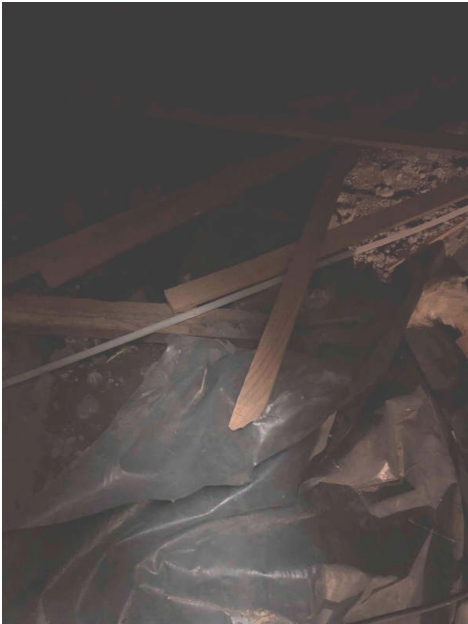
Debris hasbeen left in the crawlspace. Itshould be removed as a preventative measure for pest infestation and or wood rot that can occur over time.

Recommendation
Recommended DIY Project

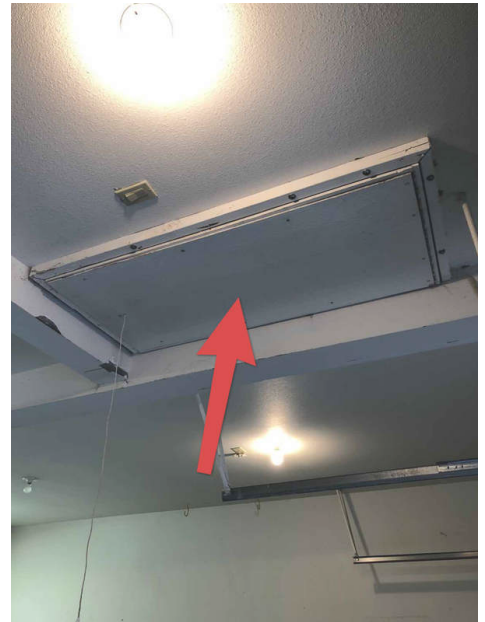
17.6.1 Pull Down Ladder

PULL DOWN LADDER

A pull down ladder is present in the garage. Suggest it be covered in metal or some other fire retardant material as a protective measure. It may not be required, but is recommended.

Contact a qualified professional.
