CIRCUITGUARD AI — PCB DEFECT ANALYSIS REPORT

Report ID: RPT-06896085
Generated On: 2025-11-17 21:39:49

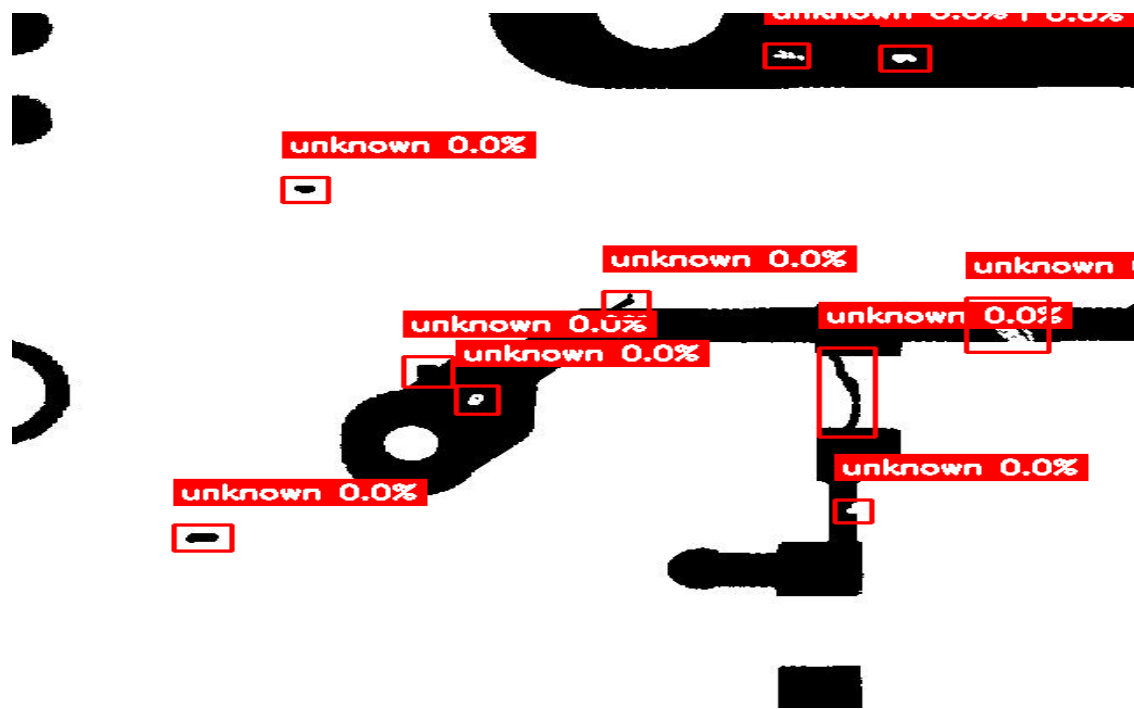
Annotated PCB

Total Defects: 10
Average Confidence: 0.00%
High: 0 | Medium: 0 | Low: 10

- Solder Bridge — Verify copper trace spacing and solder mask.
- Mousebite — Check drilling alignment and routing process.
- Open Circuit — Ensure complete etching and copper continuity.
- Spur — Clean unwanted copper residues.
- Pinhole — Inspect plating process and solder cleanliness.
- Spurious Copper — Use cleanroom inspection and re-etch.
