CIRCUITGUARD AI — PCB DEFECT ANALYSIS REPORT

Report ID: RPT-8B3C8BD7
Generated On: 2025-11-13 06:32:01

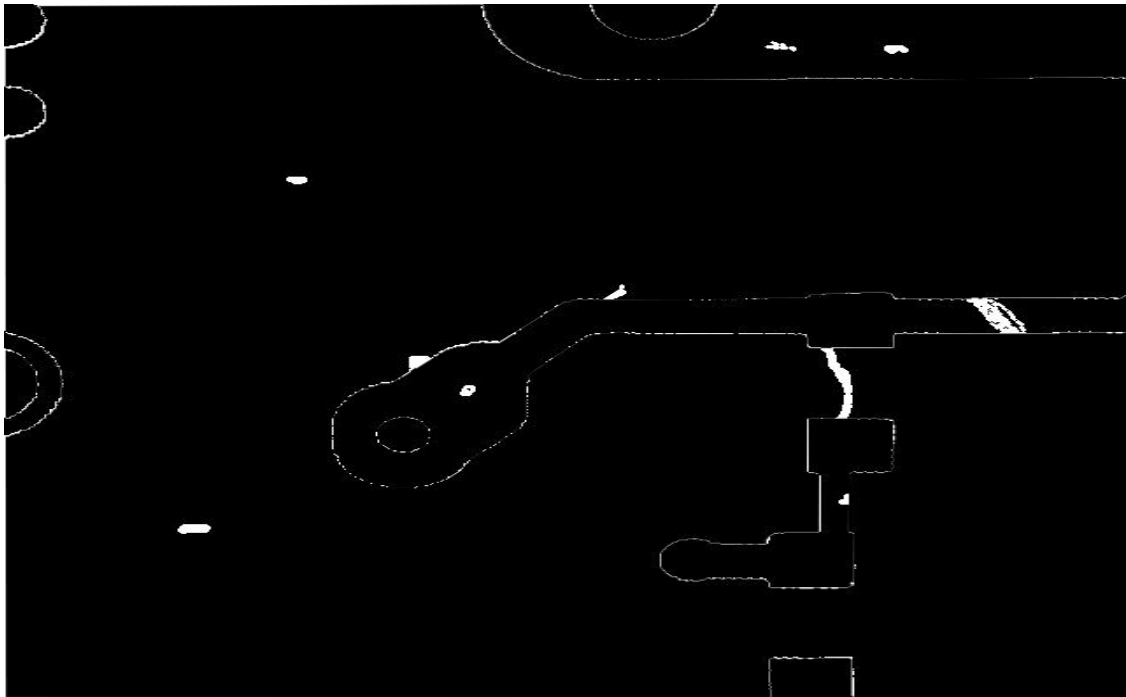
Annotated PCB

Total Defects: 0
Average Confidence: 0.00%
High: 0 | Medium: 0 | Low: 0
