CIRCUITGUARD AI — PCB DEFECT ANALYSIS REPORT

Report ID: RPT-A82FE131
Generated On: 2025-11-17 21:56:58

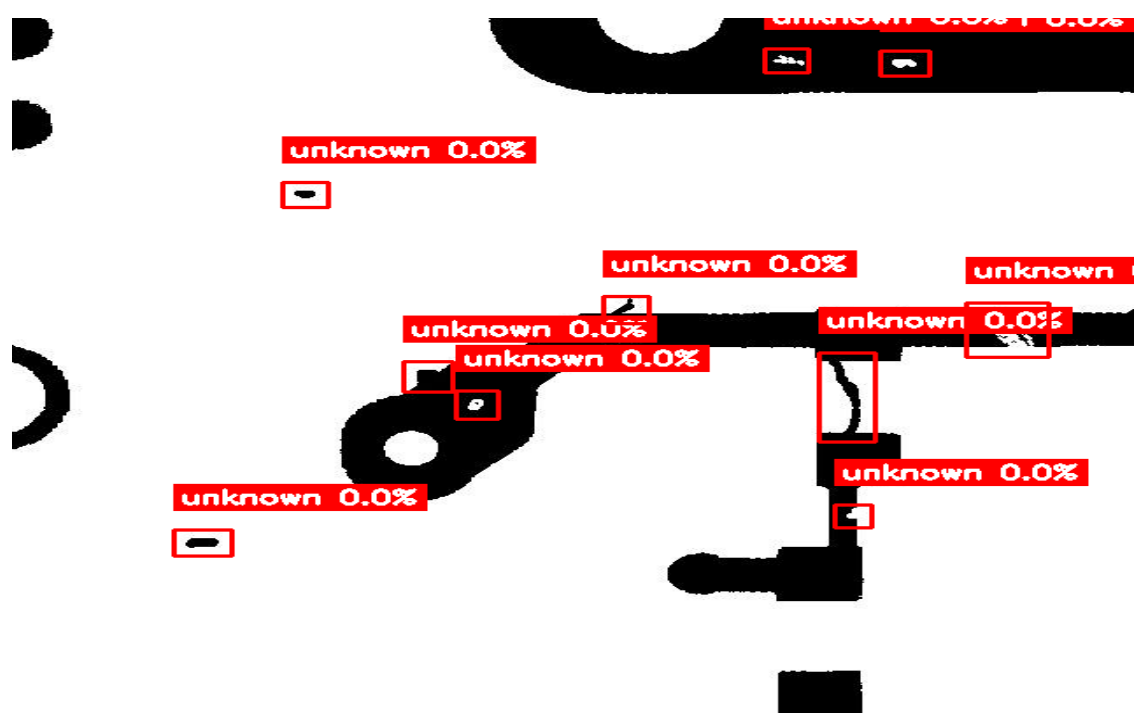
Annotated PCB

Total Defects: 10
Average Confidence: 0.00%
High: 0 | Medium: 0 | Low: 10

- Solder Bridge — Verify copper trace spacing and solder mask.
- Mousebite — Check drilling alignment and routing process.
- Open Circuit — Ensure complete etching and copper continuity.
- Spur — Clean unwanted copper residues.
- Pinhole — Inspect plating process and solder cleanliness.
- Spurious Copper — Use cleanroom inspection and re-etch.
