CIRCUITGUARD AI — PCB DEFECT ANALYSIS REPORT

Report ID: RPT-1B64F9D0
Generated On: 2025-11-12 14:31:45

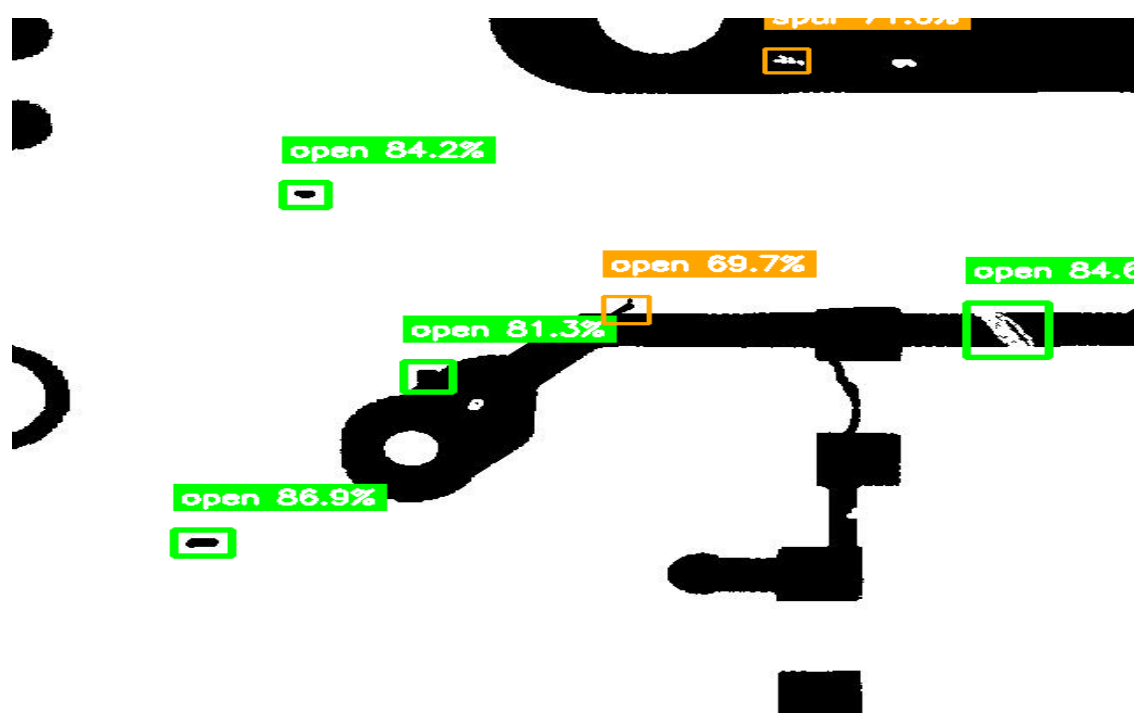
Annotated PCB

Total Defects: 6
Average Confidence: 79.62%
High: 4 | Medium: 2 | Low: 0

- Solder Bridge — Verify copper trace spacing and solder mask.
- Mousebite — Check drilling alignment and routing process.
- Open Circuit — Ensure complete etching and copper continuity.
- Spur — Clean unwanted copper residues.
- Pinhole — Inspect plating process and solder cleanliness.
- Spurious Copper — Use cleanroom inspection and re-etch.
