# CIRCUITGUARD AI — PCB DEFECT ANALYSIS REPORT

Report ID: RPT-56710A90  
Generated On: 2025-11-13 06:26:58

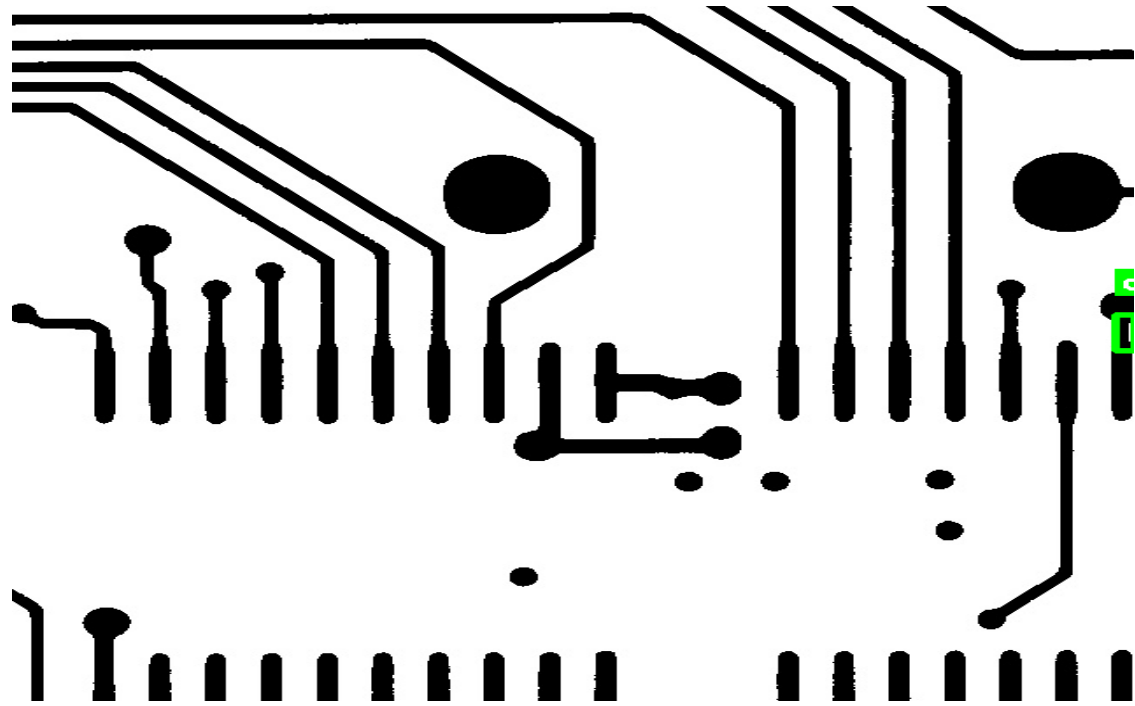
### Annotated PCB

Total Defects: 1  
Average Confidence: 88.30%  
High: 1 | Medium: 0 | Low: 0
