CIRCUITGUARD AI — PCB DEFECT ANALYSIS REPORT

Report ID: RPT-21BD370E
Generated On: 2025-11-12 14:26:26

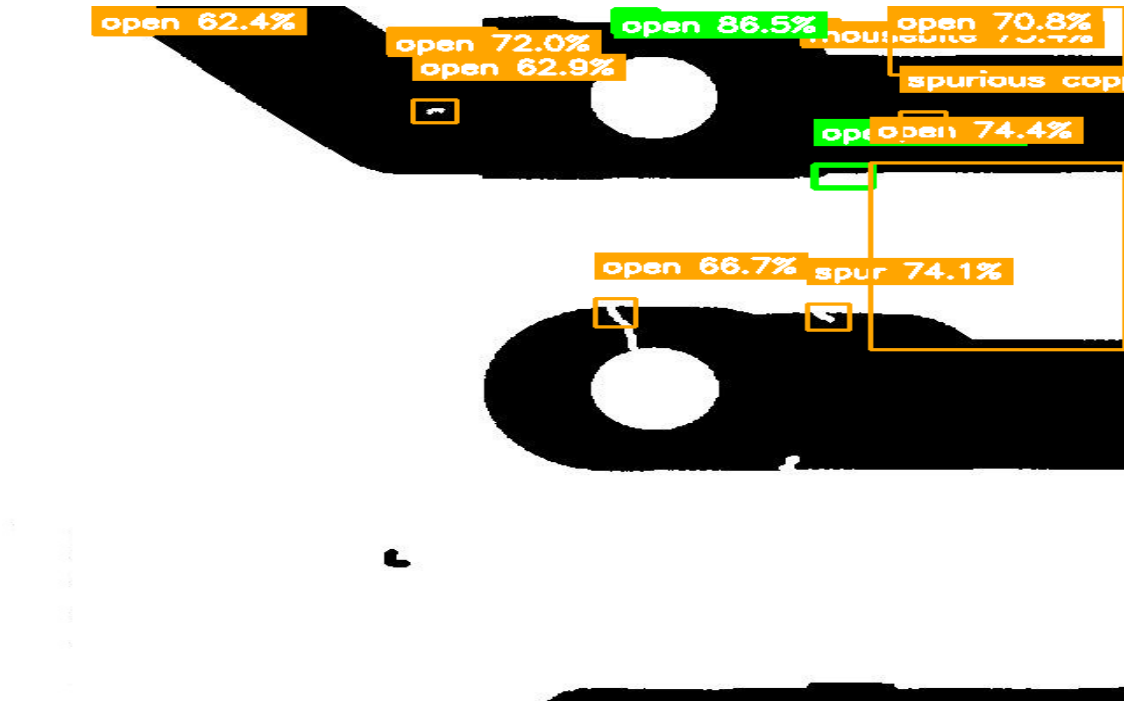
Annotated PCB

Total Defects: 11
Average Confidence: 72.35%
High: 2 | Medium: 9 | Low: 0

- Solder Bridge — Verify copper trace spacing and solder mask.
- Mousebite — Check drilling alignment and routing process.
- Open Circuit — Ensure complete etching and copper continuity.
- Spur — Clean unwanted copper residues.
- Pinhole — Inspect plating process and solder cleanliness.
- Spurious Copper — Use cleanroom inspection and re-etch.
