CIRCUITGUARD AI — PCB DEFECT ANALYSIS REPORT

Report ID: RPT-2192276B
Generated On: 2025-11-17 21:28:42

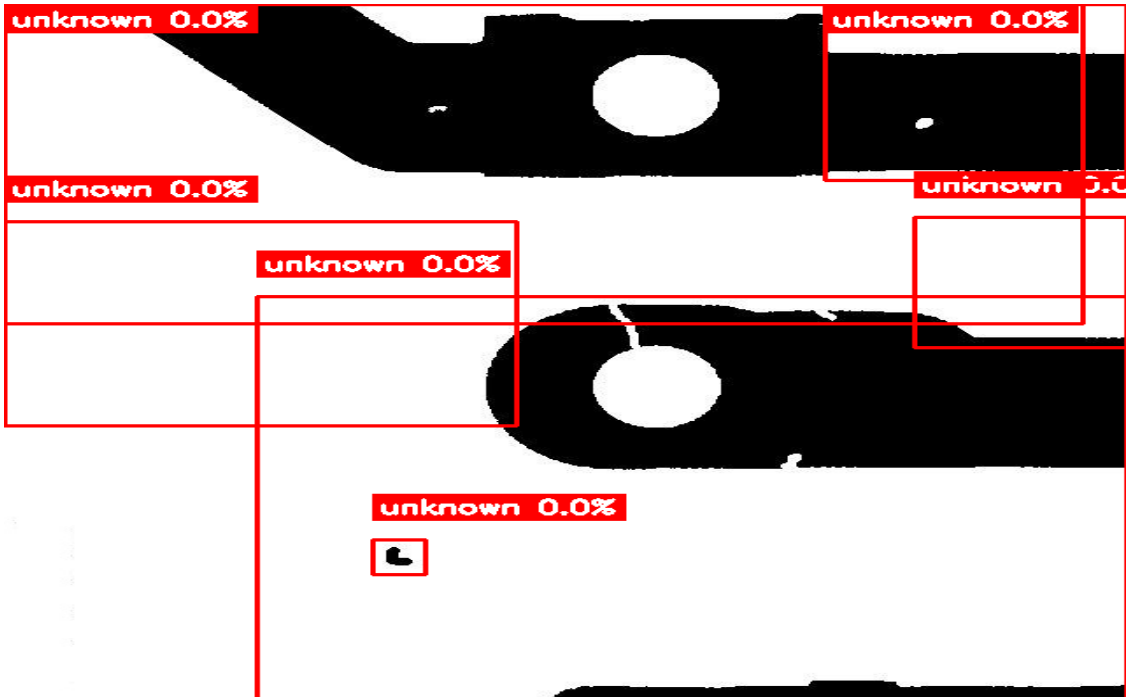
Annotated PCB

Total Defects: 6
Average Confidence: 0.00%
High: 0 | Medium: 0 | Low: 6

- Solder Bridge — Verify copper trace spacing and solder mask.
- Mousebite — Check drilling alignment and routing process.
- Open Circuit — Ensure complete etching and copper continuity.
- Spur — Clean unwanted copper residues.
- Pinhole — Inspect plating process and solder cleanliness.
- Spurious Copper — Use cleanroom inspection and re-etch.
