CIRCUITGUARD AI — PCB DEFECT ANALYSIS REPORT

Report ID: RPT-040E8A61
Generated On: 2025-11-13 06:27:00

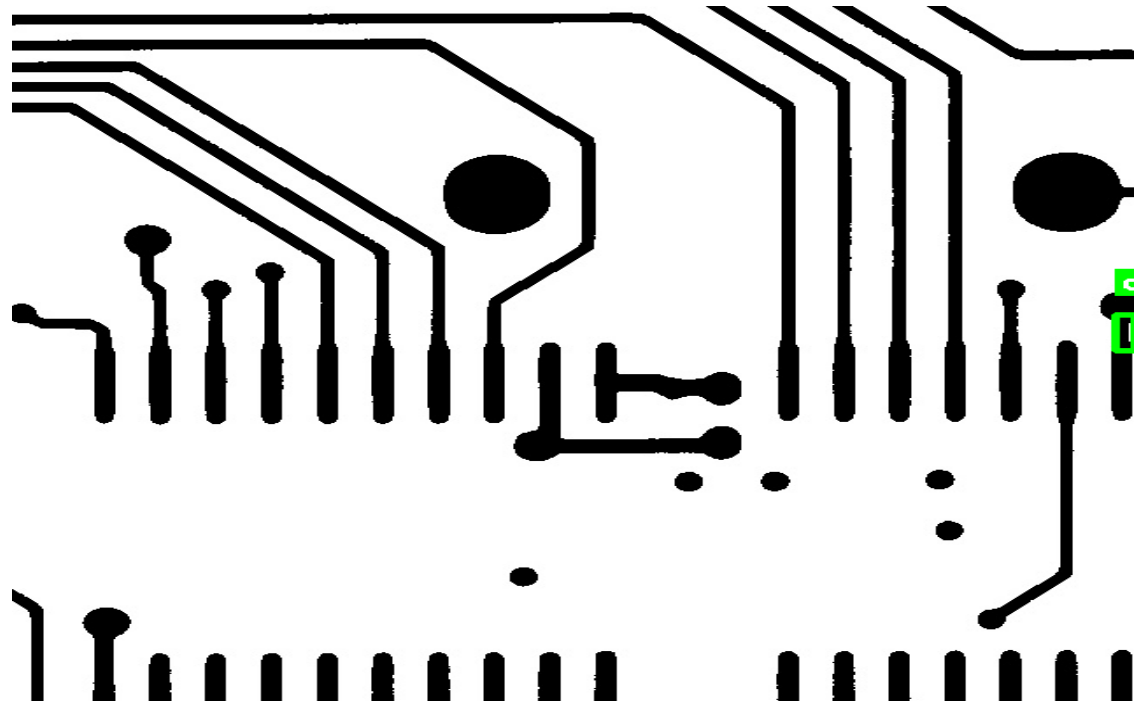
Annotated PCB

Total Defects: 1
Average Confidence: 88.30%
High: 1 | Medium: 0 | Low: 0
