CIRCUITGUARD AI — PCB DEFECT ANALYSIS REPORT

Report ID: RPT-72593C9A
Generated On: 2025-11-12 18:31:31

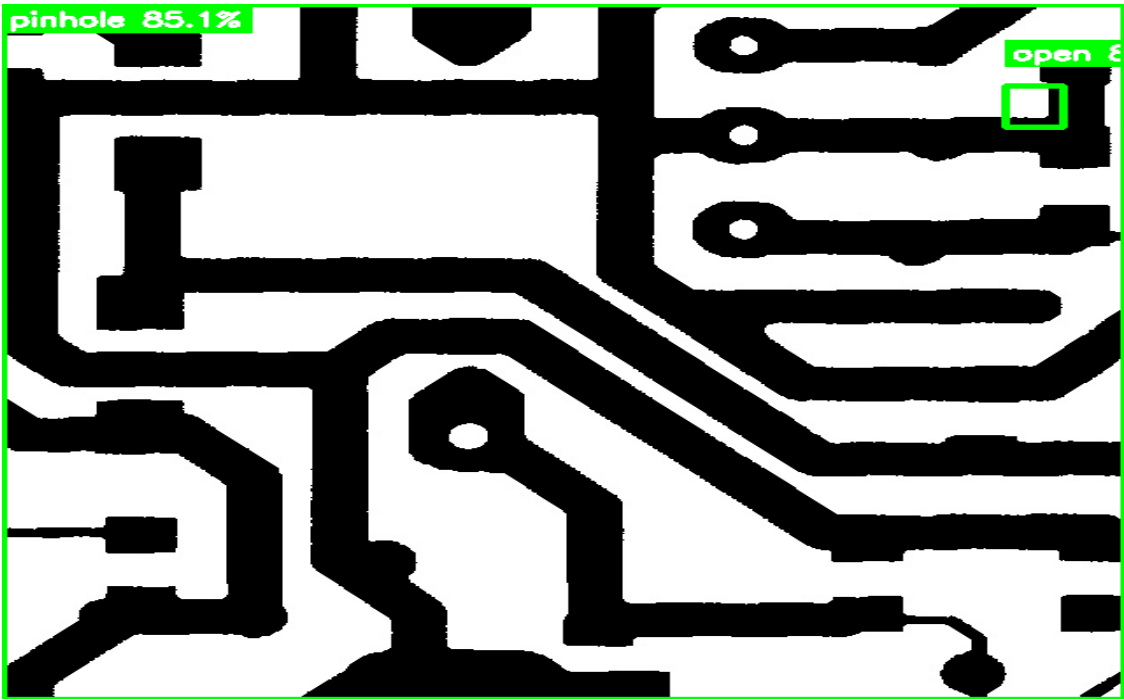
Annotated PCB

Total Defects: 2
Average Confidence: 85.53%
High: 2 | Medium: 0 | Low: 0
