CIRCUITGUARD AI — PCB DEFECT ANALYSIS REPORT

Report ID: RPT-073BC770
Generated On: 2025-11-12 18:31:42

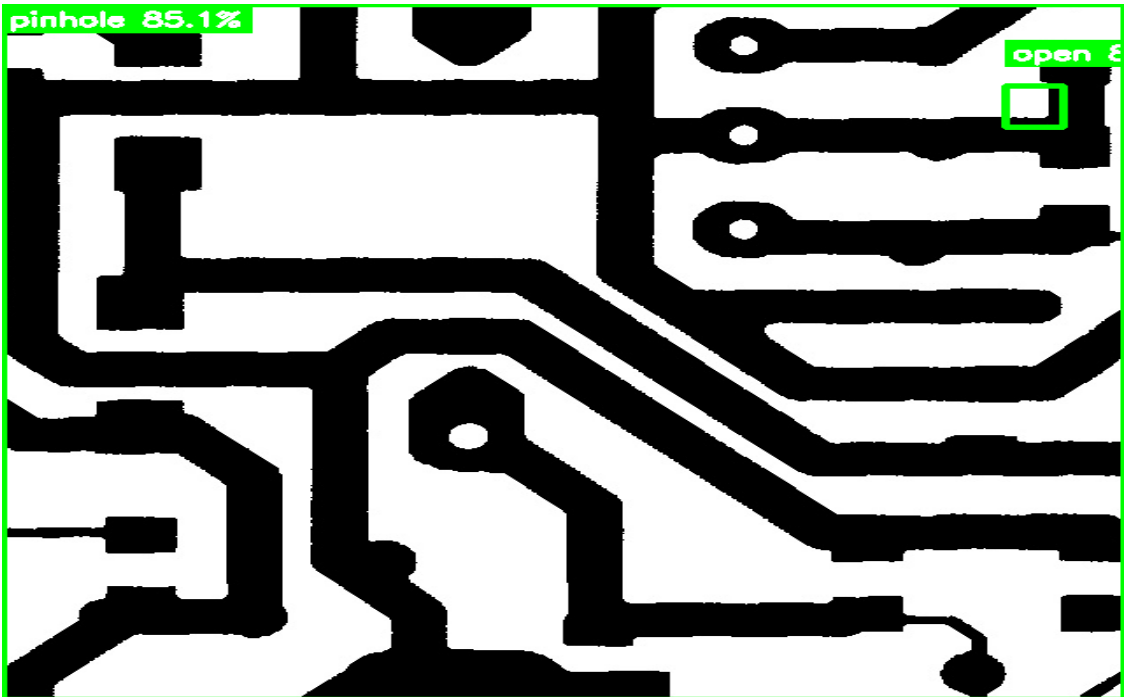
Annotated PCB

Total Defects: 2
Average Confidence: 85.53%
High: 2 | Medium: 0 | Low: 0

- Solder Bridge — Verify copper trace spacing and solder mask.
- Mousebite — Check drilling alignment and routing process.
- Open Circuit — Ensure complete etching and copper continuity.
- Spur — Clean unwanted copper residues.
- Pinhole — Inspect plating process and solder cleanliness.
- Spurious Copper — Use cleanroom inspection and re-etch.
