CIRCUITGUARD AI — PCB DEFECT ANALYSIS REPORT

Report ID: RPT-3E3E9B57
Generated On: 2025-11-17 21:27:18

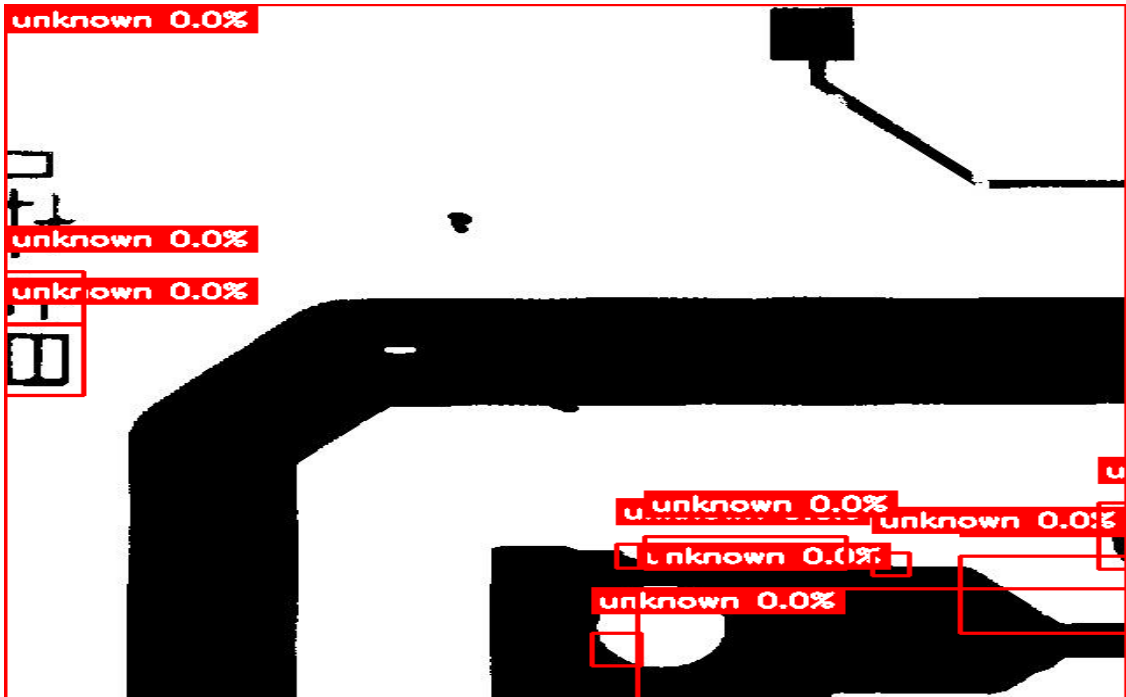
Annotated PCB

Total Defects: 10
Average Confidence: 0.00%
High: 0 | Medium: 0 | Low: 10

- Solder Bridge — Verify copper trace spacing and solder mask.
- Mousebite — Check drilling alignment and routing process.
- Open Circuit — Ensure complete etching and copper continuity.
- Spur — Clean unwanted copper residues.
- Pinhole — Inspect plating process and solder cleanliness.
- Spurious Copper — Use cleanroom inspection and re-etch.
