CIRCUITGUARD AI — PCB DEFECT ANALYSIS REPORT

Report ID: RPT-D67242CC
Generated On: 2025-11-12 19:25:30

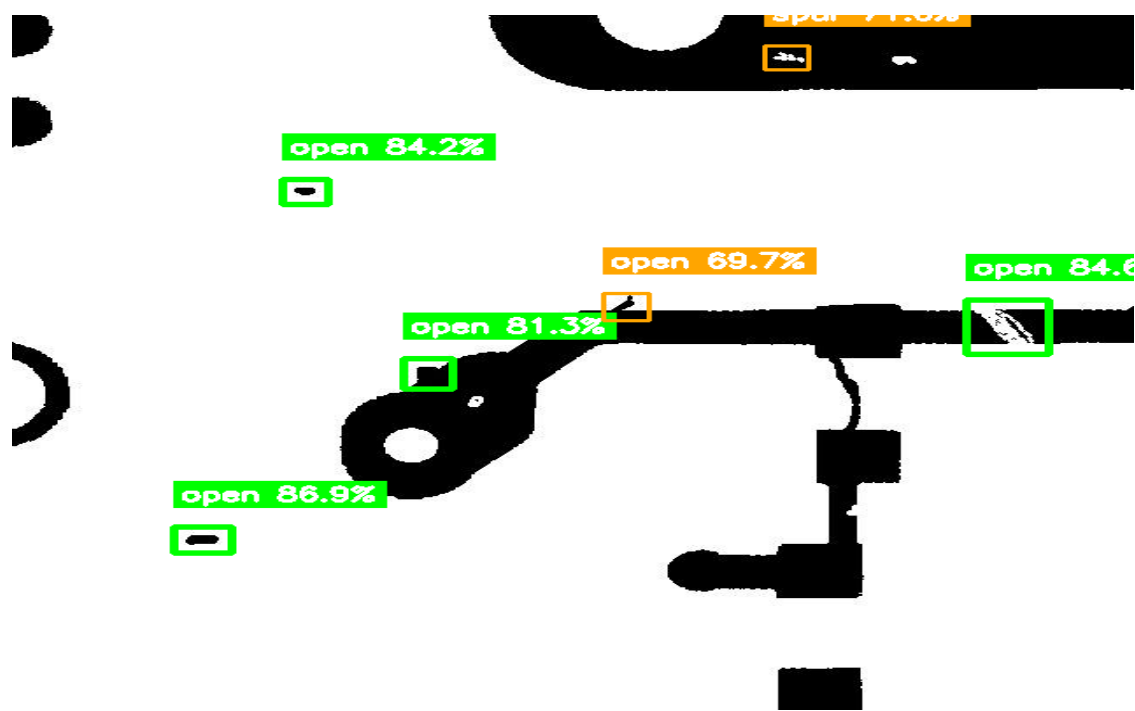
Annotated PCB

Total Defects: 6
Average Confidence: 79.62%
High: 4 | Medium: 2 | Low: 0

- Solder Bridge — Verify copper trace spacing and solder mask.
- Mousebite — Check drilling alignment and routing process.
- Open Circuit — Ensure complete etching and copper continuity.
- Spur — Clean unwanted copper residues.
- Pinhole — Inspect plating process and solder cleanliness.
- Spurious Copper — Use cleanroom inspection and re-etch.
