PCB Defect Analysis Report

Generated: 2025-11-17 23:24:34

Executive Summary

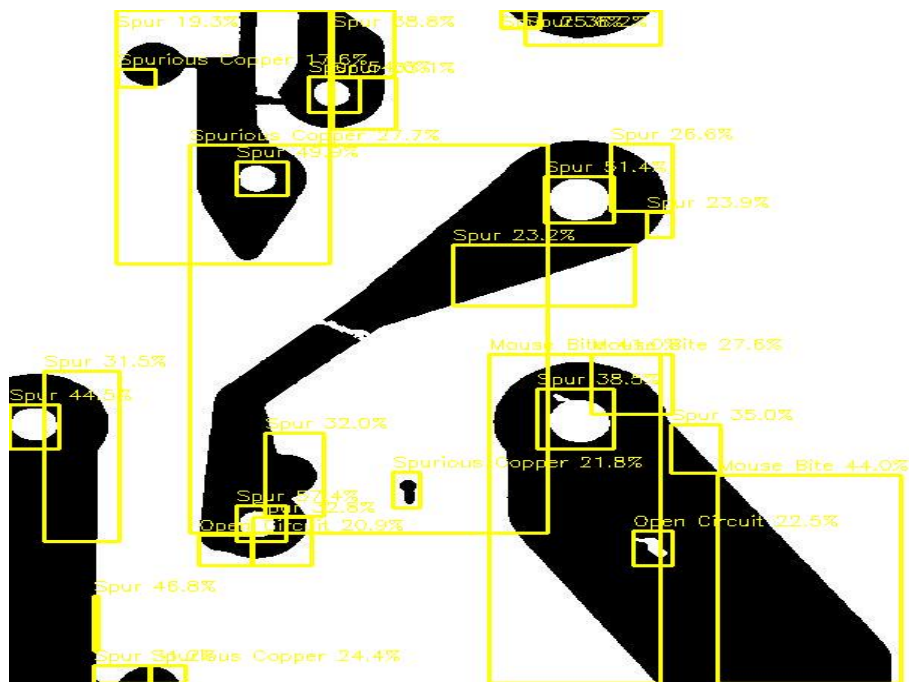
Annotated Result

High density of major defects including track breaks and severe pad damage.

ID	Type	Confidence	Area (px²)	Severity
#1	Spurious Copper	24.45%	391	Medium
#2	Spur	31.2%	629	Medium
#3	Spur	46.85%	156	Medium
#4	Open Circuit	20.91%	1015	Medium
#5	Open Circuit	22.47%	858	Medium
#6	Spur	32.78%	1794	Medium
#7	Spur	57.42%	1122	Medium
#8	Mouse Bite	43.98%	24156	Medium
#9	Spurious Copper	21.83%	612	Medium
#10	Spur	31.98%	3081	Medium
#11	Spur	35.05%	1518	Medium
#12	Spur	44.51%	1386	Medium
#13	Spur	38.51%	2907	Medium
#14	Spur	31.52%	8100	Medium
#15	Mouse Bite	27.57%	3078	Medium
#16	Mouse Bite	40.98%	35682	Medium
#17	Spur	23.23%	7018	Medium
#18	Spur	23.9%	408	Medium
#19	Spur	51.36%	2024	Medium
#20	Spur	49.92%	1088	Medium

PCB is not suitable for deployment, requires full rework or replacement.
