CIRCUITGUARD AI — PCB DEFECT ANALYSIS REPORT

Report ID: RPT-B14BD6AB
Generated On: 2025-11-13 06:31:42

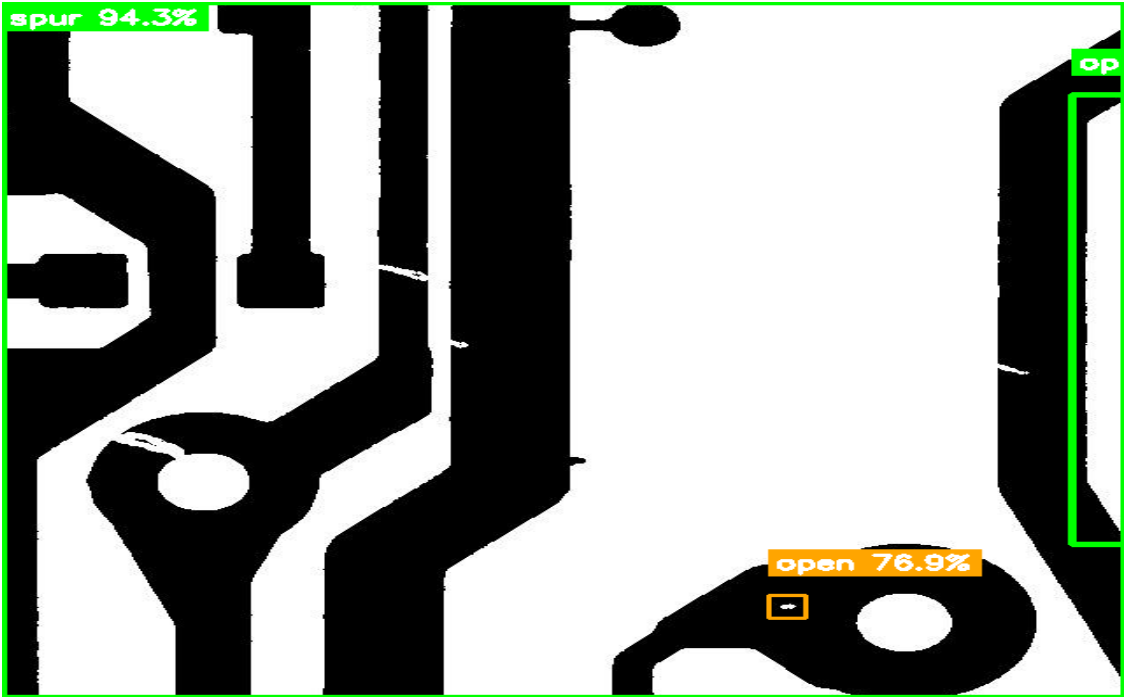
Annotated PCB

Total Defects: 3
Average Confidence: 83.73%
High: 2 | Medium: 1 | Low: 0

- Solder Bridge — Verify copper trace spacing and solder mask.
- Mousebite — Check drilling alignment and routing process.
- Open Circuit — Ensure complete etching and copper continuity.
- Spur — Clean unwanted copper residues.
- Pinhole — Inspect plating process and solder cleanliness.
- Spurious Copper — Use cleanroom inspection and re-etch.
