CIRCUITGUARD AI — PCB DEFECT ANALYSIS REPORT

Report ID: RPT-967CE29E
Generated On: 2025-11-17 21:36:34

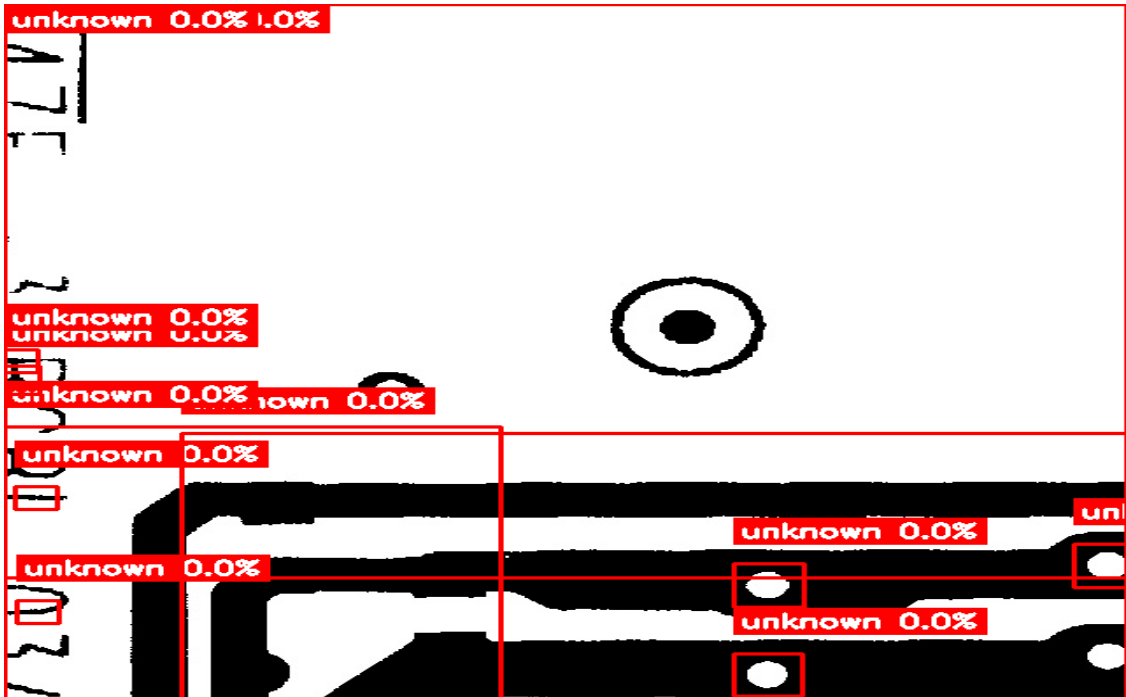
Annotated PCB

Total Defects: 11
Average Confidence: 0.00%
High: 0 | Medium: 0 | Low: 11

- Solder Bridge — Verify copper trace spacing and solder mask.
- Mousebite — Check drilling alignment and routing process.
- Open Circuit — Ensure complete etching and copper continuity.
- Spur — Clean unwanted copper residues.
- Pinhole — Inspect plating process and solder cleanliness.
- Spurious Copper — Use cleanroom inspection and re-etch.
