COMPLAIN/CLAIM REPORT PT ASTRA DAIDO STEEL INDONESIA

No: /CR/ADASI/ /20 CLAIM
 No. WO/DO : 120048/4649
 Size Material : 90x45x45 = 2

PT. Primitra Eng. Perkasa
 12/12/2024
 DC53
 0.6 kg

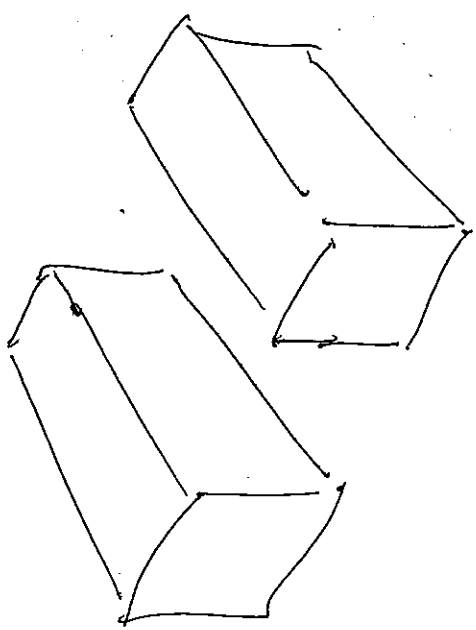
Keterangan Drawing/Gambar

- ☐ Material
 ☐ Pin hole
 ☐ Inklusi
 ☐ Sulit Machining
 ☐ Karat
 ☐ Other
- ☐ Machining
 ☐ Retak/Patah
 ☐ Bending
 ☒ Kekerasan Minus
 ☐ Kekerasan Lebih
 ☐ Scratch/Gores
 ☐ Aus
 ☐ Appearance
 ☐ Other
- ☐ Marketing
 ☐ Jumlah tidak sesuai
 ☐ Dimensi tidak sesuai
 ☐ Type Material tidak sesuai
 ☐ Other
- ☐ Cutting
 ☐ Ukuran Minus
 ☐ Potongan Miring
 ☐ NG Dimensi
 ☐ Other
- ☐ HT
 ☐ Dimensi NG
 ☐ Ada step
 ☐ NG Paralelism
 ☐ NG Siku
 ☐ Other

Deskripsi Masalah	Penyebab Masalah	Tindakan Perbaikan	Tindakan Pencegahan	Evaluasi Hasil Tindakan Pencegahan
HRC material drop saat di handle. pembelian material. co/41888 - target 58-60 dapat mnga. 40 HRC	Material salah etc, material rest kecil			<div> <div>Checked By</div> <div>Prepared By</div> </div>
<div> <div>Date: 12/12/2024</div> <div>Prepared By</div> </div>	<div> <div>Date: 12/12/2024</div> <div>Checked By</div> </div>	<div> <div>Date: 12/12/2024</div> <div>Approved By</div> </div>	<div> <div>Conclusion/Kesimpulan</div> <div> <input checked="" type="checkbox"/> DOI <input type="checkbox"/> C/A <input type="checkbox"/> REJECT <input type="checkbox"/> LMK </div> </div>	<div>Due Date :</div>
