Transportation Safety Committee

Final Report of

The Winged Guard Seniorious SEN-001

Severe Incident in Scarborough

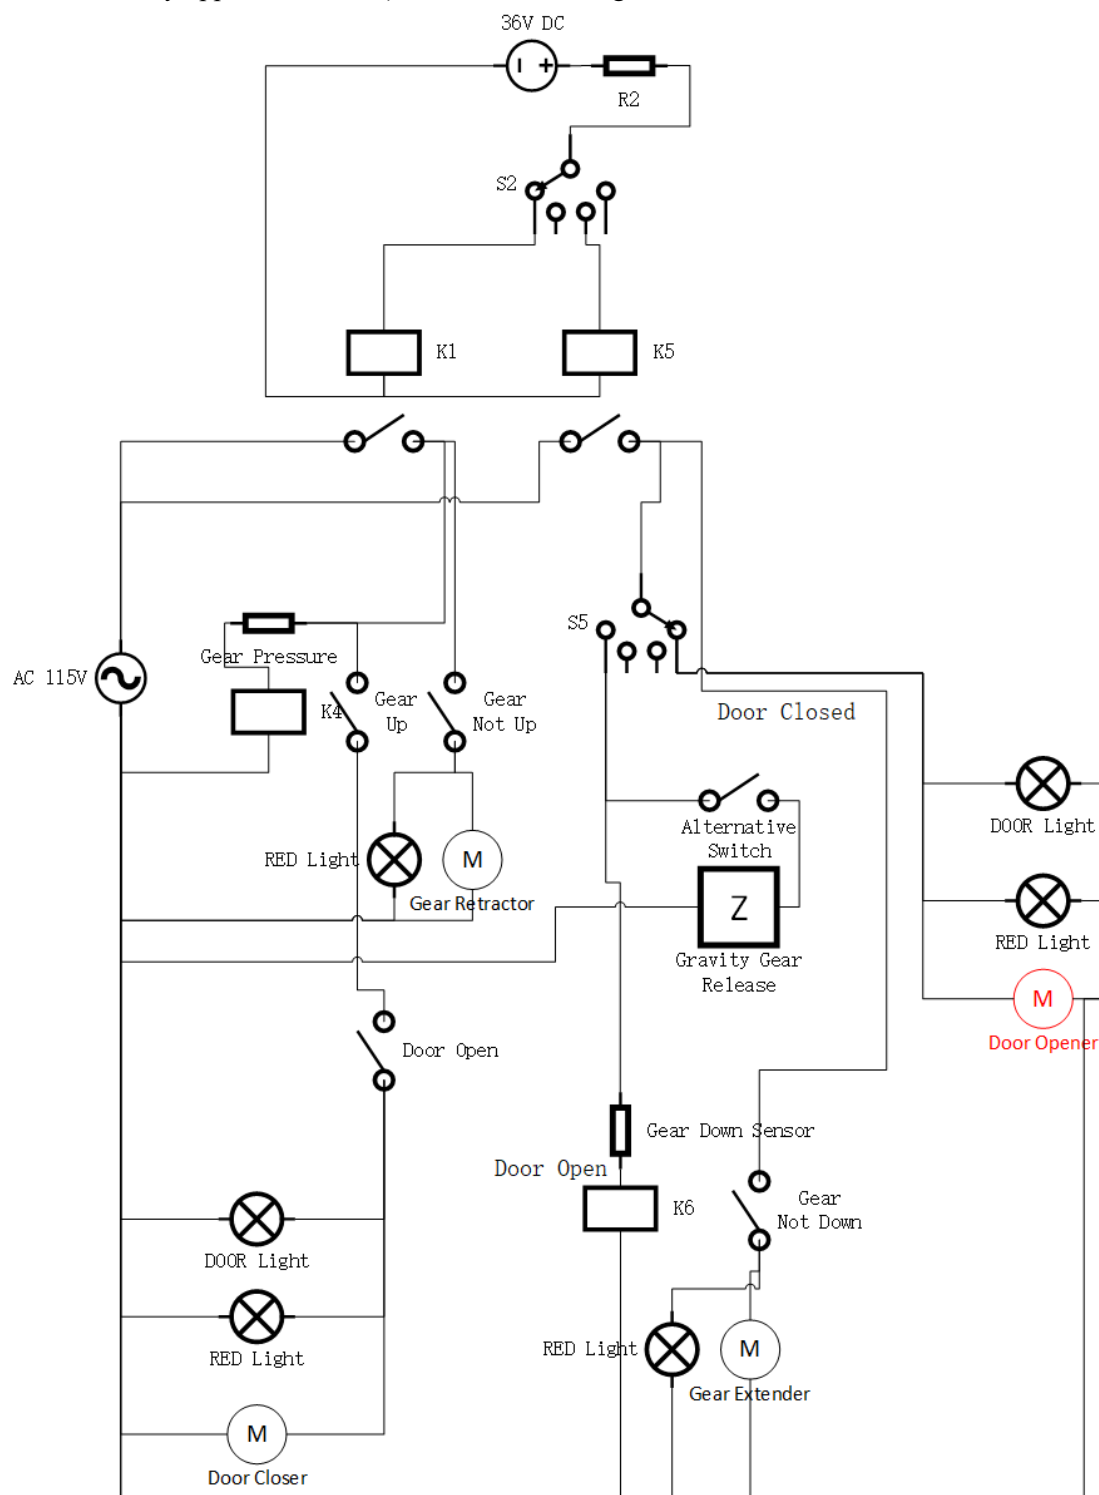
Figure 2. Circuit diagram of the landing gear system (The incorrectly wired motor is in red)

The nose gear component was inoperative during the incident. Investigators successfully got the component and found an incorrect wire. More detailed, the door opener motor of the gear extension module was reversely connected. Therefore, the door can never open (because it's going towards exactly opposite direction). See the circuit diagram below.

Investigators also noticed that the wire near the left gear's and right gear's door-opening motors were partially cut down.

According to the circuit diagram, the gear won't be extended if the door couldn't open, even if the alternative system is used. This stops pilots from manually extending the gear during an

emergency in which the door is stuck.

Also, the plugs might be reversely connected, since they have the same shape and only use color to tell the difference. These are against the safety principle of the designing.

Another threat is that if the motor is stuck, it might produce too much heat and cause smoke and/or fire.

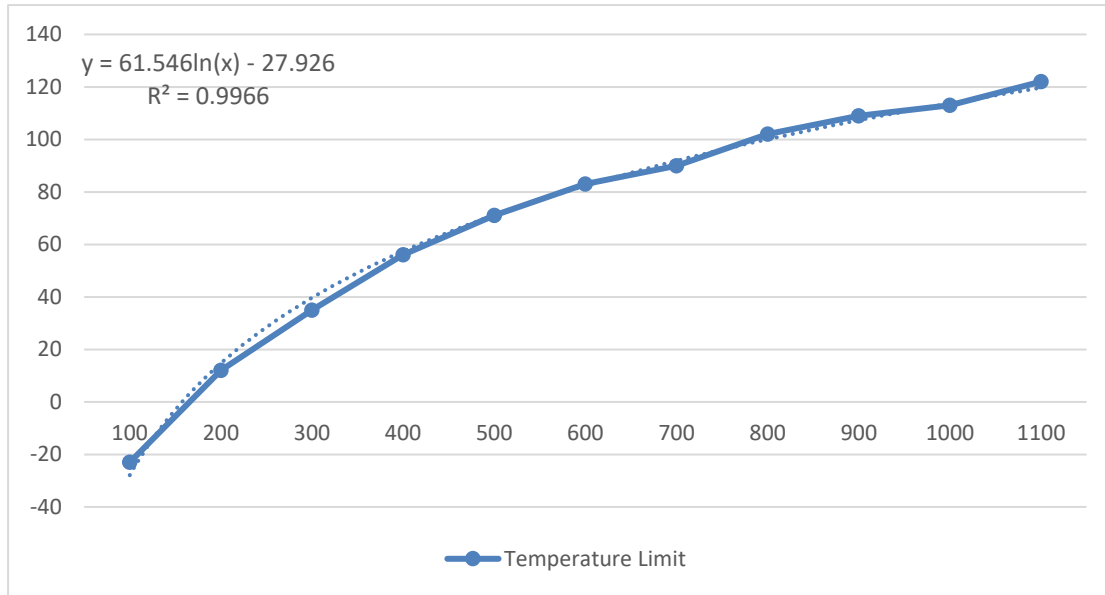
Figure 3. The measured temperature limit (beyond which the material would break down)

Investigators heated the material whose size is the same as the aircraft to certain temperature, and then let it suddenly cool down (which takes at most 5 minutes) and recorded the maximum cooling temperature in which they broke done. The result is given below:

The firefighter's mission was done in time, but the sudden cool-down of the fuselage caused its damage. The detailed curve is given in Section 1.16.2.

Firefighters should not pour too much water to heated fuselages to cool it down in order to prevent sudden breakdown. However, when the fuselage is likely to be on fire, an immediate cooling-down procedure should still be carried out as usual.

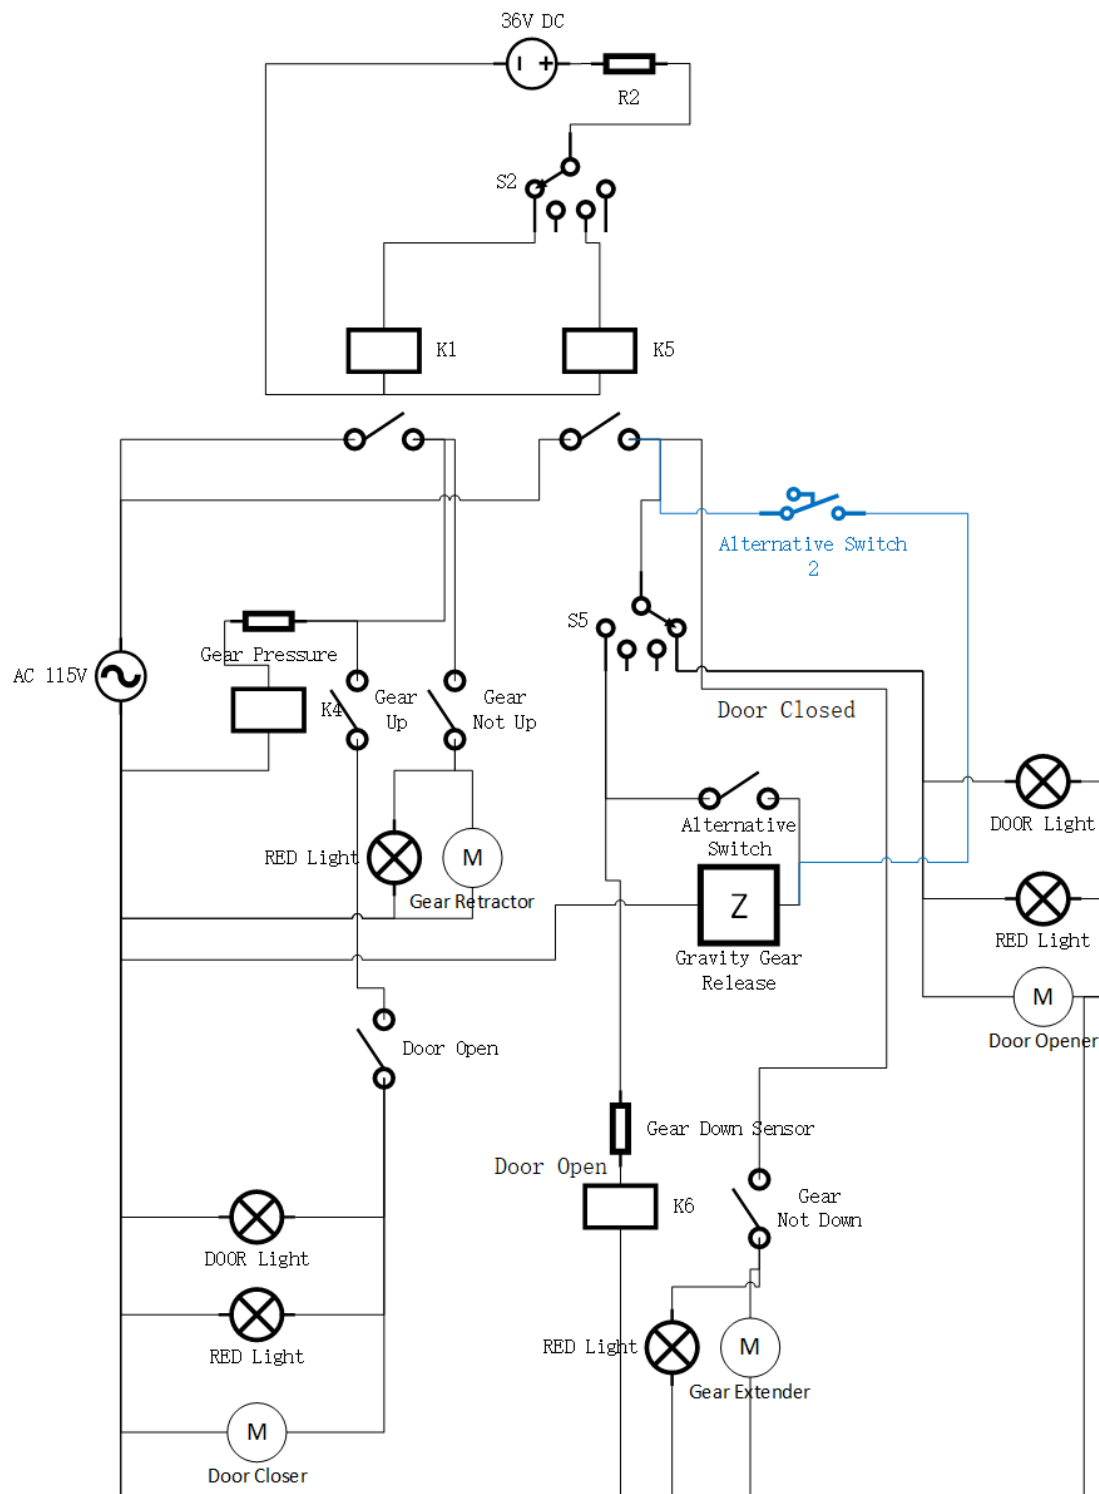
Figure 4. Recommended electronic system

(Blue switch is a delayed switch which automatically engages after being turned on for a few seconds. The timeout should be determined through calculation or experiment.)

In this way, even if the door is stuck, the gear will extend. However, whether the broken door will cause damage, remains to be seen. Anyway, the damage caused by the broken door won't be more serious than the damage caused by unextendible landing gear.

Besides, to prevent unexpected wire, plugs are recommended to use both different colors and different shapes, which should be different enough so that a plug can't be connected to the wrong position.

Response: All Seniorious and Historia aircraft, which have similar design, have all been equipped with new alternative system by the end of January 437.
