Presented by **Regule Aire Transportation Safety Committee**

Final Report of
8L-CAX Seniorious 300
Accident over Lyell
on May 30th, 449

Released in May 450

FLIGHT NUMBER: RE193
OPERATOR: Air RE
OWNER: Air RE
MANUFACTURER: Seniorious Aircraft Manufactory CO
AIRCRAFT TYPE: Seniorious 300
REGISTRATION: 8L-CAX
PLACE OF ACCIDENT: Over Lyell Airspace
DATE AND TIME: MAY 30TH, 449 – 13:16:25

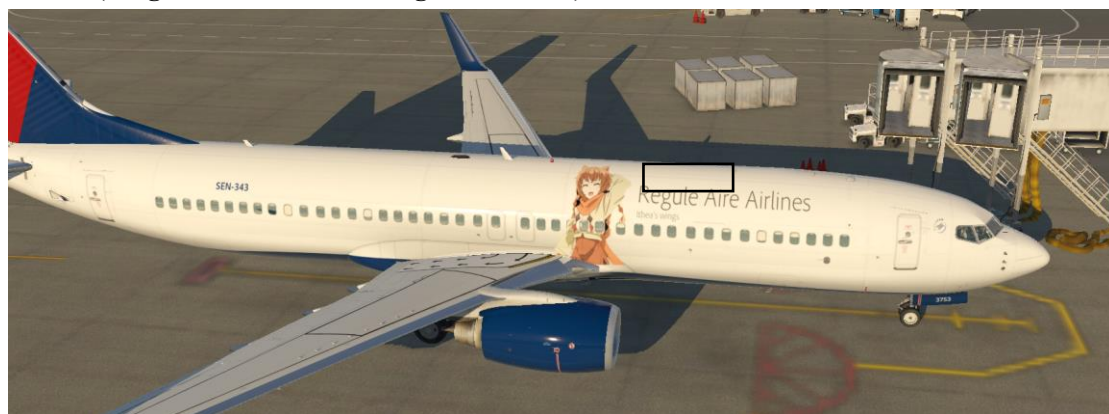
Diagram – General Damage of Aircraft
(The rectangle area is the approximate damaged area)

The aircraft structure generally remained complete, except a part of fuselage at the top of the aircraft (**Diagram – General Damage of Aircraft**):

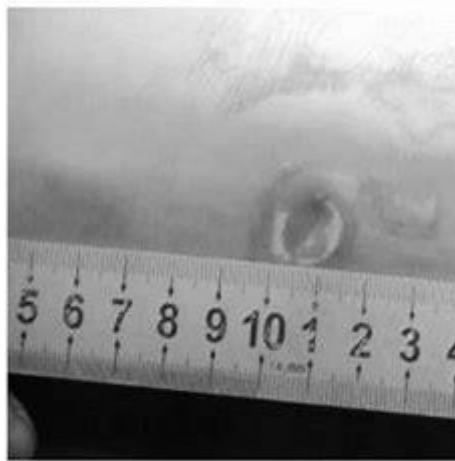
Photo – The Fallen Component

The point in the center, whose length is approximately 15 mm, suggests internal explosion.

Besides, from where the fallen fuselage should have connected to the aircraft, investigators found rivets exposed to the air.

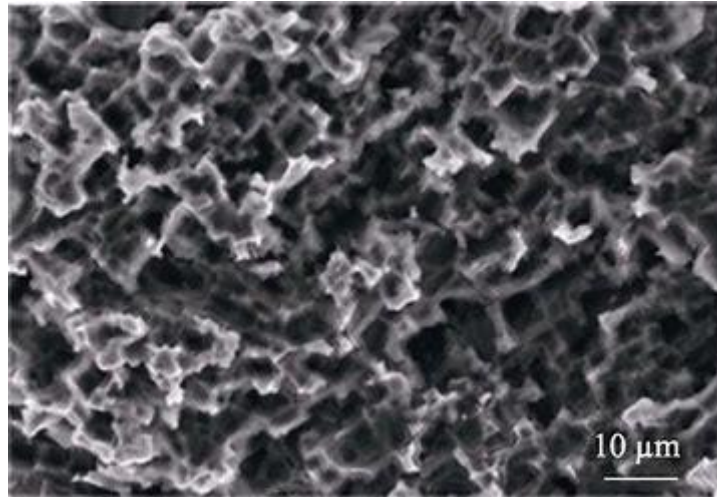
Photo – Broken Isolation Locker Component Under Microscope

This structure suggests erosion of the Aluminum material.

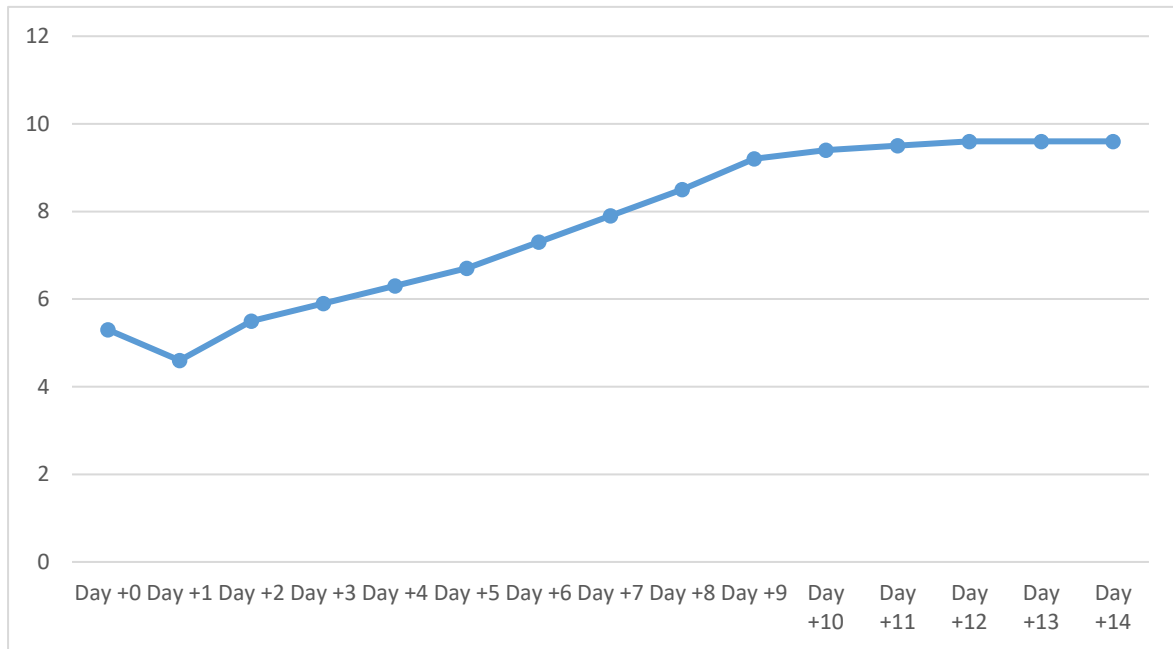
Figure – Measured Blood pH

According to the former investigation, it suggests that erosion had taken place. However, it seems that she recovered from it. In 155 days, she wasn't eroded again.
