Presented by  
**Civil Aviation Administration of Mitakihara, and  
Regule Aire Transportation Safety Committee**

# Primary Report of Homura Akemi Properties' Aircraft MA-HMR (BAE 146)'s Accident over Mitakihara on December 15<sup>th</sup>, 2022

Released in November 2024

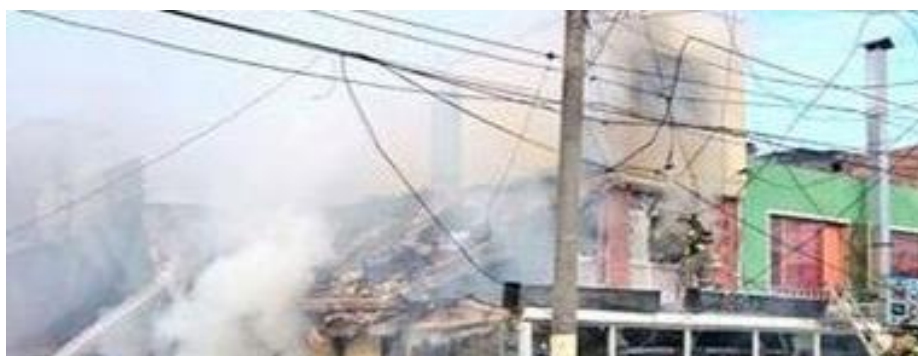
The aircraft was completely damaged. Wreckages of the aircraft, mixed with wreckages of houses in the downtown, distributed in a circle with approximately 32m radius. Most of wreckages were found in the collision site.

**Figure 1. MA-HMR's Wreckage Mixed with Houses' Wreckage**

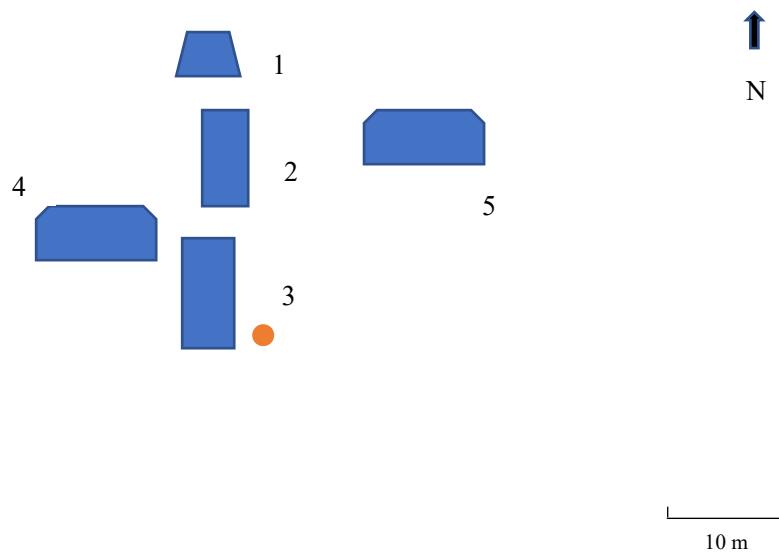
**Figure 3. Distribution of MA-HMR's Wreckage**

**Legends:** 1 – Cockpit; 2, 3 – Fuselages; 4, 5 – Wings; Orange – FDR and CVR (Black boxes).  
(Detailed distribution of key wreckages will be given in following sections)

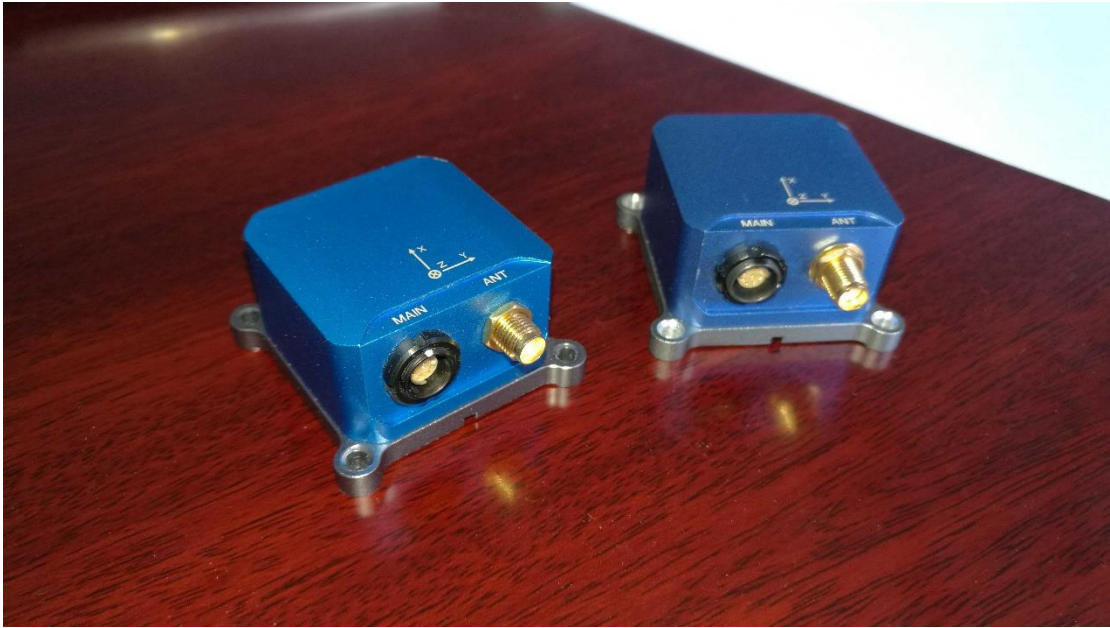
In the crash site, investigators found IRS components in the distribution area of cockpit wreckage.

**Figure 7. IRS Modules (Cleaned<sup>7</sup>)**

Investigators also tested if IRS provided incorrect attitude information (the process can be seen in experiment part). The result was that the IRS worked correctly.

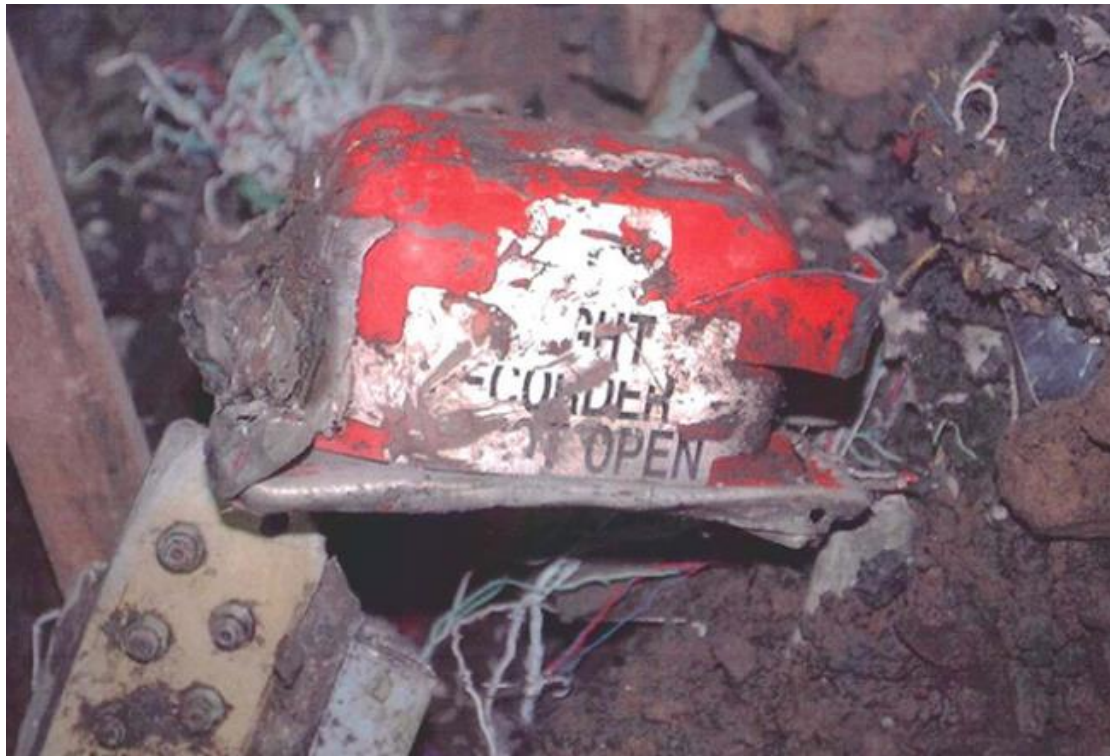
**Figure 8. Black Box Found in Crash Site**

The data from the CVR and FDR were successfully downloaded 6 days after the accident by RATSC. Integrity check revealed that the data are reliable.

The FDR data revealed that at the beginning of the accident, there was steep climb and unsteady back inputs, and the aircraft generally responded to the input (see experiments). The input immediately disappeared and replaced by full nose-down input and trim<sup>12</sup> adjustment after 6 seconds, and FDR recorded increasing thrust input and engine output after that.

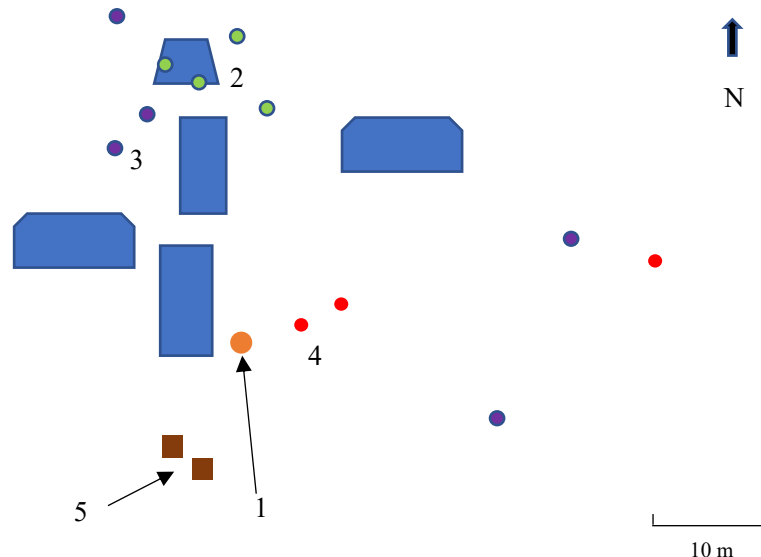
**Figure 9. Distribution of Key Wreckages**

**Legends:** 1 – Black boxes; 2 (Green) – Avionics; 3 (Purple) – Feathers; 4 (Red) – Components of “Soul Gem”; 5 (Brown) – Tail wing flying control surfaces (Stabilizers and Rudders).

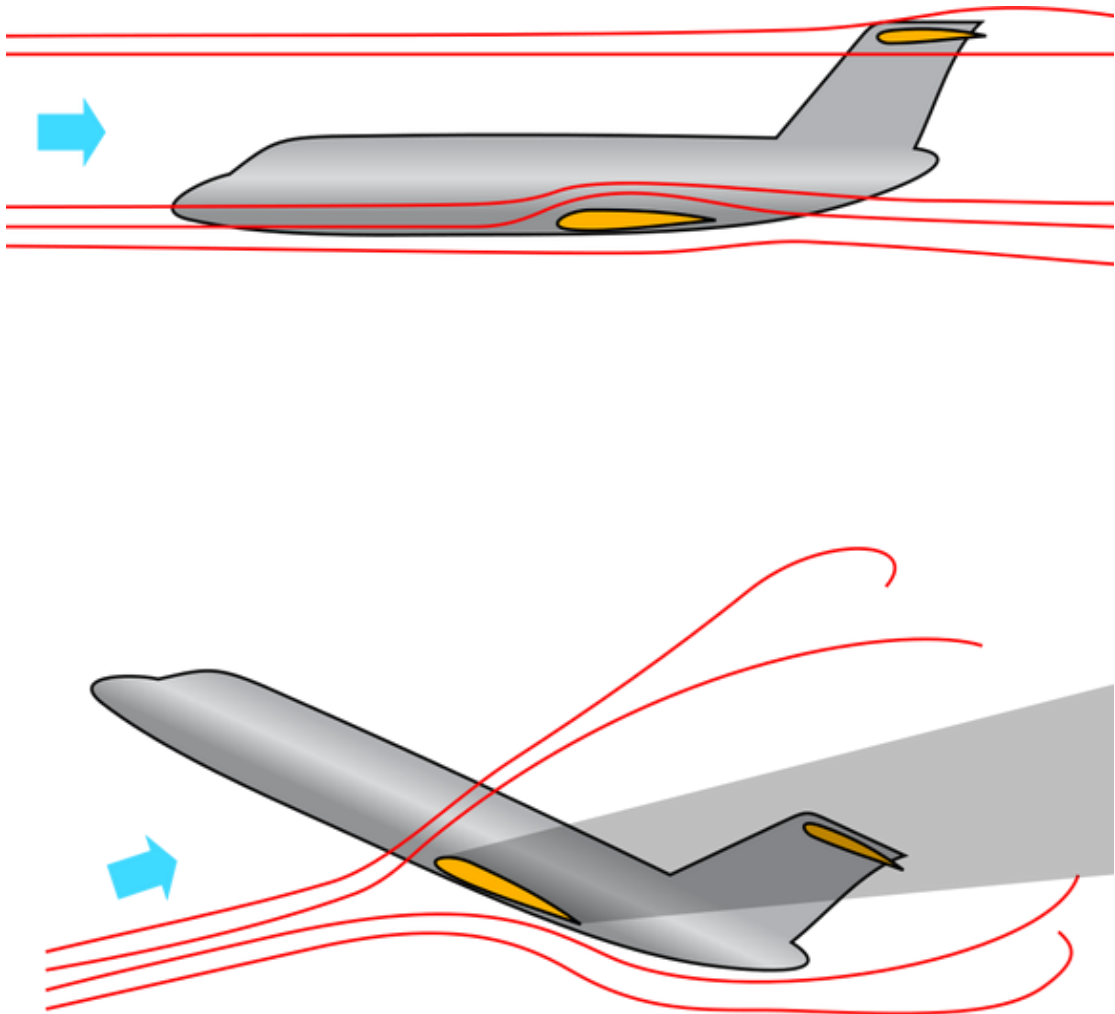
BAE 146 has T-shape tail design (stabilizer placed at the top of the tail, not the bottom). As a result, when it stalls, air passing through the tail immediately becomes turbulences (see following figures), which invalidates most of control input to the tail wing. It is for this reason that if the aircraft stalls, it's more likely to enter "deep stall"; when it enters "deep stall", or a state where the aircraft enters horizontal spin or long-lasting vertical spin (with airspeed sufficiently low), it becomes difficult for crew members to roll out, for which most pilots failed roll-out attempts in the *1.16.3 Flight Simulation* when an early roll-out fails because of the inefficiency of input caused by reduction of strength.

**Figure 12. Aerodynamic Performance when T-Shape Tail Stalls (Gray: Turbulence Area)**
