REPORT ON SURVEY OF VESSEL - SHAULA

Type	Lock Fyne skiff gaff cutter		
Designer	G. L. Watson	Builder	Alan Edmunds – Isle of Skye
Year of Build	1984	Construction	Carvel – larch on oak
Bow	Straight	Stern	Double ended
Keel	Long	Ballast	Iron keel and internal ballast
LOA	10.21m – 33ft 6ins	Beam	3.05m – 10ft
Draft	1.68m – 5ft 6ins	SSR	69888
Machinery	Perkins diesel		
Steering	Tiller		
Type of survey	Structural		
Date	2 nd February 2015		
Place	Creekside Boatyard, Old Mill lane, Dartmouth		
Condition	Ashore on beach		
Weather	Overcast with sun later

attended the above mentioned vessel as she lay ashore at Creekside Boatyard, Old Mill Lane, Dartmouth on the 2nd February 2015 for the purpose of ascertaining her general condition prior to purchase.

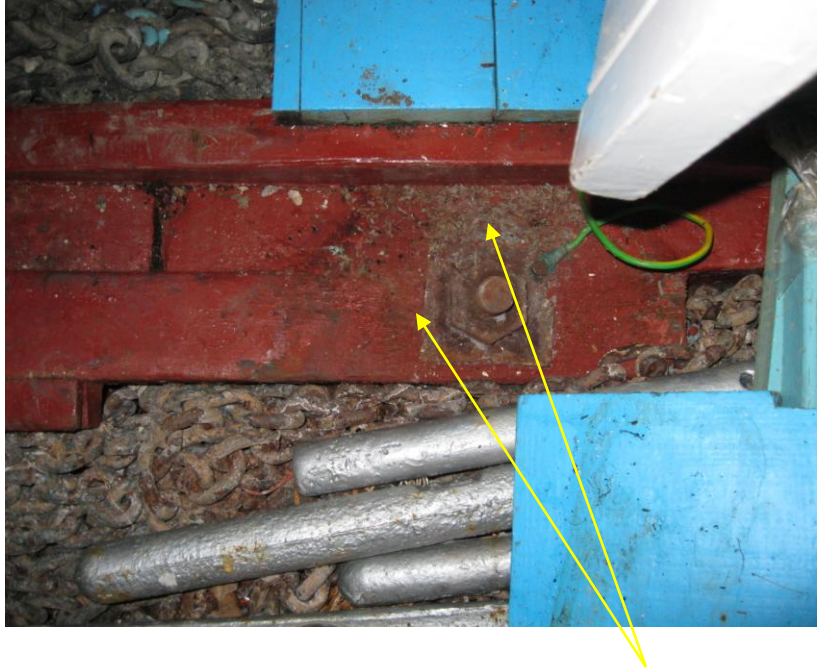
- 11.2 There are 3x keel bolt ends exposed to inspection two forward of the mast and one aft of the heating stove. The keel bolts, their nuts and plate washers are in good condition where open to inspection. The keel bolts are bonded, (tied together electrically).

- 11.3 The floors in way of the keel bolts are affected by delignification. The worst affected is the floor in way of the forward keel bolt which is denatured to the depth of 1" due to the fact that the keel bolts are bonded. The electrochemical activity results in large numbers of electrons trying to dissipate at the cathode, the keel bolt. These electrons react with water and oxygen to form hydroxyl ions, creating an alkaline environment. This alkaline environment destroys the lignin, which is the natural binder in the timber. Bonding is a good way to protect the keel bolts in a dry environment however this is seldom the case in an older timber vessel and consequently bonding in a wooden vessel should be avoided.

The floors are large in section and the defect does not represent an immediate threat to the security of the structure of the vessel or the keel.

- i. *The bonding wire should be disconnected. (B)*
- ii. *The floors should be repaired one at a time, by removing the keel bolt nut and plate washer, cutting out the delignified section of the floor and scarphing in a new section. The plate washer can then be re-fitted and the nut re-fastened. (C)*
