# Corrosion growth of solar cells in modules after 15 years of operation

This paper is to study the deterioration of PV modules after 15 years of operation in Thailand. All 16 modules of a string were annually measured in the standard testing laboratory, then taken back to the same position of string since the 7th year after operation. The results and data analysis can be divided into 3 parts consisting of electrical performance evaluation, physical deterioration observation, and corrosion growth on cell ribbons. From the electrical results of performance at STC, it was found that power of modules were less than 80% of the nameplate value in the 15th year for 75% of total modules. The average degradation rates, based on nameplate, was 1.47%/year. The degradation rates of modules since the 10th year after operation were in the range of 2.5 to 3.0%. From the visual failures on the front and rear side of modules were appeared in all modules. During the 12th – 15th year, the corrosion area growth on cell ribbons, calculated by ImageJ program, was around 10–17%/3 years of ribbons area, especially for cells beside junction box. The colors of corrosion products were also observed in both

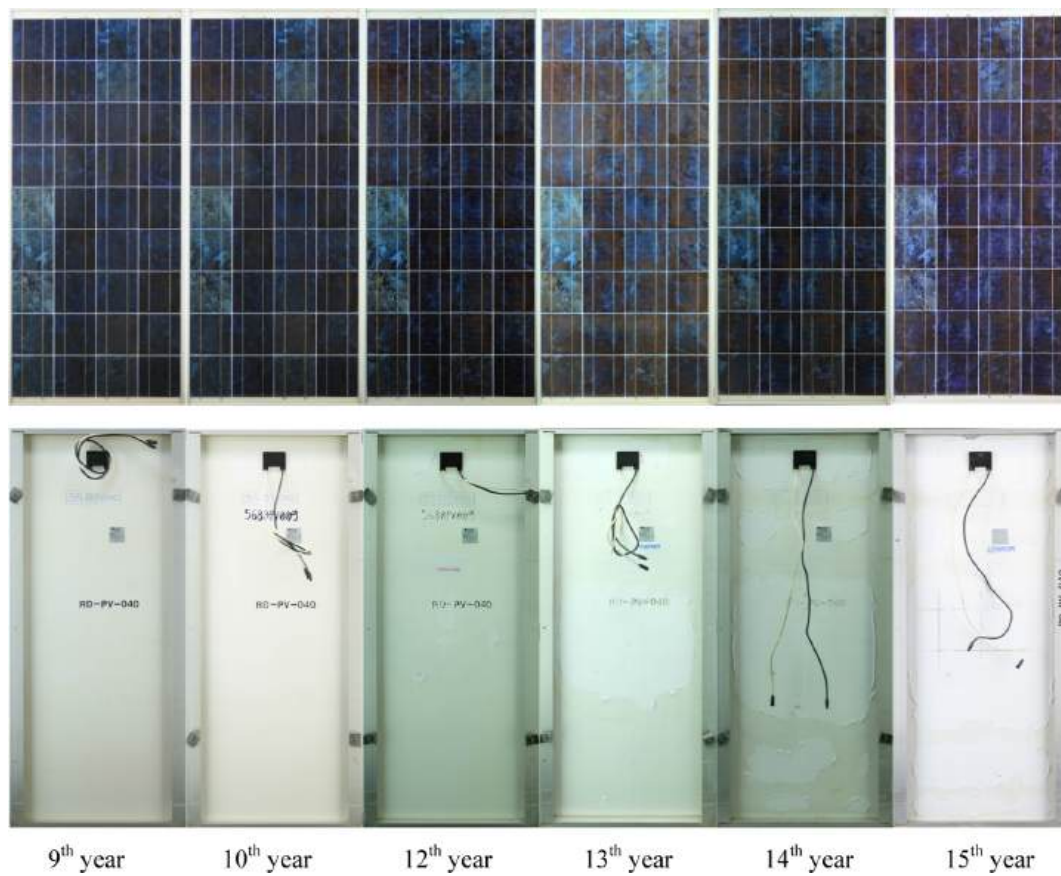
Fig. 6. Images of front side and rear side of Module No. 13 (Module C) during the 9th to the 15th year.

The visual images, during the 9th to the 15th year, of the M13 module called Module C, were shown in Fig. 6 for example. The deterioration or defects observation on modules were focused such as in Fig. 7. Fig. 8 shows the example of visual defects observation on each cell in each module.

The deterioration on the rear side of modules can be annually observed. It is noted that the backsheet color of each module was light brown since the 9th year after operation. From images of modules at the 12th year, the backsheet delamination was observed beside their junction boxes around 20% of total module area, and the beginning of chalking of backsheet was found. The backsheet layer separation was found. From images at the 13th year, the backsheet delamination area was around 50% of total module area, and EVA appearance was especially found in the module area without cell. In the 14th and 15th year, the area of backsheet delamination was more than 80% and completely, respectively.

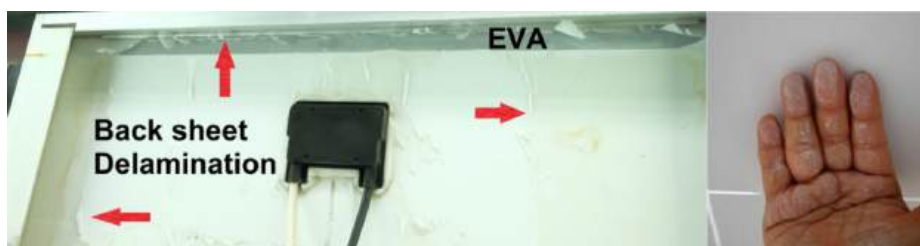
Fig. 7. Back sheet delamination and chalking.

From the visual images on the front side of modules, the browning, crack, corrosion, delamination and snail trail on superstrate materials were appeared in all modules. On the rear side of modules, the deterioration, consisting of backsheet browning, delamination and chalking, were appeared on the substrate materials as shown in Fig. 6. In the 15th year, the backsheet delamination was presented more than 80% of total area of all modules.

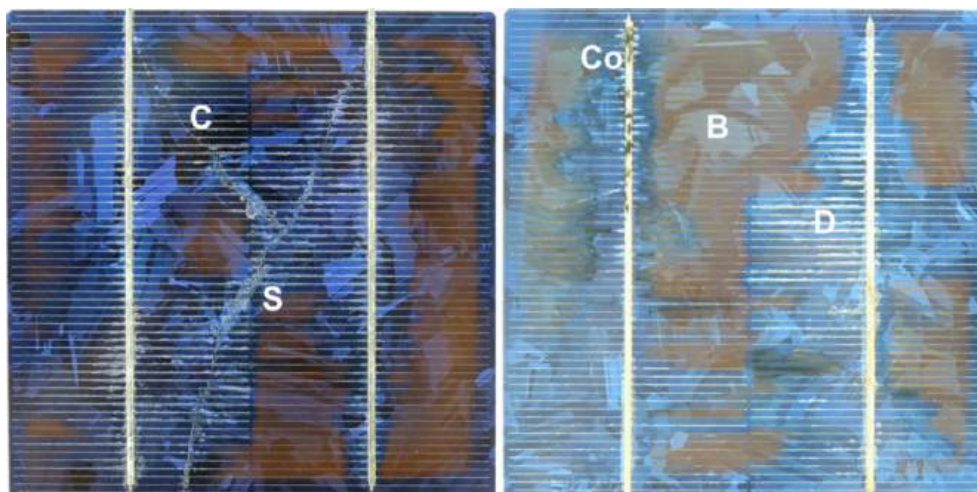
Fig. 8. Visual defects appeared on a cell such as Browning (B), Crack (C), Corrosion (Co), Delamination (D) and Snail trails (S).

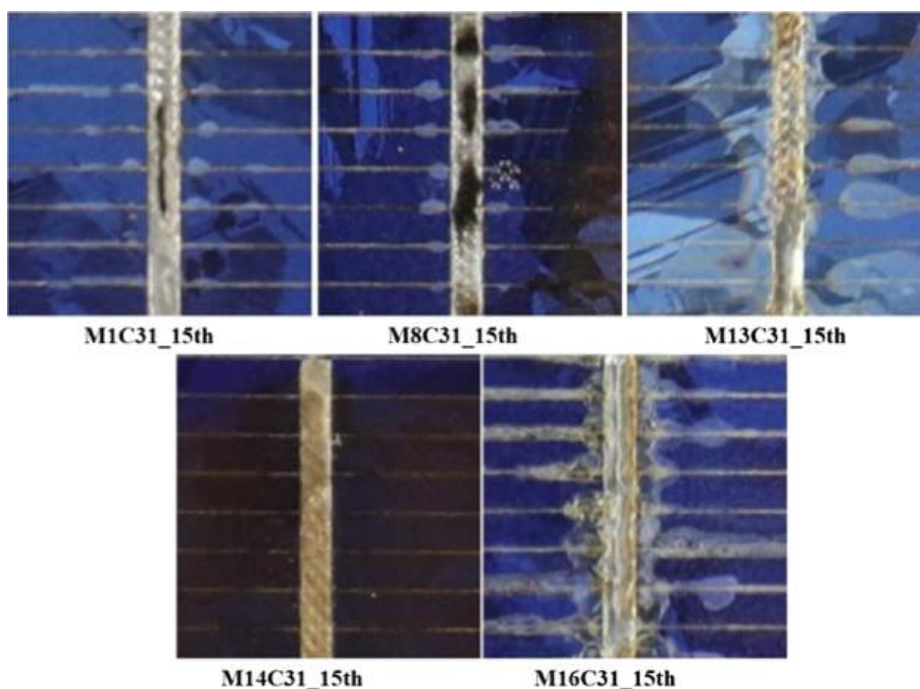
Fig. 9. Colors of corrosion on ribbon and gridline consist of yellow, light gray, dark brown and black. (For interpretation of the references to color in this figure legend, the reader is referred to the web version of this article.)

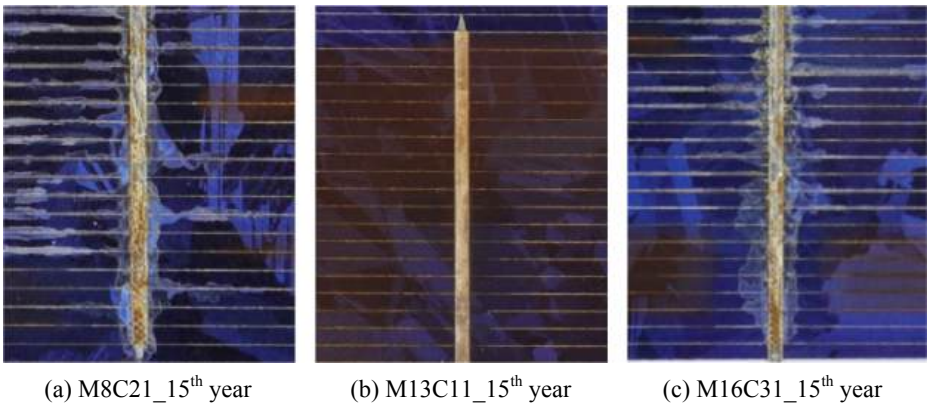
Fig. 10. Corrosion on ribbon (a) corrosion with delamination (b) corrosion with browning (c) corrosion with delamination and browning.

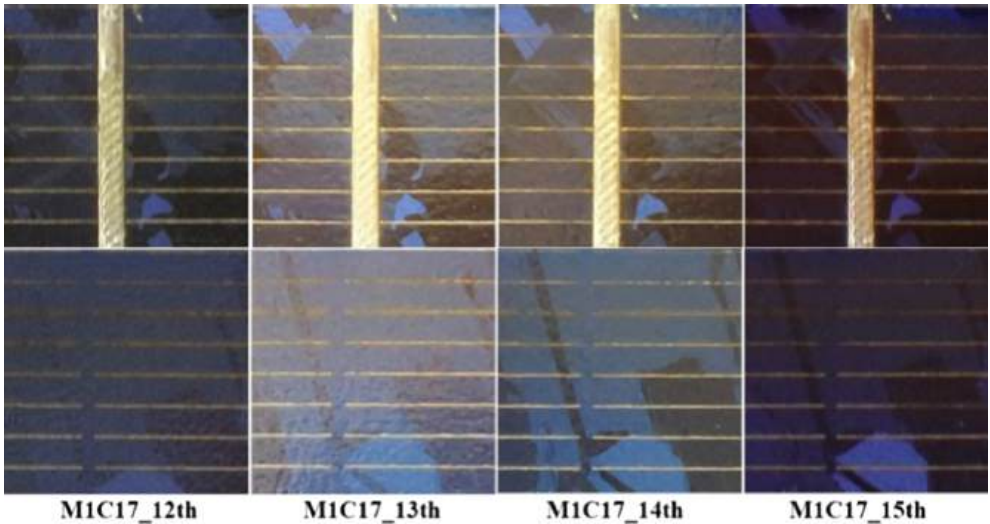
Fig. 12. Changing of corrosion colors during the 12th–15th year.

The ribbon corrosion colors were yellow, brown and light gray in the 12th and 13th year, then changed to dark brown, gray and black in the 14th and 15th year as shown in Fig. 12. Hence, gridline corrosion was yellow in the 12th – 13th year, then changed to dark brown and black in the 14th and 15th year.

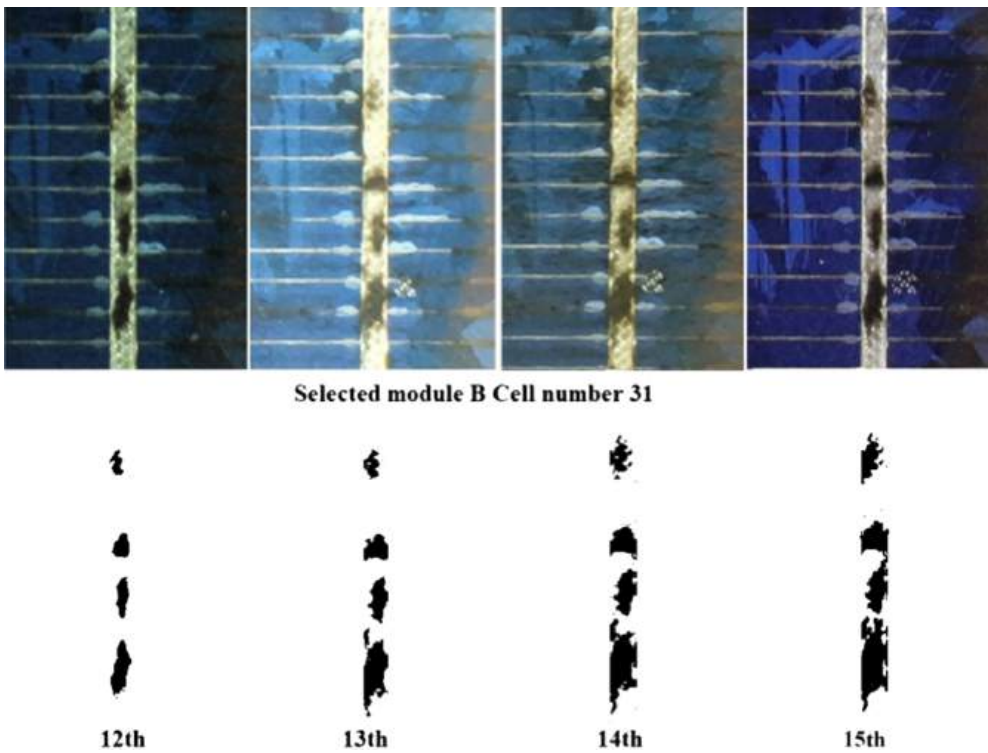
Fig. 14. Images of cell 31 of the Module: B.

The corrosion areas on the ribbons, of each cell of selected modules, were calculated based on total area of each ribbon. The total area of two ribbons is 6.72 cm<sup>2</sup>. Fig. 14 describes the method how to determine the corrosion area on the ribbon of cell. The threshold of color or quantization levels of image were used to quantify the area of corrosion. Reference is made to the ASTM D130 standard regarding colors of corrosion products. The area calculation was done by the ImageJ program on each visual image of cell. The corrosion growth along the width of ribbon was limited by the width, but the growth along the length of ribbon was annually dominant on the increasing of corrosion area. The calculation of the ratio of corrosion area and total ribbon area can be shown in Fig. B5. The ribbon corrosion on C21 cells appeared only on Module B and D. While we focus on the growth of corrosion area of ribbons on C31 cell, the cell beside the junction box, of each selected module, it is found that the corrosion area, on both ribbons of

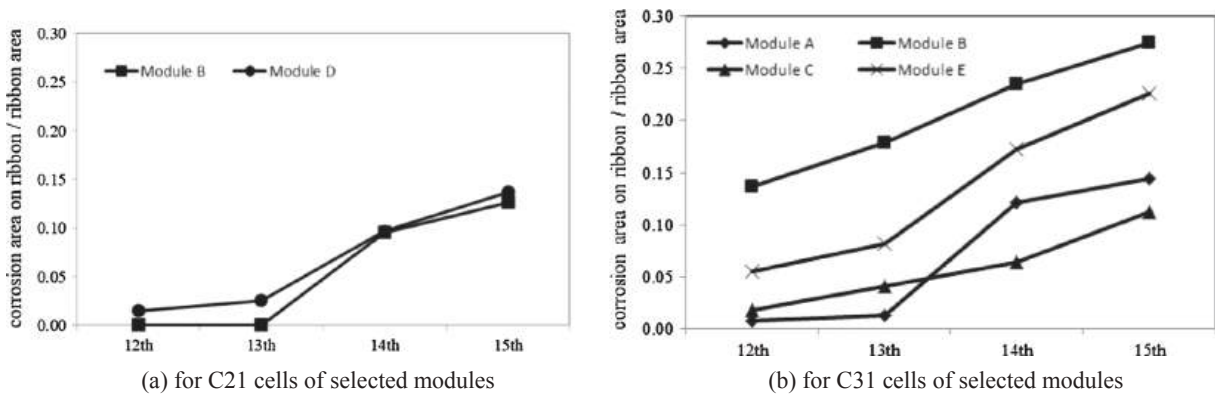
Fig. 15. Increasing of corrosion area on both ribbons of C21 and C31 cells appeared in selected modules during the 12th–15th year.

C31 cell, of Module B was larger than other selected modules. For C31 of Module B, the corrosion area increasing was 13% of total ribbons area during 4 years under observation. For the four selected modules, except Module D, the corrosion areas increased around 10 to 17% of each total ribbon area during the 12th–15th year after operation. The high steepness of corrosion growth was observed between the 12th and the 13th year after operation (see Fig. 15).

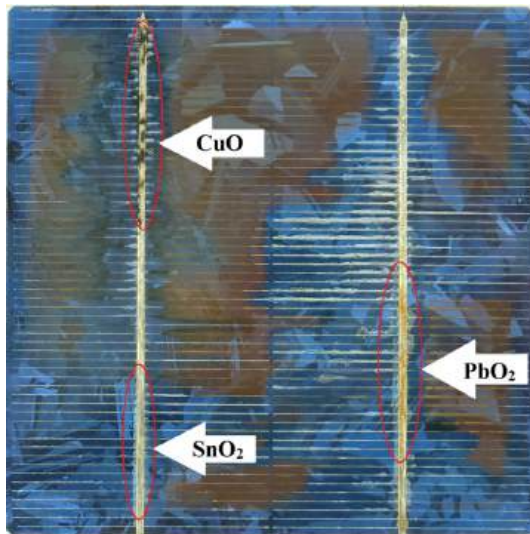
Fig. 19. Color of corrosion products of cell C31 of Module B in the 14th year.

Fig. 19 demonstrates the corrosion products and their colors for example of Module B in the 14th year after operation. From the galvanic corrosion (Xiong et al., 2017), the chemical reaction galvanic cell can be listed

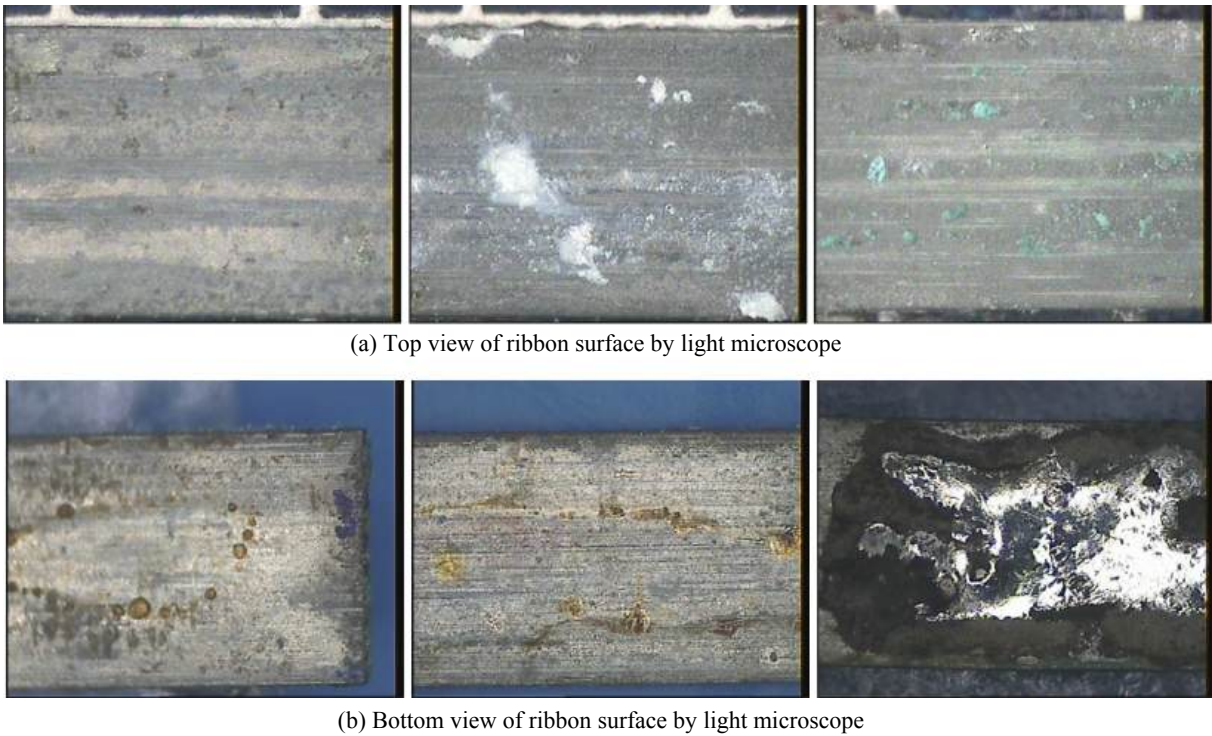
Fig. 20. Images of ribbon surface obtained by light microscope (with  $\times 50$ ).

The corrosion products and color of corrosion products can be justified by EDS and referred to ASTM D130 standard. From Figs. 20–24, the colors of corrosion products on ribbon surface consisted of yellow, dark-brown, light gray, and blue green (patina). Figs. 21 and 22 are to confirm Pb and Sn density decreasing and Cu remaining. Figs. 23 and 24 confirm the Sn and Pb corrosion product by SEM and EDS mapping.

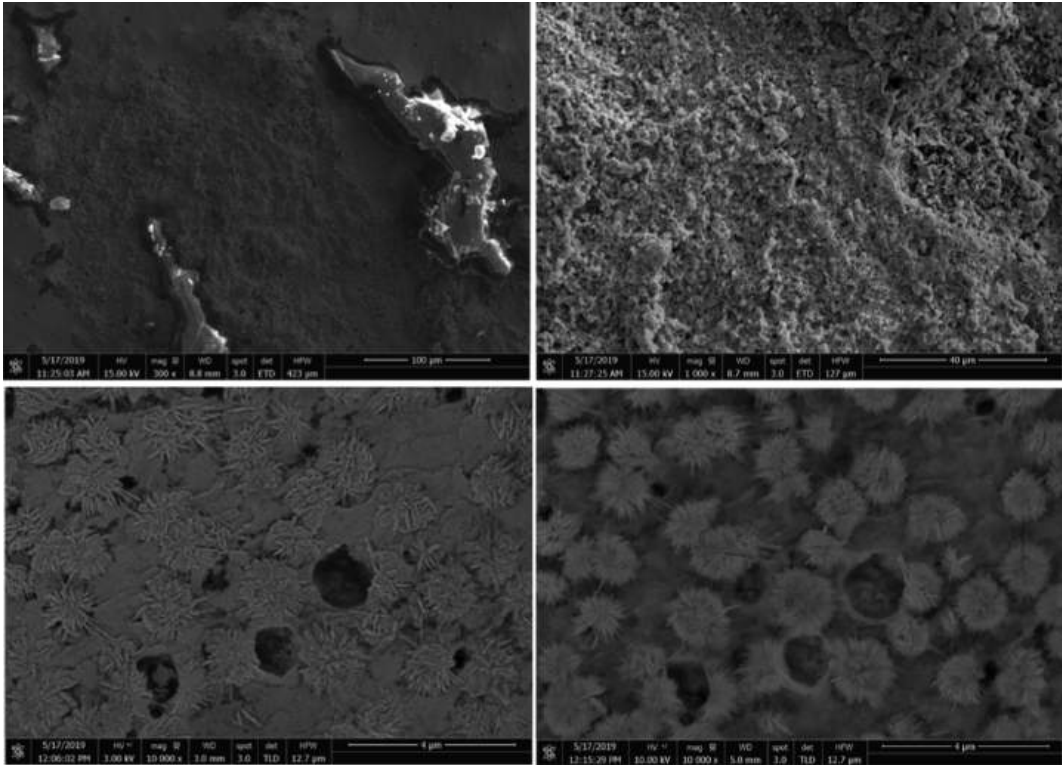
Fig. 23. SEM images of Pb corrosion product.

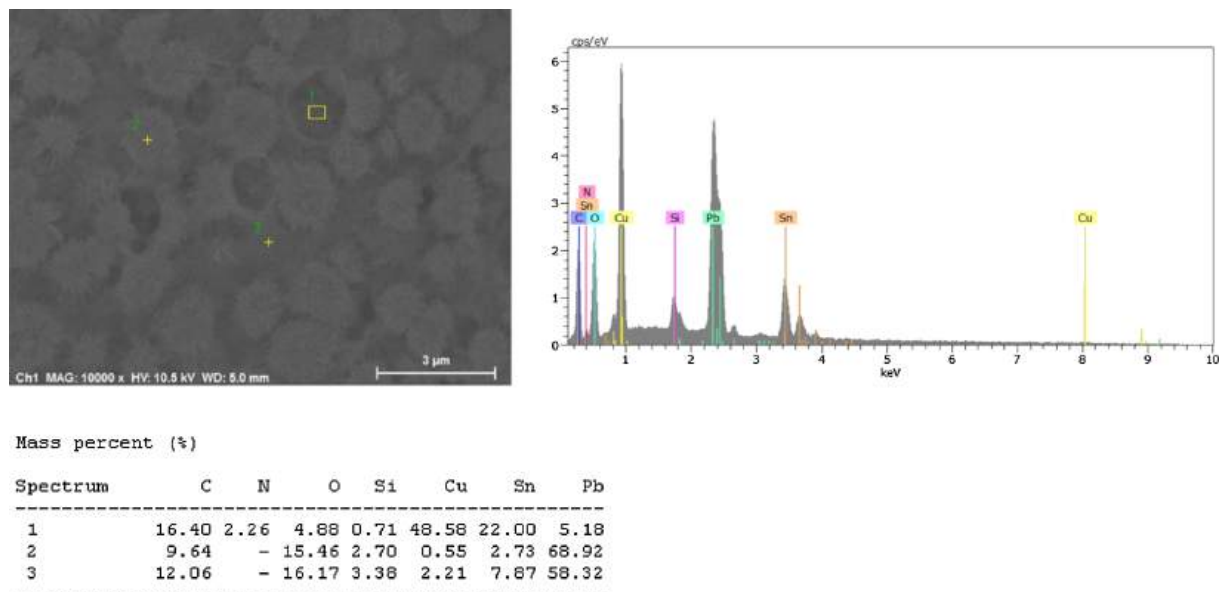
Fig. 24. SEM image and EDS results of Sn and Pb corrosion product.

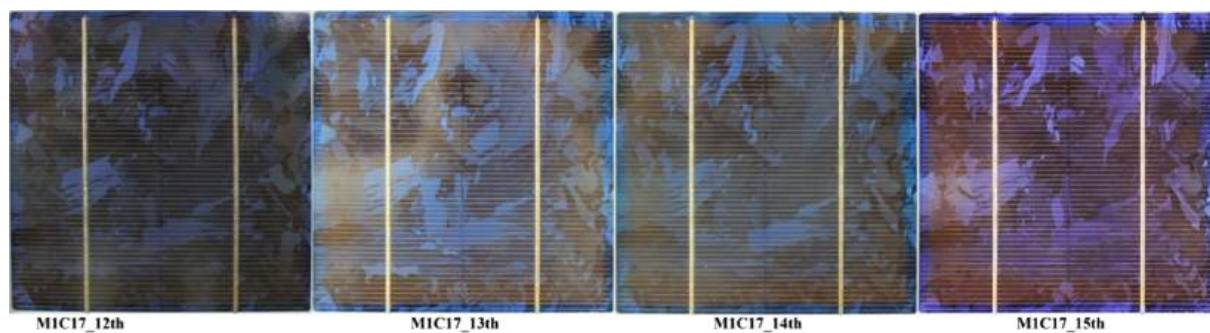
area on each cell was not significantly changed, but the degree of browning or the light brown was slightly changed to dark brown annually. From the population of images of cells, the browning area can be classified into 3 groups consisting of (a) the browning appeared over 90% of cell area, (b) the browning appeared over 50% of cell area, and (c) the browning scattering appeared in small pieces over cell area. Fig. B1 shows the three groups of browning appearance. It is found that most of cells, more than 70% of total cells of all modules, was classified in group (c). There were 20% of total cells classified in group (b), and the left 10% of total cells were in group (a). In case of group (a), there were not other defects such as ribbons or gridline corrosions. In other hands, there were other defects, such as delamination, corrosions, snail trail, on cells in group (b) and (c).

(a) the browning appeared over 90% of cell area

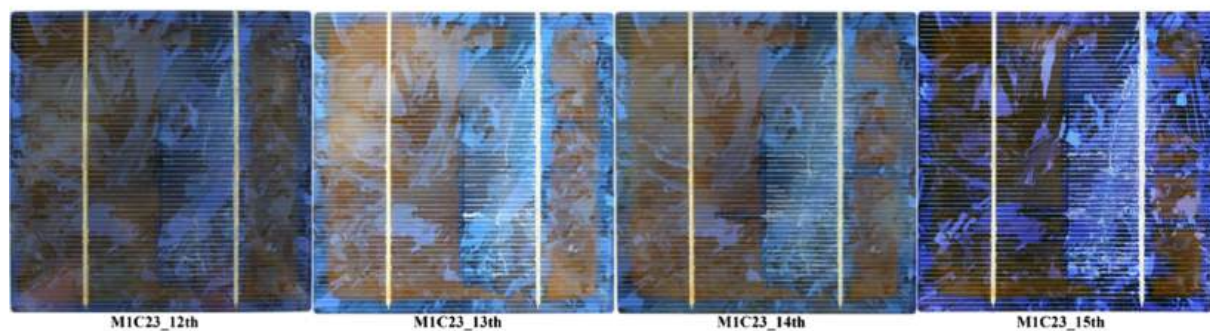
(b) the browning appeared over 50% of cell area

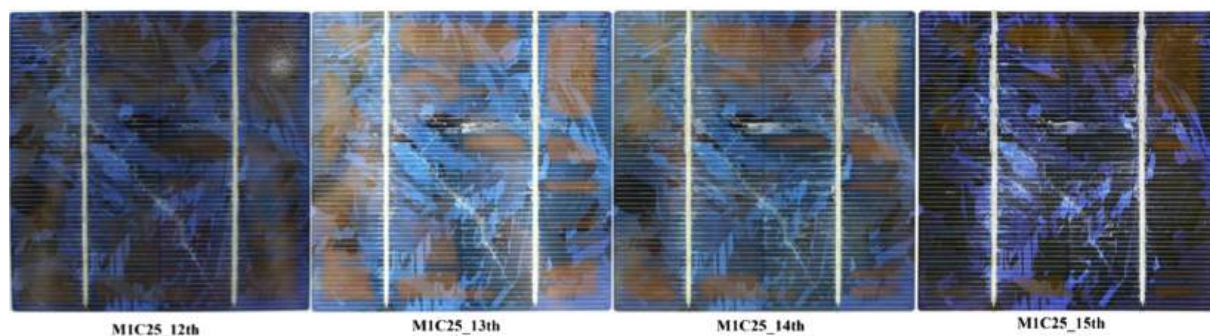
(c) the browning scattering appeared in small pieces over cell area

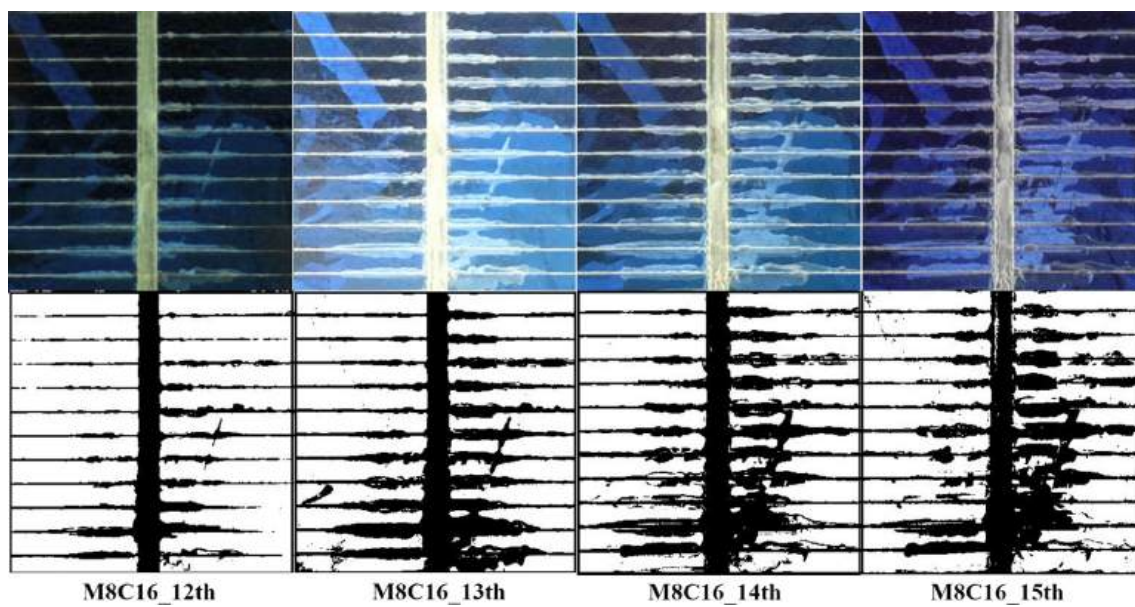
Fig. B2. Increasing of delamination areas on a part of cell in cell No.16 on the M8 module.

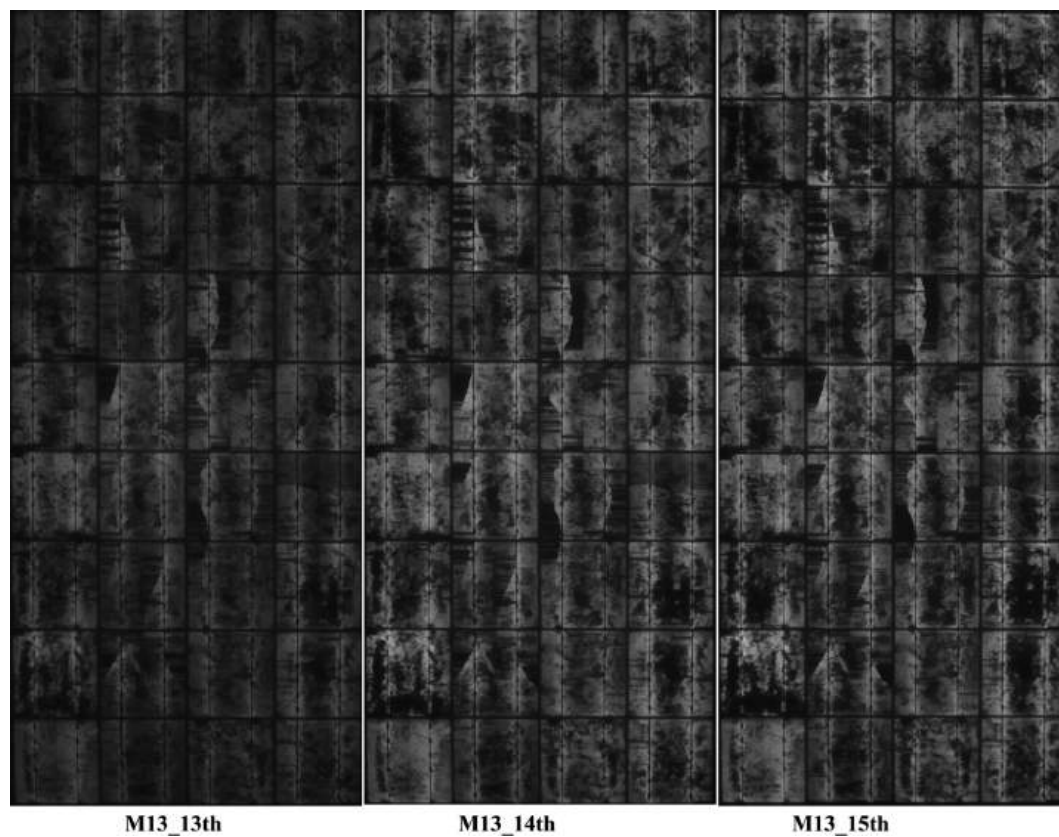
In Figs. B3 and B.4, the Electroluminescence (EL) images were also taken for all modules since the 13th year. There were many types of crack cells found in M13 module. Details of crack cells were mentioned in other reports such as IEA-PVPS Task13 report (Köntges et al., 2014).

Fig. B3. EL images of M13 module during the 13th to the 15th year.

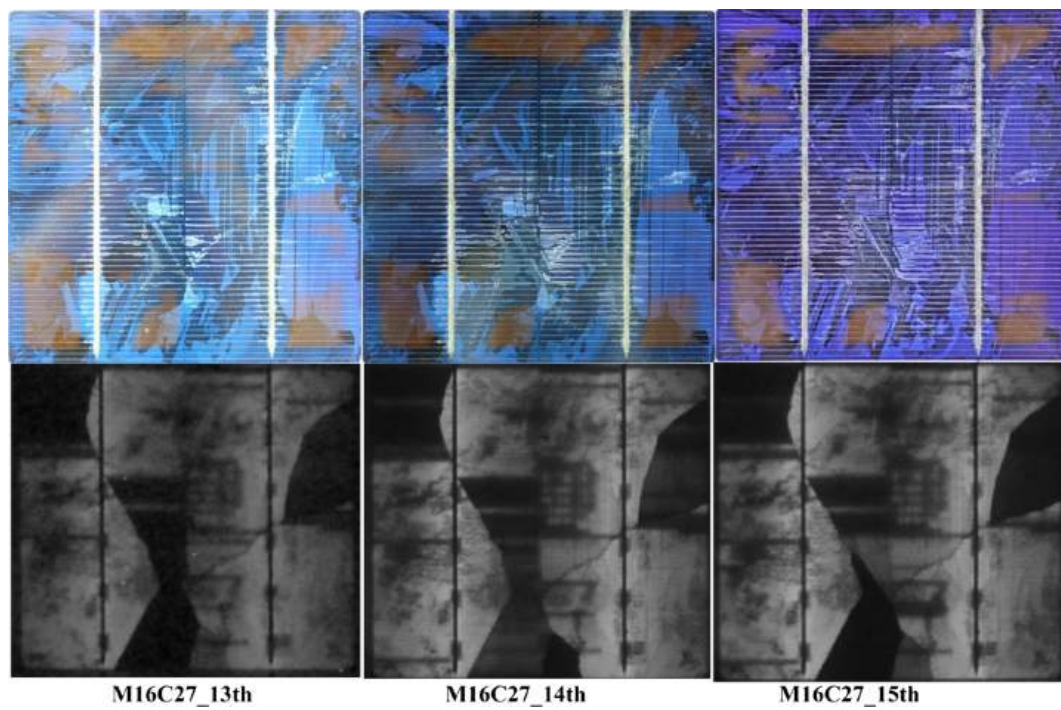
**Fig. B4.** EL images of cells in M16 module during the 13th to the 15<sup>th</sup> year.

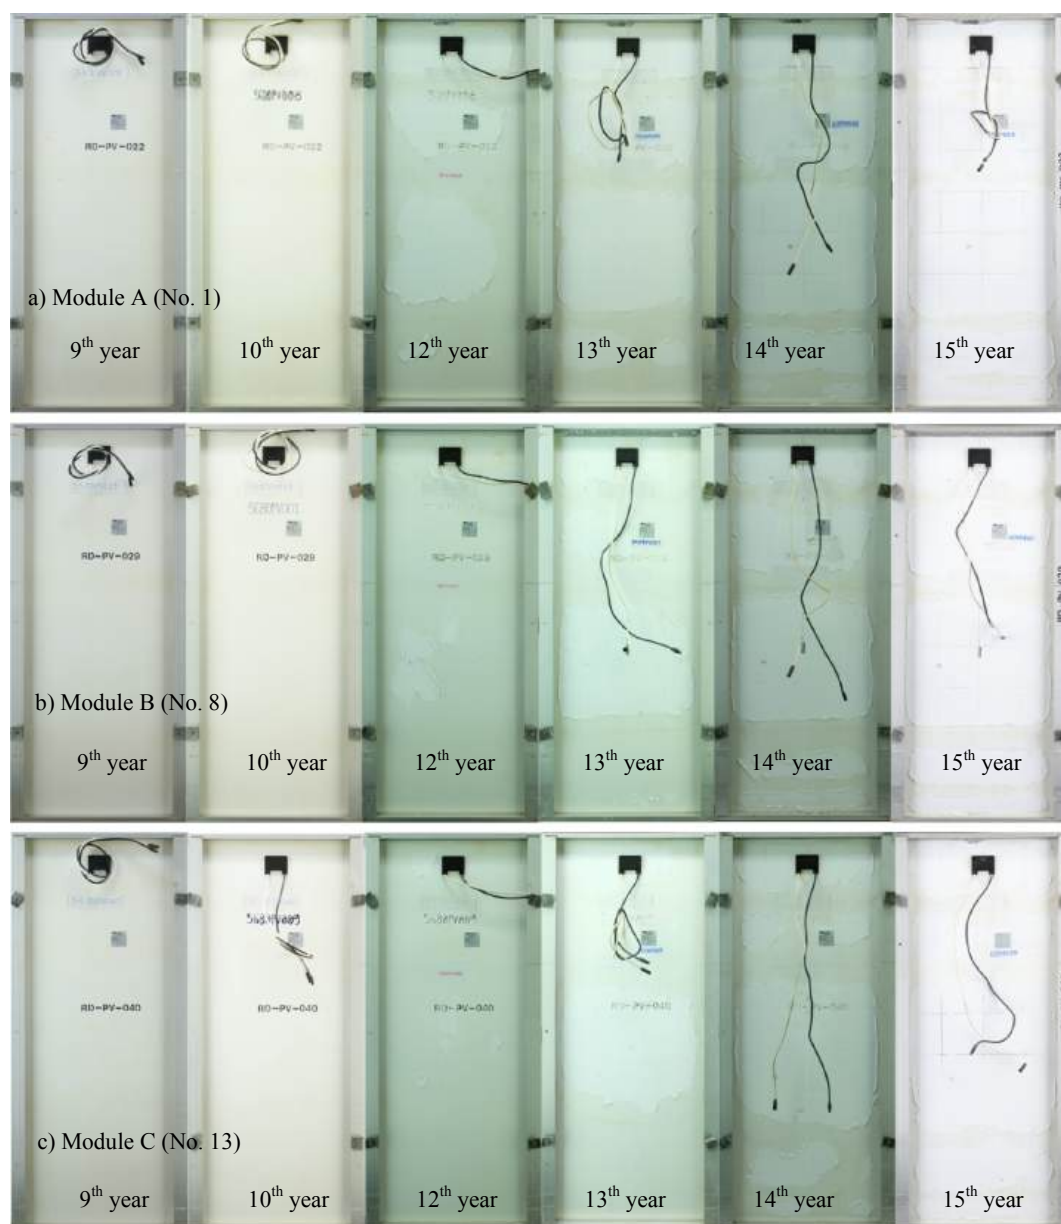
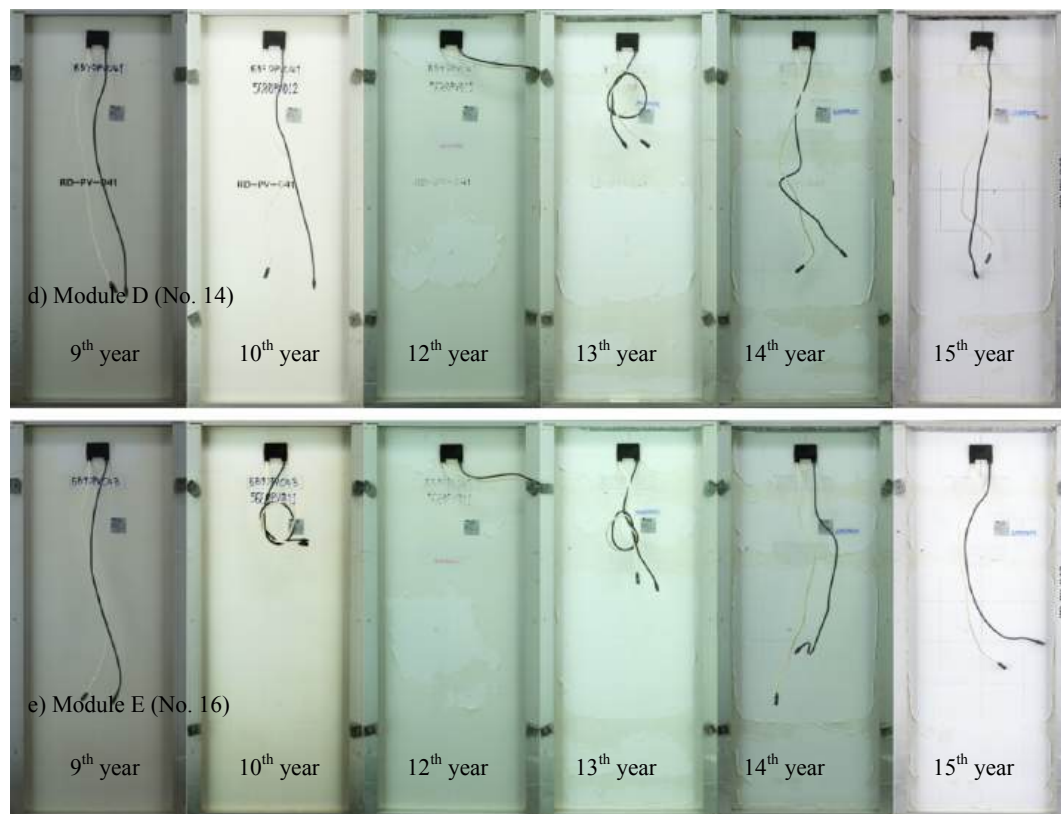
**Fig. B5.** Images of rear side of the 5 selected modules.

When we turn back to images of rear side of the five selected modules as shown in Fig. B5, the backsheet delamination, especially near the frame edge beside the junction box, may affect to develop the growth of metal corrosion on cells.
