## Container Record Check Form

Container Number: BOBU 000019-7Date: 10/16/13WO#: 500056042

14/18T ISO Container Inspection Record

Vessel ID: BOBU 000 019-7

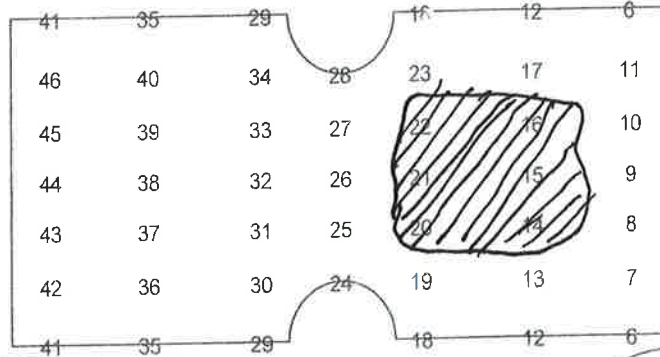
FRONT

Resurface nozzle - 45  
Low area in both - of container  
Low area in Rear end

Repairs complete  
& Vessel Clean:

yes
