# Lightning Protection of a Golf Course Irrigation System

**Abstract**— The Moliets golf located is South West of France in a stormy area. This golf course uses electronic devices to monitor the water sprinklers and reduce water consumption. Buried decoders associated with the sprinklers receive orders from the central monitoring system. Since early 2012, 1262 decoders were installed but on 31st July 2016 445 decoders were destroyed by lightning surges. An expertise has been performed involving analysis on site and in laboratories regarding the surge withstand of the decoders and the failure mechanism. An analysis of the recommended surge mitigation measures proposed by the sprinkler's manufacturer for a few sprinklers (external SPDs and fuse as well as earthing system lower than 10 ohms) has also been performed. The provided SPDs were found too slow to satisfactorily protect the sensitive electronic devices. In addition, the SPDs were unable to provide satisfactory protection due to the distance between SPDs and many sprinklers (much more than 10 m) and also due to the voltage generated inside the loop. It was then decided to ask for the development of specific fast protections d

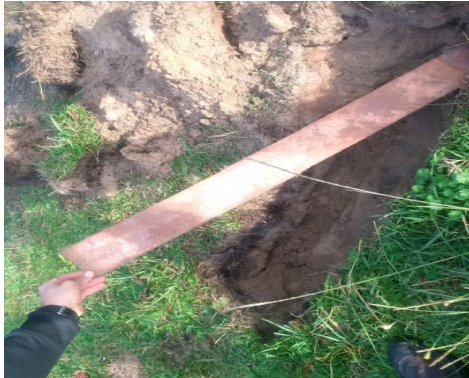
The external SPD is associated with an earthing system based on earth rods. The recommended maximum value for the earthing was 10 ohms. However, values measured locally (see Table I) have shown that many values were in the range of 30 ohms that is not surprising due to the sand base of the ground. When resistance was very bad copper earth "plates" (see Fig. 3) were used to improve the earthing but the improvement was not noticeable due to their bad resistance (the plates were mainly band with limited surface and installed in the sandy part of the ground).

The resistance is not so much relevant because decoders that failed were also located in places where resistance was lower than 10 ohms. In addition, the decoder being of class II (double

Fig. 3. Additional earth plate

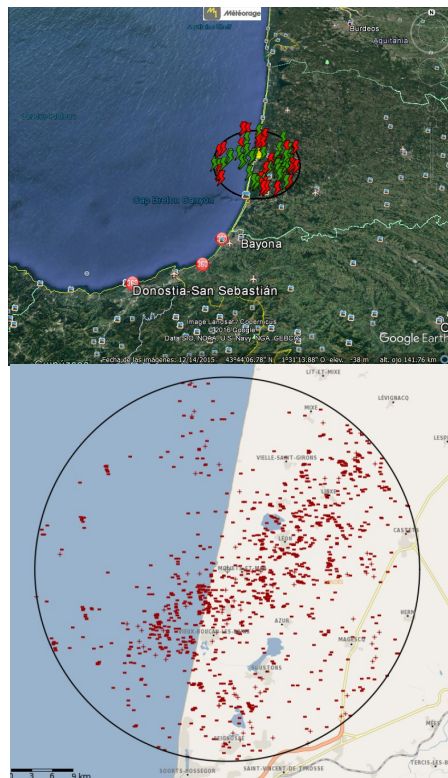
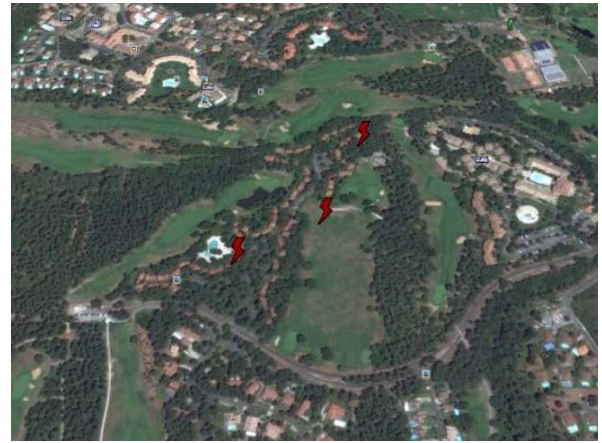
Fig. 4. Lightning activities on 22 august 2015 in the golf area

Fig. 5. Lighting strike points on 22<sup>nd</sup> August 2015

The lightning currents given by Météorage associated with the lightning strike points presented on Fig. 5 are 9.3 kA, 2.3 kA and 1.5 kA. As a result of these atmospheric disturbances, a large number of decoders are no longer operational (445 failed decoders have been recorded so 35% of all the decoders.). Other decoders were later detected as out of order. Failed decoders (see Fig. 6) were also found near the external SPDs but it should be noted that these SPDs are connected with long lead length (accepted by the sprinkler manufacturer) and with a high resistance (higher than recommended by the sprinkler manufacturer). Apparently, the built-in surge protective components (see below) are not efficient enough.

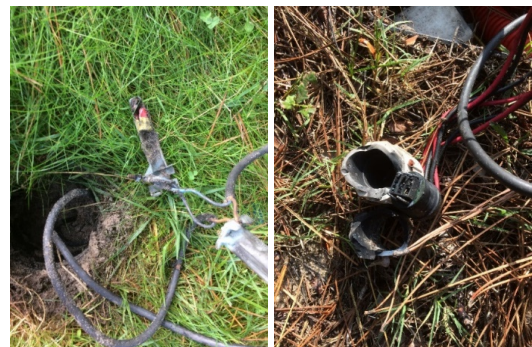
Encountered problem are apparently not due to direct lightning effect on the electrical circuits but to induced effects on the electrical circuits of decoders. Each decoder is distant from the other by 20 m, so much more than what is needed to provide an adequate protection by SPDs (10 m max according to SPD standards). The golf has a small 9 holes green for which they never experienced problems and for this installation the buried power cables of the decoders are armored connected to earth at both ends.

Fig. 6. Pictures of the sprinkler systems after lightning damages

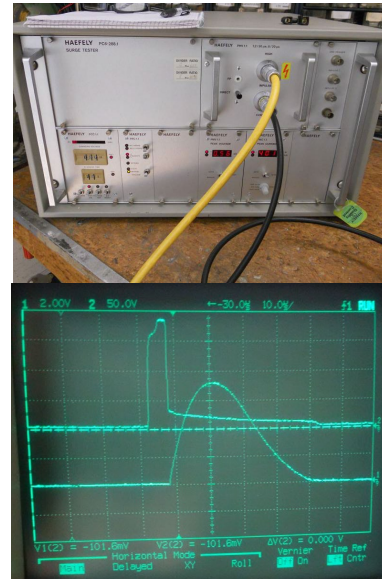
Fig. 7. Combination wave generator used in laboratory and example of answer of the decoder to a combination wave generator impulse

These tests, and the analysis of the curves led the conclusion that embedded surge protective components exist and are mainly (but not only) based on GDT. The external SPD itself is a combination based on GDT and MOVs.

The GDT-based protection certainly limits the voltage across the equipment, but this GDT has the drawback of having, on the one hand, a relatively long reaction time, which generates a short overvoltage but which can be of very large amplitude, and secondly to have a relatively high sparkover level (dynamic sparkover that was observed during testing between 150 V to 180 V), which is very high for the electronic components of the decoder.

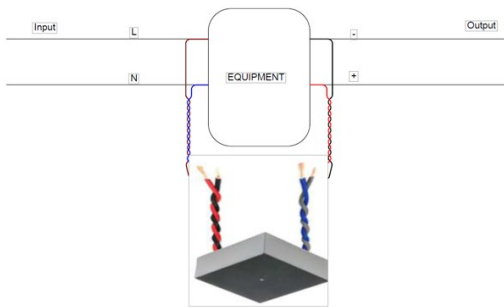
Fig. 8. Principle for connection of the fast protection

Given the problems encountered on the decoders of the Moliets Golf, it was planned to improve the built-in protection of decoders by an adding an external dedicated protection equipment specific to the decoders (voltage, frequency, low level of protection), acting faster than the built-in surge protective components. This protection will be named fast protection in short and is different from the external protection mentioned before. This fast protection should be installed next to each decoder. This fast protection system should have no detrimental influence on the operation of the decoders and should not interfere with the propagation of the frequencies used for the communication to the decoders. This fast protection will replace the existing original external SPD when it exists but should coordinate with the decoder built-in protection. Especially, in case of high surges, the withstand of the fast protection (limited by design to less than 1 kA 8/20) should rely on the high withstand of the internal GDT.

The concept was then to increase the surge withstand of the decoder input, output and input-output thanks to a dedicated fast protection but with low protective level. The proposed system that will be implemented provides differential protection input/output for each decoder and should then be cheap enough.

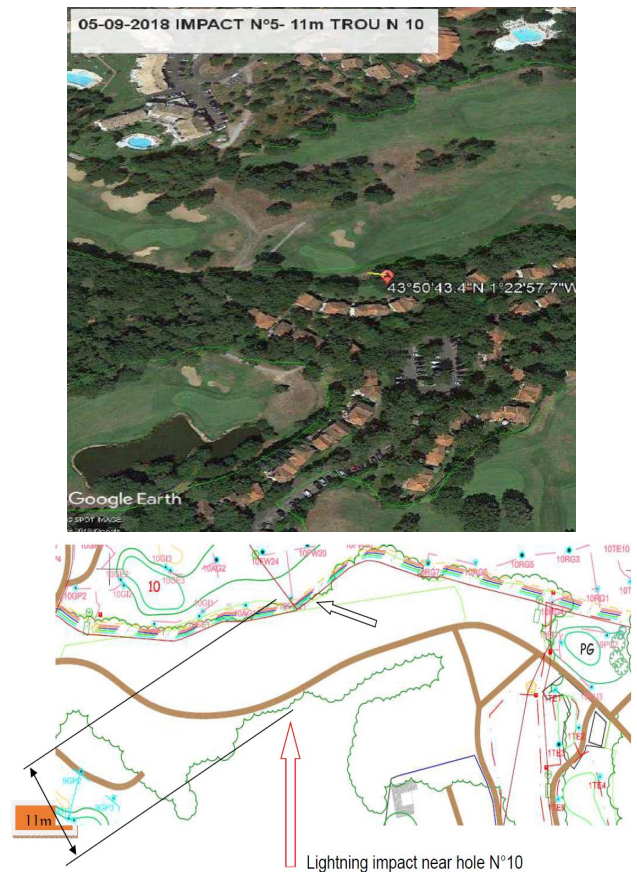
The most relevant impact for the golf course was for the ground strike on 5<sup>th</sup> of September near hole N°10, with a current level of 25.4 kA, located at a distance of 11 m only from decoders, see Fig. 11.

Fig. 11. Lightning strike point on 5th September 2018.

The decoders in the vicinity that were protected by the fast protection are all operational. Decoders on practice N°2, supplied from the same source but not protected by fast protections, have been damaged (excess of power consumption).

It is interesting to note that near hole N°10, the external original earthing system and fuses have not been removed by mistake. The fuse holder and the box containing it (junction box located in the soil, at around 1 m in front of the sprinkler and its fast protection) have been destroyed during the lightning strike on the 5<sup>th</sup> September 2018. This is clearly showing that a partial lightning current has been circulating in this circuit. As this partial lightning current was flowing upstream of the fast protection, the fuse was not protected by the fast protection but the decoders, located downstream of the fast protection, were
