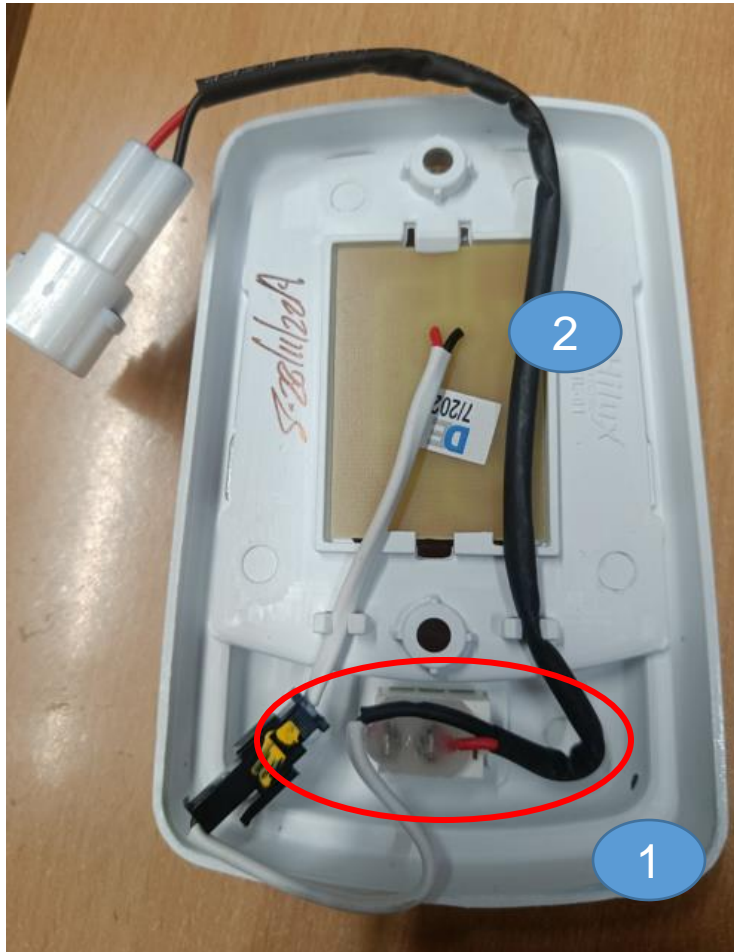
## Existing

1. Excess length, Wire routing has sharp curves near joints. Wire is getting cut near marked areas.
2. Epoxy Not Applied near weak wire joint

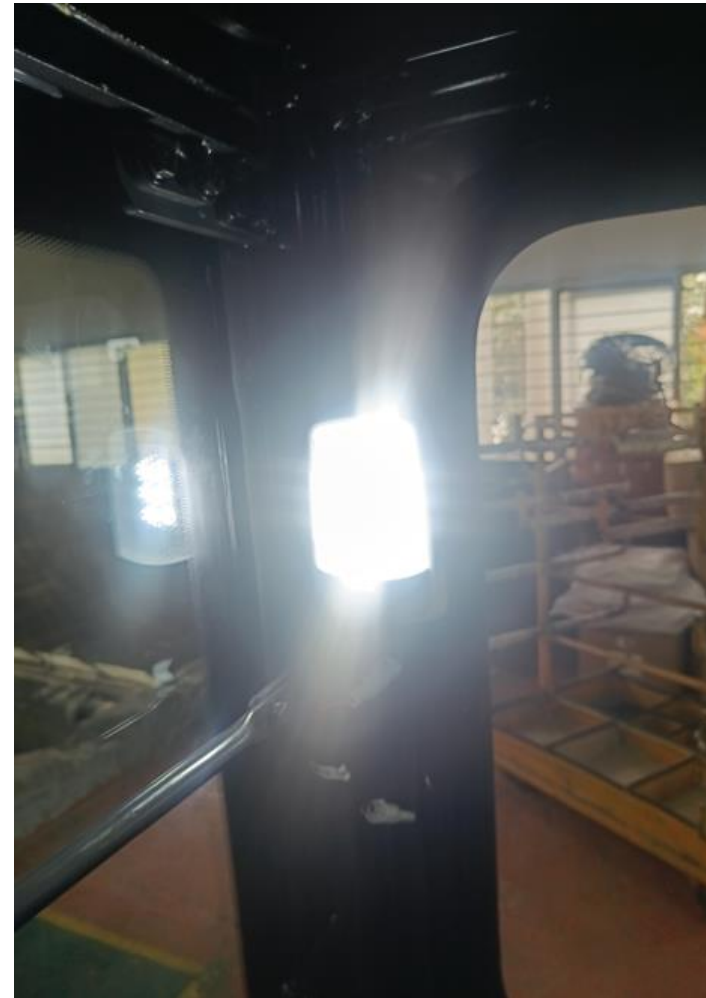
## Functional testing

Sample Lamp fitted in cabin and found glowing , and Switch on/off function found ok.
