From: Mcconnell, DAVE P <dave.p.mcconnell@lmco.com>
Sent: Tuesday, March 27, 2018 8:56 PM
To: Grant Robinson
Cc: Daryl Dixon; Mrazik, Philip; Thomas Jacobson
Subject: APU Inboard Mount

Case Number: C0091097
Customer: Thai Aviation Services Limited
Aircraft S/N: 920146
Aircraft Model: S-92A
Aircraft TT: 6,125
ATA: 49
Part Number: 92303-02101-043
Case Subject: APU I/B Mount-Pilot Holes Misaligned And Tapered Shims Required

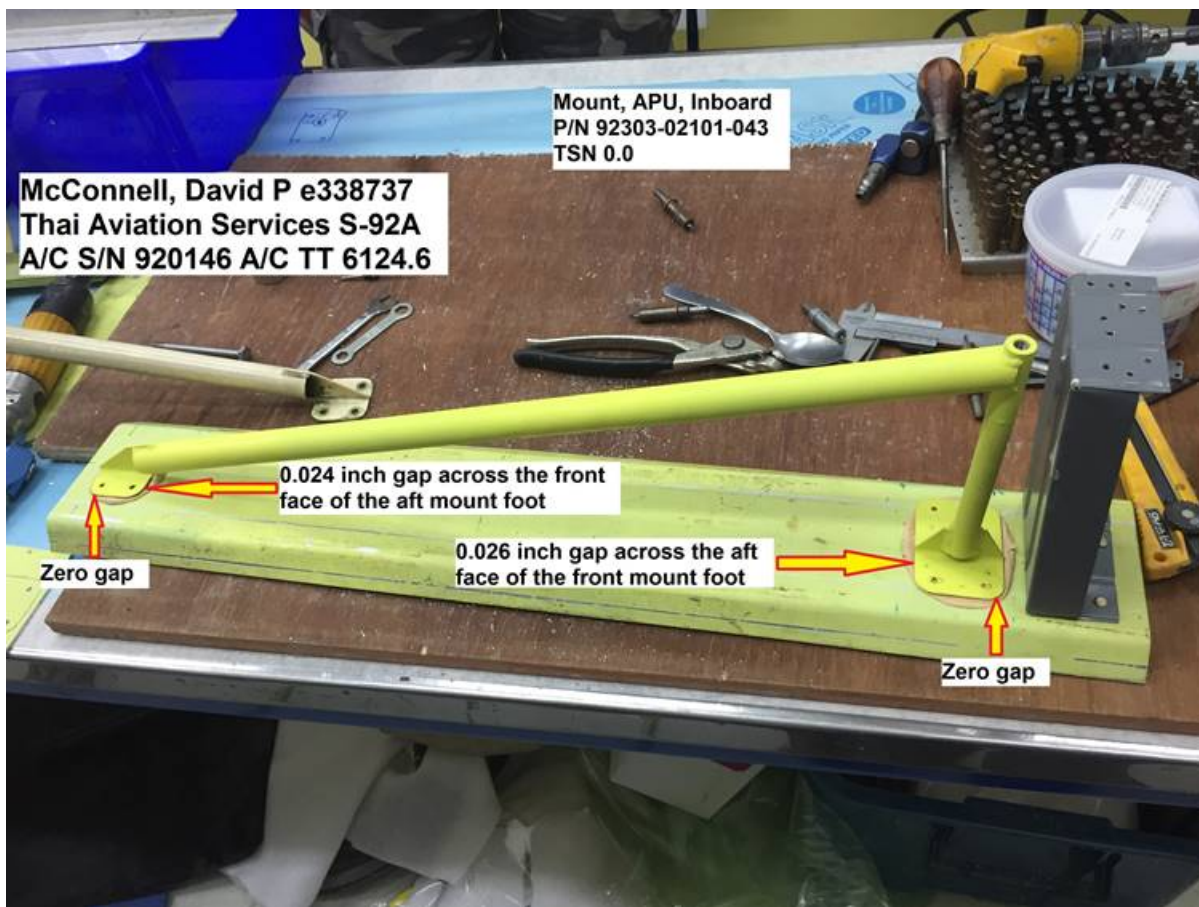
McConnell, David P e338737
Thai Aviation Services S-92A
A/C S/N 920146 A/C TT 6124.6

1. The attach bolt pilot holes in the replacement mount forward foot did not fully align with the bolt holes on the airframe. All were out by approximately 1/2D. Opening the holes to -5 Hilok size will not clean up the holes.
2. The mount feet of the replacement mount did not have the same angle as the removed mount. The replacement mount was found to have an 0.024 inch gap along the front edge of the rear mount foot and an 0.026 inch gap along the aft edge of the front mount foot.

All aft pilot
holes line up

Mount, APU, Inboard
P/N 92303-02101-043
Component TSN 0.0
