**From:** McConnell, David P SIK <DMcConnell@SIKORSKY.COM>  
**Sent:** Tuesday, August 09, 2016 6:16 AM  
**To:** Grant Robinson  
**Cc:** Thomas Jacobson  
**Subject:** 920143 Ramp Puncture Repair

Customer: Thai Aviation Services Limited  
Aircraft Serial Number: 920143  
Aircraft Model: S-92A  
ARA: 52  
Part Number: 92207-03170-047  
Case Number: C0035921  
Title: Ramp Puncture-Request For Repair

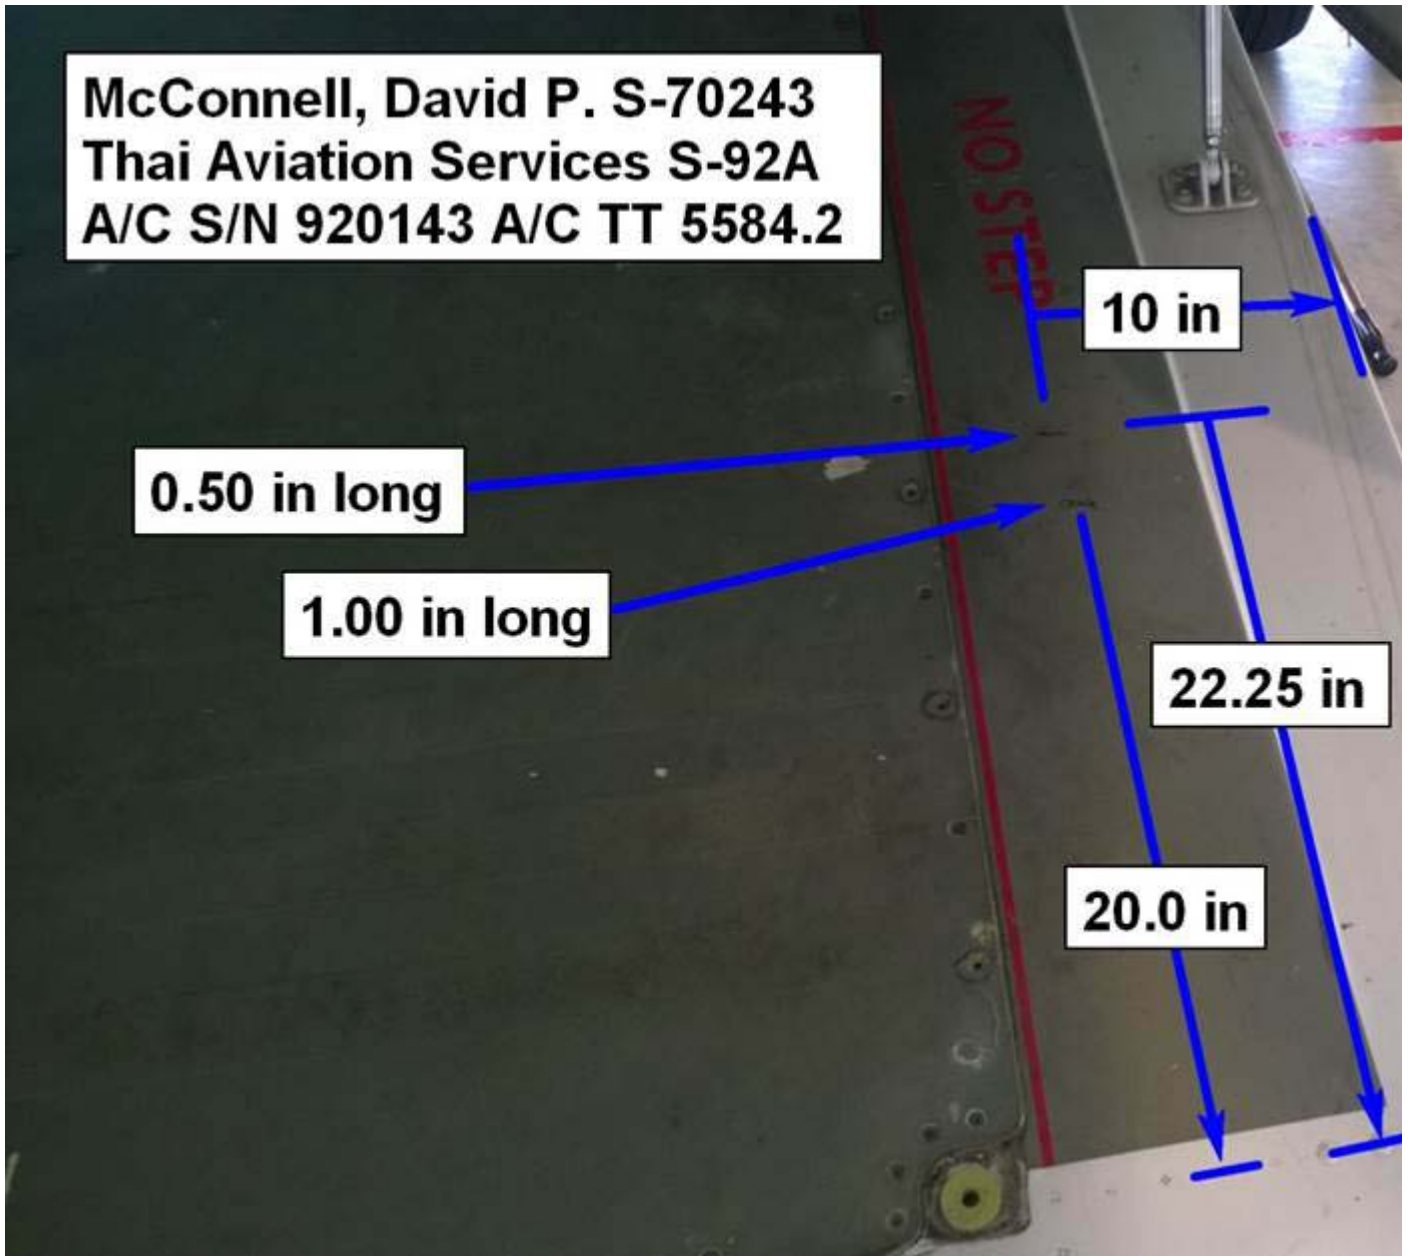
**McConnell, David P. S-70243**  
**Thai Aviation Services S-92A**  
**A/C S/N 920143 A/C TT 5584.2**

Maintainers have discovered two punctures in the cargo ramp upper surface No Step area, R/H/S.

The first puncture is approximately 0.50 inches long and is located 22.25 inches up from the lower line of fasteners, and 10 in inboard from the R/H edge.

The second puncture is approximately 2.25 inches below the first.

Please see FSR-Thailand (Thailand) DocPak for DRB "2009-SA-92-022.pdf". This will provide repairs to the punctures in the customers cargo ramp. Also per Materials and Processes the use of CABOSIL (AMS 3755) up to approximately 2% by weight to be added to EA956 is acceptable.
