CCS-76-APL-17-0004

Subject: S-76D™ Uncommanded Engine Shutdown at Idle

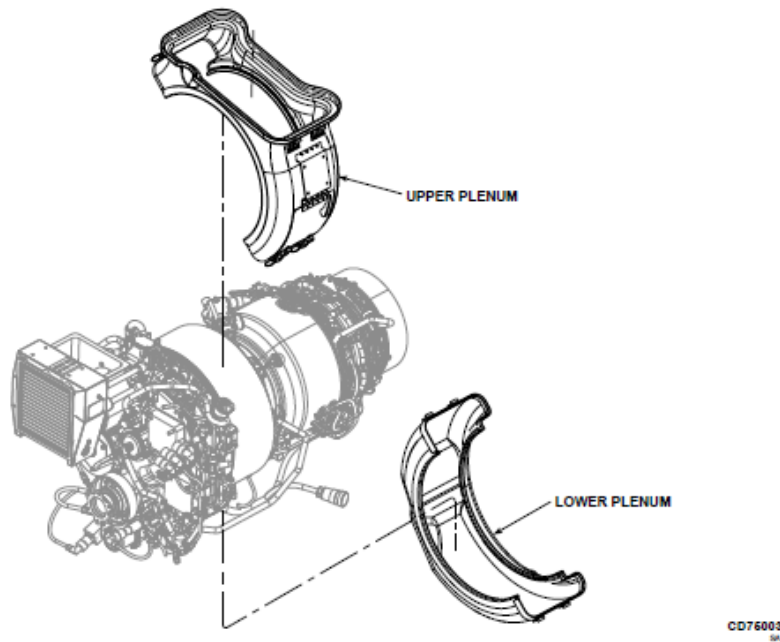
Upper and Lower Plenum

It is suspected that while the engines were at IDLE for 25 minutes; water may have accumulated in the lower plenum. When the pilot advanced the throttles to FLY, the water was introduced into the engine causing the engine to flame out. Operators should be aware that there is reduced airflow inside the air inlet bypass duct during ground operation at IDLE and, therefore, reduced separation of water and particles out of the exhaust.

Operational Considerations: Pilots should be aware of the possibility of rainwater accumulating in the lower plenum while operating the engines at IDLE for extended periods in heavy precipitation. However, operators should have confidence that the engine has undergone extensive testing and evaluation to demonstrate this is not an issue in flight.

Until further guidance is provided, we recommend pilots operate with the engines at FLY while performing sustained ground operations in heavy rain.
