Weldment Assembly Repair

<h1 style="margin: 0;">SIKORSKY</h1> <h1 style="margin: 0;">AIRCRAFT</h1> <h1 style="margin: 0;">DESIGN RECORD BOOK</h1>			
Prepared by: <u>Kenny Welch</u>		DRB No: <u>2017-SA-92-090</u>	
Title: <u>Weldment Assembly Repair</u>			
Start Date: <u>6/21/2017</u>		Detail Dwg: <u>92306-04102</u>	
End Date: _____		Assy Dwg: <u>92306-04102-057</u>	
No. Pages: _____		Related Documents: (1) _____ (3) _____	
Model: <u>S-92A</u>		(2) _____ (4) _____	
Keyword: (1) <u>Crack</u> (2) <u>Weldment</u>		Hours: _____

## Background

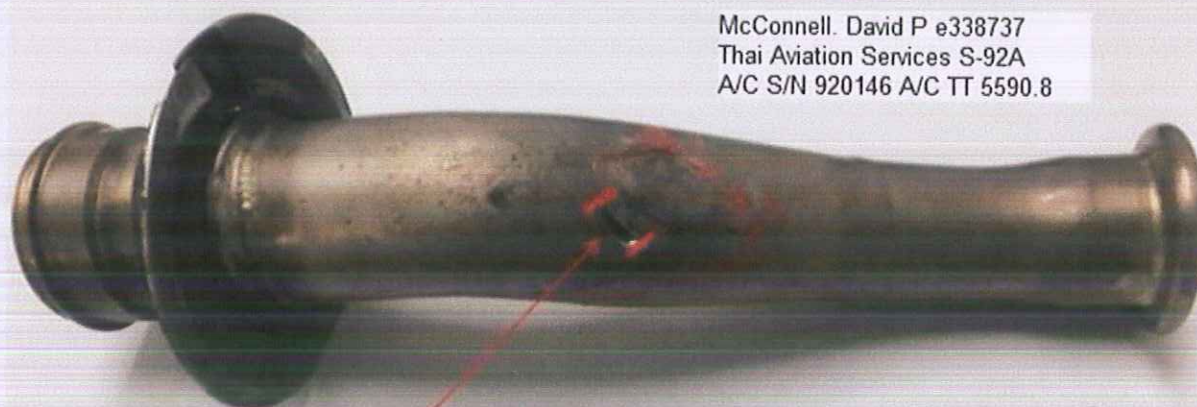
**Figure 1- Reported Damage**

The No. 1 engine weldment assembly P/N 92306-04102-057 was found chafed by the No. 1 engine inboard expandable pin due to pin migration.

The chafed opening measures 0.625 in. long x 0.125 in. wide, and is located approximately mid-span on the tube.

Total Length 0.625"  
Width 0.125"

Weldment P/N 92306-04102-057  
IPC Ref. 21-27-01 Fig. 402 Item 190  
Position #1 Engine Installation

1. Remove the Weldment Assembly from the aircraft.
2. Repair the chafe damage by welding per MIL-STD-2219 Class B using AMS 4951 filler wire. Grind flush.  
Note: Do not cut the damaged area out - just apply a weld bead (puddle) into the chafe.
3. After welding, stress relieve per AMS-H-81200 AT 850 +/-25F FOR 2 +/- 0.25 hours.
4. Penetrant inspect ASTM-1417, no cracks allowed.
5. Upon completion of repair the unit will be pressure tested to 120 PSIG for 5 minutes. Zero leakage is allowed.
6. If any problems are encountered or if further assistance is required, please contact Service Engineering.
