**From:** Mcconnell, DAVE P <dave.p.mcconnell@lmco.com>  
**Sent:** Thursday, January 11, 2018 9:21 AM  
**To:** Grant Robinson  
**Cc:** Thomas Jacobson; Mrazik, Philip; Daryl Dixon; Aaron Scally  
**Subject:** S-76D TR Boot Fairing Repair

Case Number: C0078633  
Customer: Thai Aviation Services Limited  
Aircraft S/N: 761XXX  
Aircraft Model: S-76D  
ATA: 64  
Part Number: 76101-06025-041  
Case Subject: S76D TR Boot Fairing Damage Repair Greater Than CMM Limits

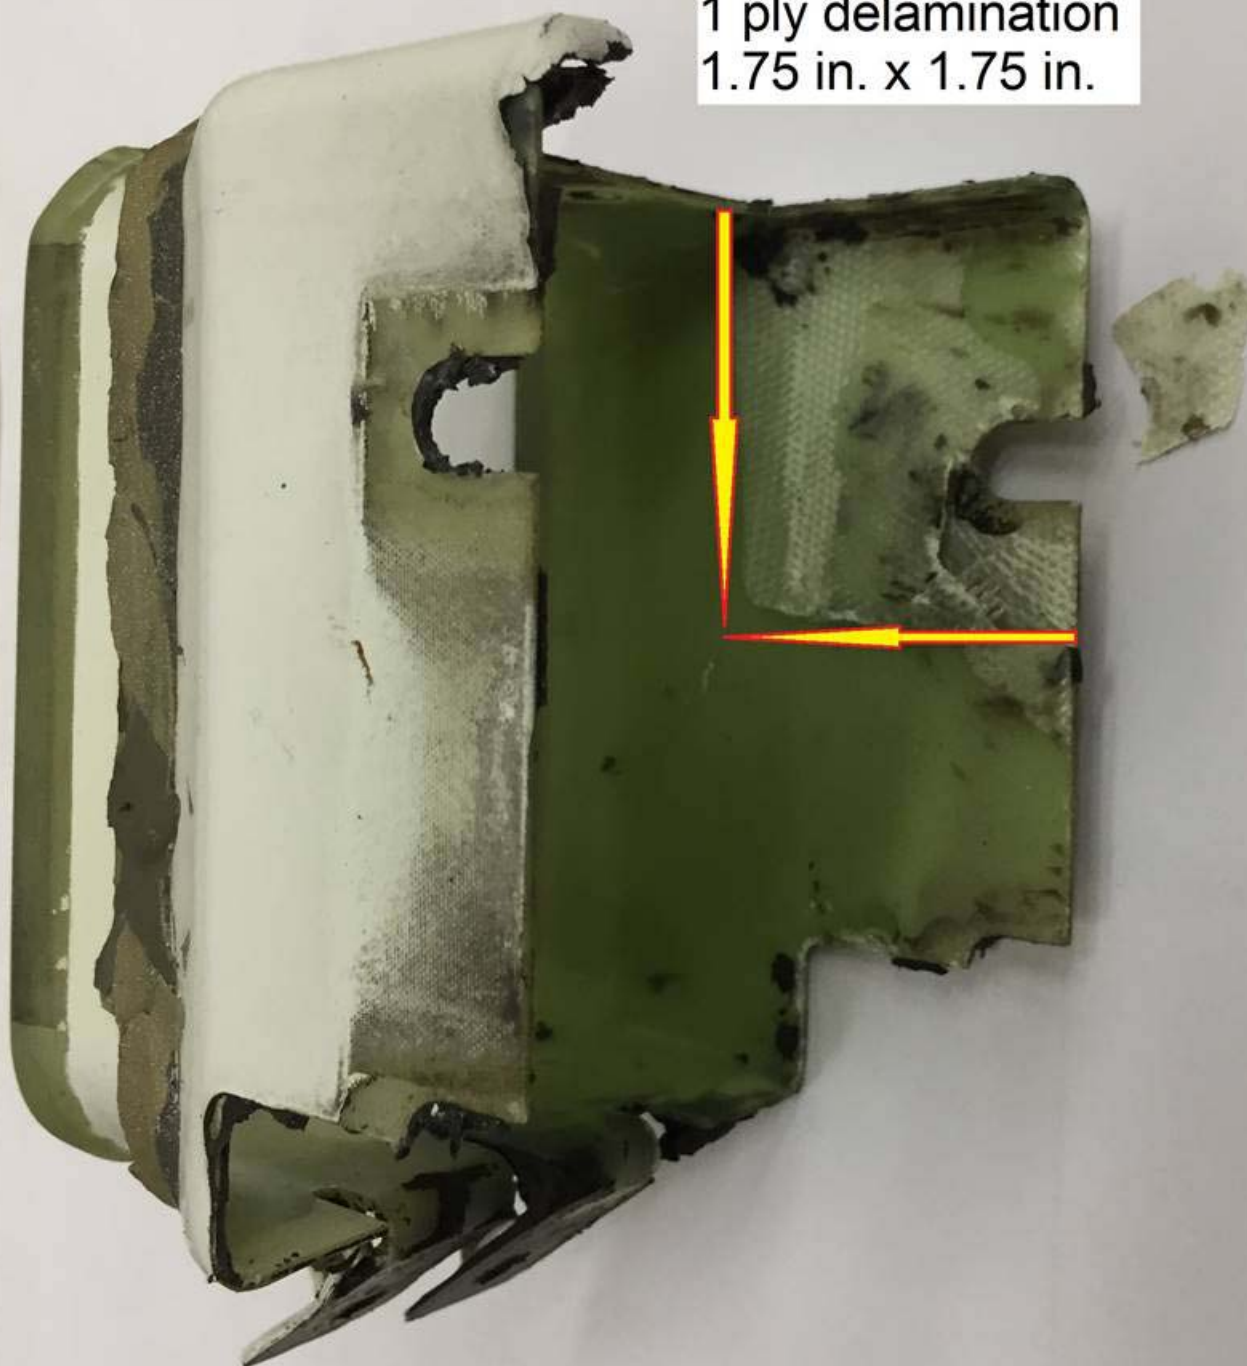
TR Boot Fairing

TAS reports two recent events of P/N 76101-06025-041 tail rotor boot fairing damage incurred while trying to separate the boot fairing from the Proseal in which it was bedded.

Damage in both cases was virtually identical and resulted in the delamination of a single ply (0.010 inches deep) over an area 1.75 inches by 1.75 inches square.

CMM 65-25-00 T-Rev 65-03 Table 202 Item 9 lists Boot Fairing edge bond separation maximum as 0.125 in. deep maximum.

1 ply delamination  
1.75 in. x 1.75 in.

TAS have a well-equipped and staffed composite shop. They propose to repair both boot fairings by vacuum bagging a single ply fiberglass and EA956 over the damaged area using standard CMM procedures.

Sikorsky Blades engineering has reviewed the case details and concurs with the proposed repair procedure.
