DRB 2015-SA-76-037-A

## Repair Doubler on RHS Center Firewall

While removing both engines to perform an unrelated airframe repair, cracks were discovered on the engine center firewall attachment areas for the engine bleed air lines and "Y" tube.

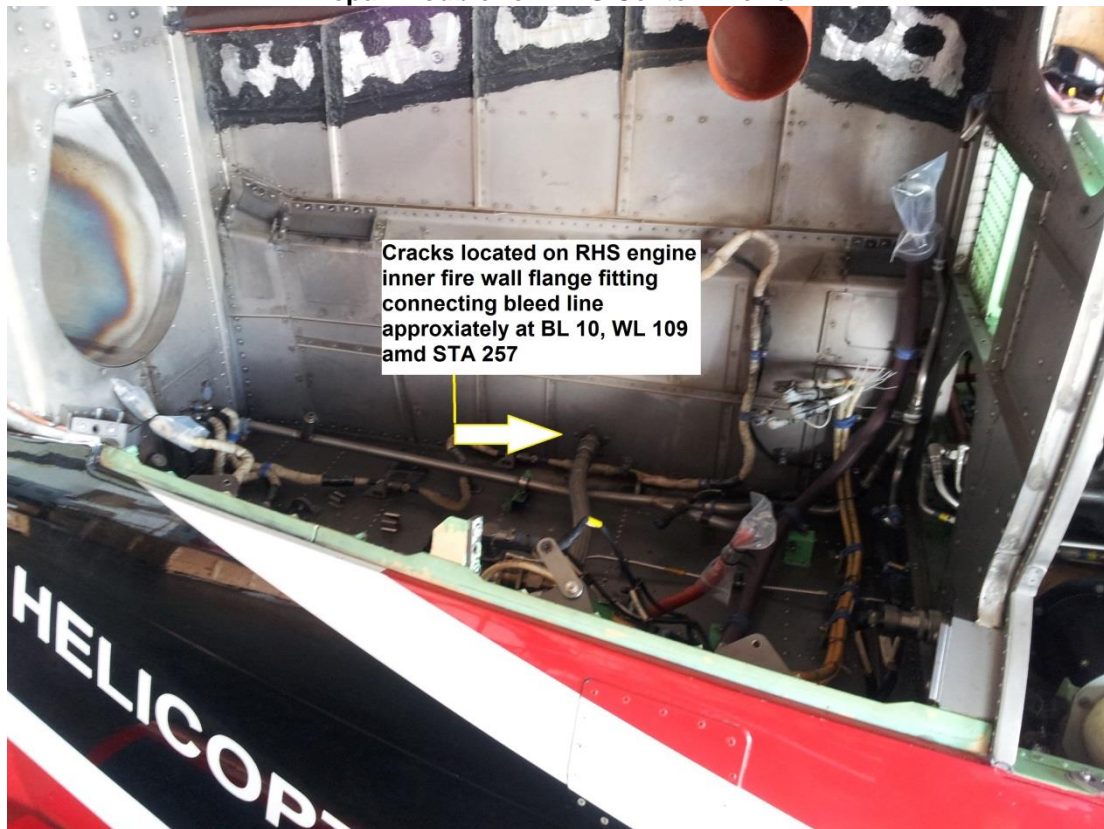
The L/H side panel P/N 76202-77003-130 is cracked on the panel skin and the #1 engine bleed air line attachment flange. The R/H side firewall skin and # 2 engine bleed air line attachment flange are cracked also (R/H side attachment area differs from the L/H side, as the R/H side firewall does not have a removable panel at the bleed air line attachment flange). See attached photos for reference. Customer reports the flanges on the P/N 7435-1 "Y" pipe are cracked as well (photos have not been provided as of yet. FTR will be updates with "Y" tube photos when available).

Figure 1 Crack on RHS Center Firewall At Y-tube Flange

The recommended repair procedure for the right hand side is to stop-drill the crack and install a repair doubler as shown in Figure. The removable panel on the left hand side that is cracked will be removed and replaced with a new panel.

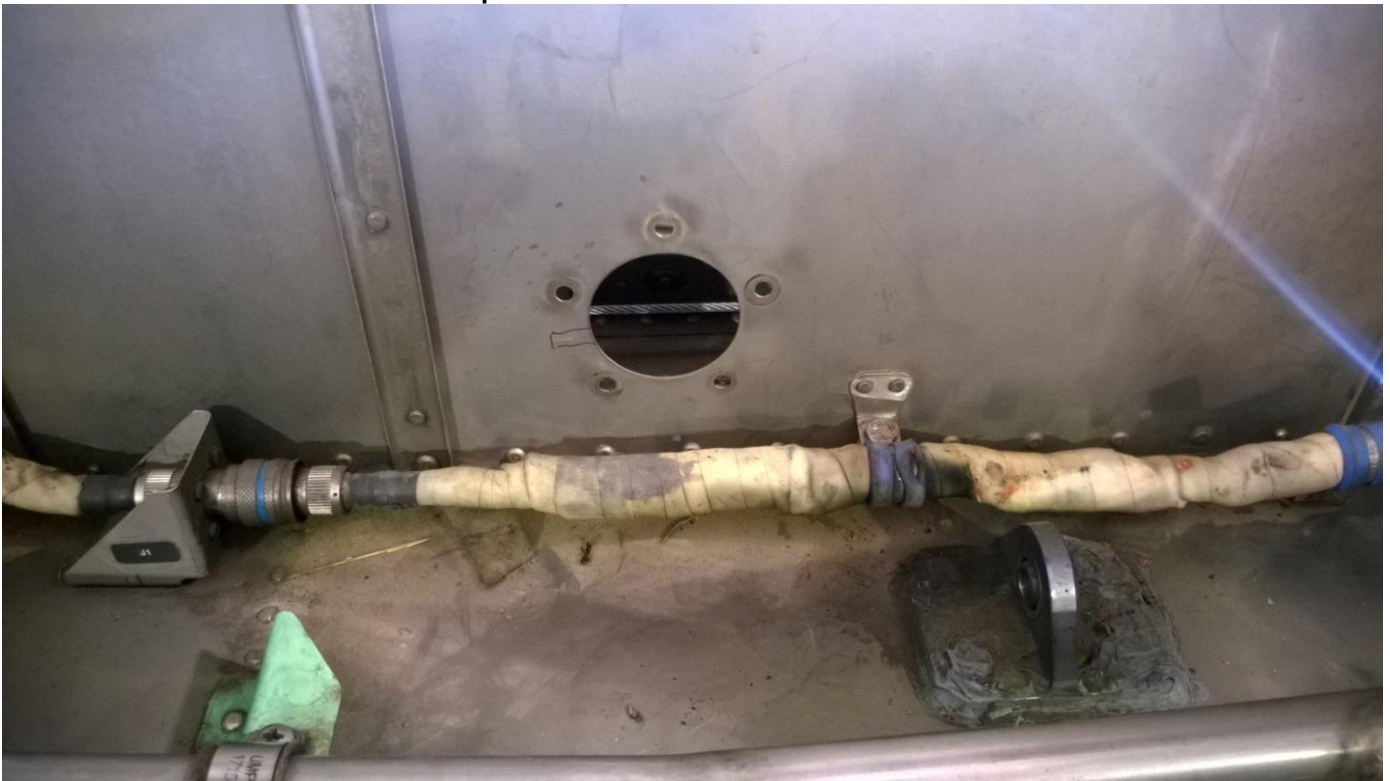
Figure 2 Crack in Firewall at Y-Tube Flange

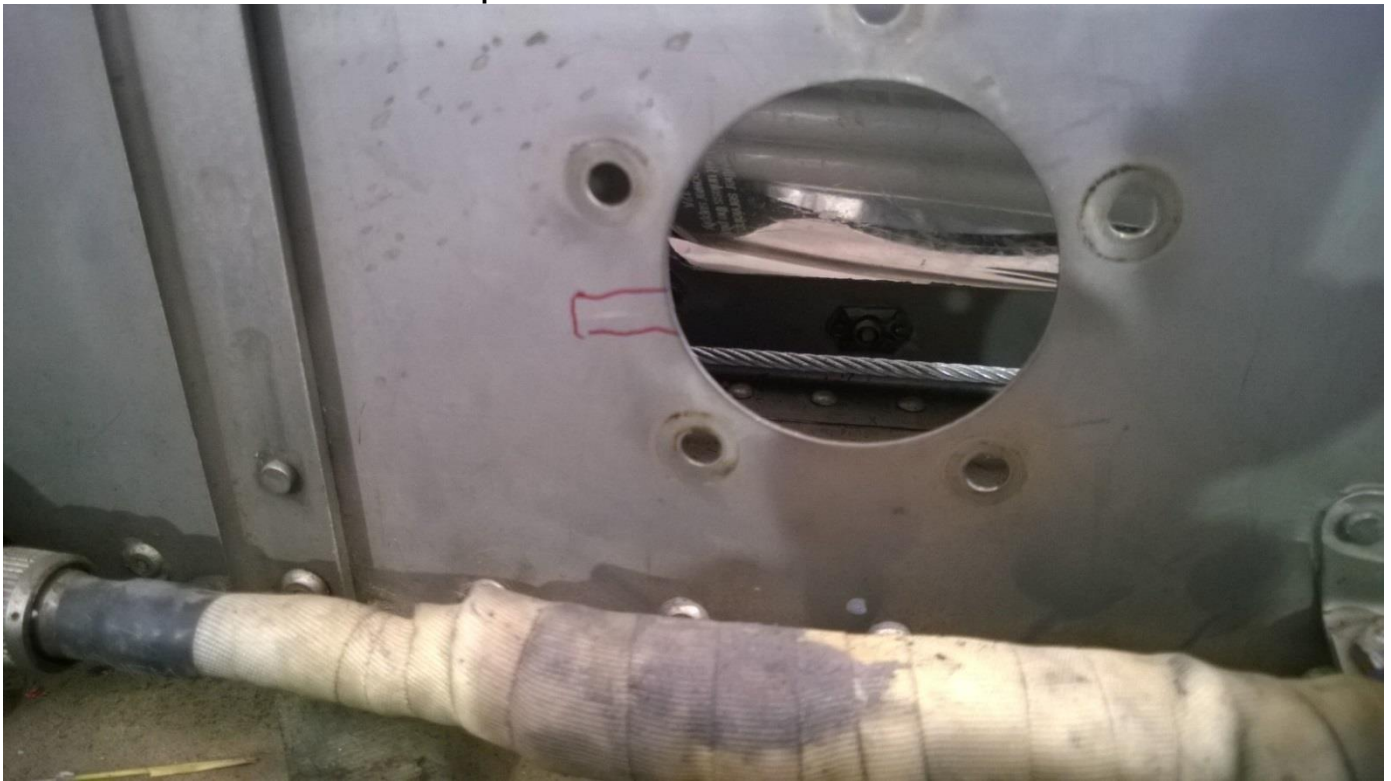
Figure 3 Tank Panel Damage

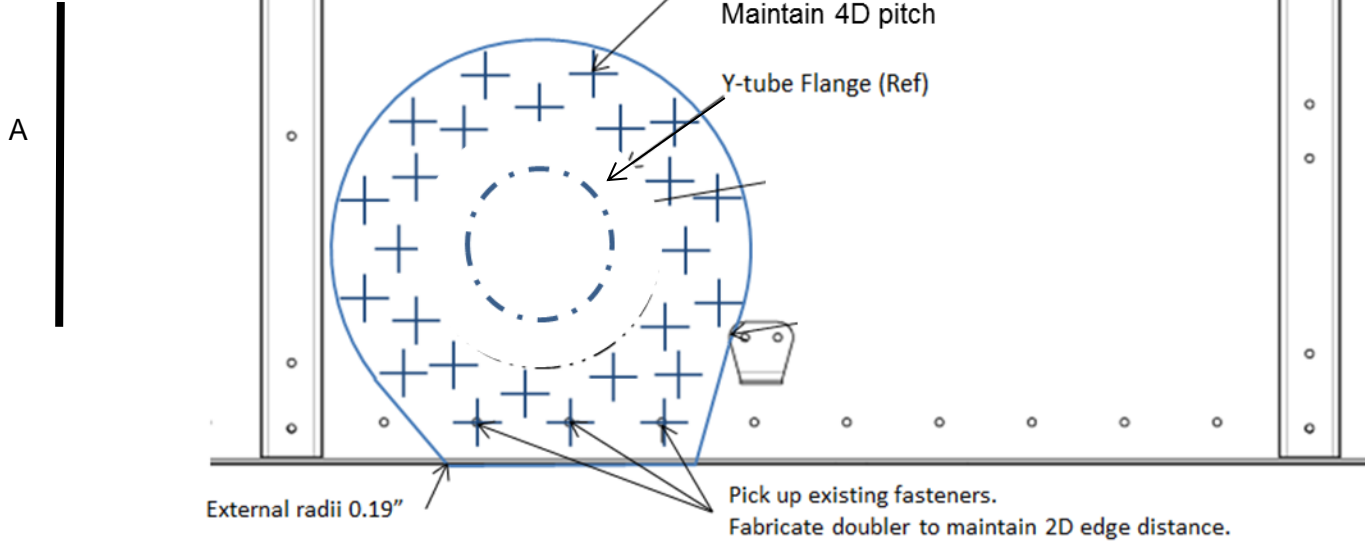
Figure 4: Doubler Installed Over RHS Y-Tube Pass Through

10. Fabricate a reinforcement doubler panel approximately as shown in Figure 4. **Do not** cutout center hole as this doubler will act as the deactivation closeout. The doubler will be made of 0.020 TI 6AL-4V or 0.025 301 ¼ HD SS as available. Reorient as necessary to avoid crack and existing fastener holes. The doubler will cover the Y-tube pass through hole on the outboard side of the RHS firewall as shown in Figure 4. The doubler shall be sized to allow a staggered row of 1/8" fasteners, maintaining 2D edge distance and a minimum of 4D pitch on the fasteners. Corner radii shall be 0.190" minimum. Deburr the edges of the doubler. Avoid Crack and existing fastener holes.

11. Temporarily locate the doubler in place. Back drill any removed fastener locations that would be common to the doubler. Transfer pass through hole and flange mounting holes to doubler from firewall as shown in Figure.

12. Remove the doubler and pilot drill fastener holes. Form two rows maintaining 2D edge distance and a minimum of 4D pitch on the fasteners. Again temporarily locate the doubler in place and use the pilot holes to mark the fastener locations on the original skin panel.
