From: Mcconnell, DAVE P <dave.p.mcconnell@lmco.com>
Sent: Friday, April 27, 2018 7:48 PM
To: Grant Robinson
Cc: Mrazik, Philip
Subject: HTH Start Tube Chafe Repair

Case Number: C0093487
Customer: Thai Aviation Services Limited
Aircraft S/N: 920146
Aircraft Model: S-92A
Aircraft TT: 6,149
ATA: 21
Part Number: 92306-04102-052
Case Subject: Engine Start Tube Chafe-Request For Repair Scheme

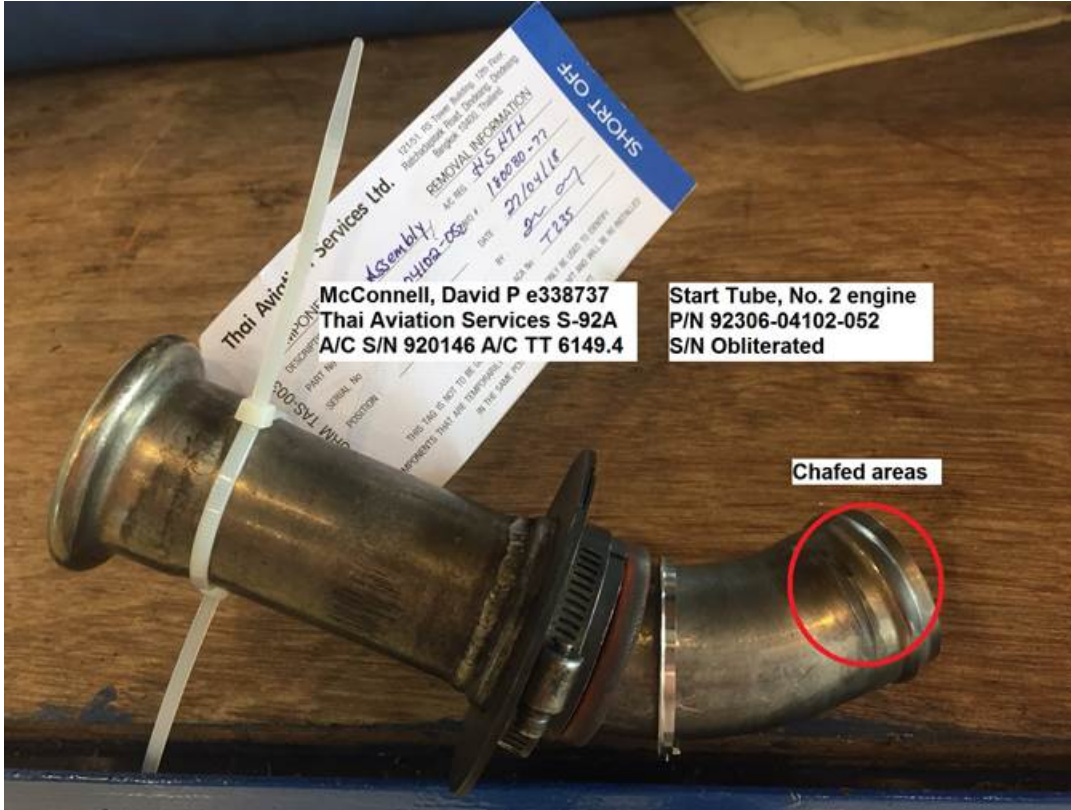
TAS maintainers removing the 5-pack on A/C S/N 920146 noted chafing damage on the P/N 92306-04102-052 No. 2 engine air start tube.

The chafed area measures 1.00 inches long x 0.100 inches wide inches. Depth is approximately half the wall thickness at the deepest point.

There is also a 1.00 inch long flattened area on the bead adjacent to the chafe.

There are no perforations and no cracking is noted.

As a precautionary measure in order to avoid a potential AOG situation TAS request SA approval on a Work Stop basis to perform a weld fill repair in the chafed areas, similar to the procedure called out in DRB 2017-SA-92-090. EoM

Sikorsky Engineering approves the use of DRB 2017-SA-92-090 to perform a weld fill repair on S/N 920146
