Fire Bottle Support Angle Cracks

<h1 style="margin: 0;">SIKORSKY AIRCRAFT DESIGN RECORD BOOK</h1>			
Record NO: 			
Prepared by: Kenneth Welch		DRB No: 2018-SA-92-085	
Title: Fire Bottle Support Angle Cracks			
Start Date: 10/9/2018		Detail Dwg: 92210-03382	
End Date: 		Assy Dwg: 92201-03140	
No. Pages: 		Related Documents:	
Model: S-92A		<div style="display: flex; justify-content: space-between;"> (1) (3) </div>	
Keyword: (1) Cracks (2) Fire Bottle		<div style="display: flex; justify-content: space-between;"> (2) (4) </div>	
Hours: 		Model Effectivity: 920279	
Supersedes: 		FEM Analysis: 	
Analysis Type: Repair		Charge No: 	
Reason for Analysis: Field Support		Superseded By: 	
Description:			
<div style="border: 1px solid black; padding: 10px; min-height: 150px;"> <p>During a 1500 hour scheduled maintenance inspection TAS maintainers found a one-inch long radius crack on either end of the P/N 92210-03382-113 fire bottle support forward angle, and a one inch radius crack on the inboard end of the -121 aft angle.</p> </div>

Thai Aviation Services S-92A
A/C S/N 920279 A/C TT 2791.9

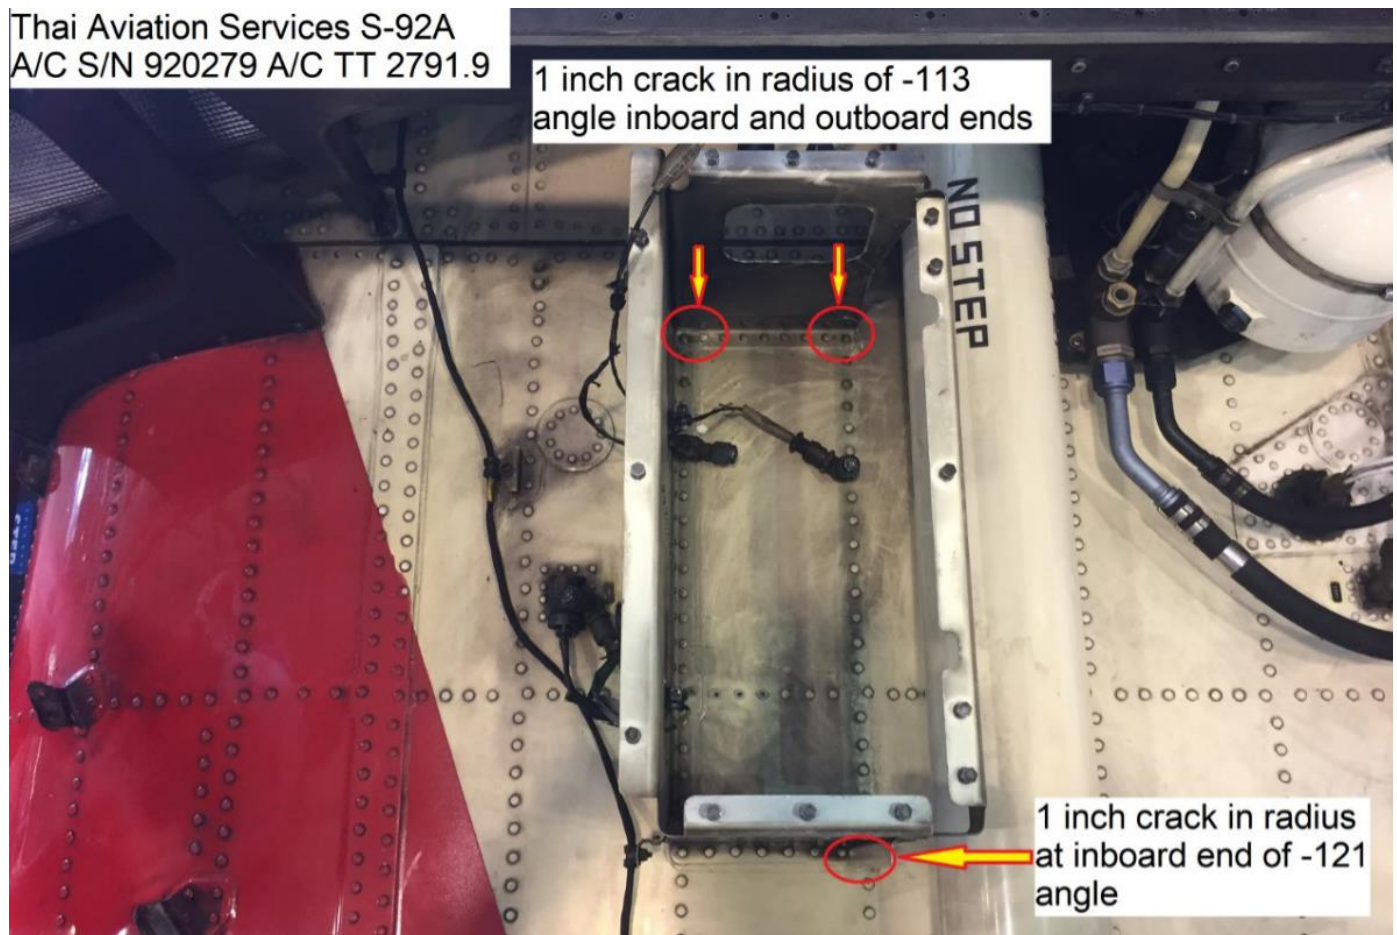
Figure 1 – Crack Locations

During a 1500 hour scheduled maintenance inspection TAS maintainers found a one-inch long radius crack on either end of the P/N 92210-03382-113 fire bottle support forward angle, and a one inch radius crack on the inboard end of the -121 aft angle.

1. Prepare the ship for ground maintenance.
2. Gain access to the cracked fire bottle attach angle.
3. Remove the fire bottle attach angles from the aircraft by drilling out the rivets. Vacuum the area to remove any loose particles.

4. Inspect area for any other cracks or anomalies. If any are found, report to Sikorsky Aircraft.
5. Fabricate a new attach angle from 0.040" thick, 301 ¼ hard stainless steel sheet, using the existing angle as a template. Break all sharp edges 0.005-0.015 in radius. The 90 degree bend radius is .12".

6. Measure and transfer the rivet hole locations from the existing angle to the new angle and drill the rivet holes. De-burr the rivet holes and the edges of the angle. Vacuum the area to remove any loose particles.

7. Degrease the new angle by wiping with a low-lint cleaning cloth (conforming to A-A-59323, Type II) using acetone (conforming to ASTM D329) or ethyl alcohol (conforming to A-A-51693). Wash with clean water to a water-break free condition.

8. Brush cadmium plate the new angle per MIL-STD-865.
9. Apply one coat of MIL-PRF-23377 or MIL-PRF-85582 epoxy primer to the new angle and allow to cure.

10. Prior to the final installation, lightly coat the mating surfaces of the doubler with one of the following sealants, in order of preference: MIL-S-81733 or AMS 3265, Class A-2.

11. Rivet the new angle into position with MS20470AD5-6D rivets. Blind rivets may be used if necessary (ensure proper fit and edge distance). Wet install the fasteners with one of the following sealants, in order of preference: MIL-S-81733 Type IV-12 or AMS 3265, Class A-2.

12. Apply another coat of MIL-PRF-23377 or MIL-PRF-85582 epoxy primer to the repair area and allow to cure.
13. After the sealant has cured, scrape off any excess with a non-metallic scraper.

14. Re-install the items removed in Step 3 per the Maintenance Manual.
