DRB 2016-SA-76-034

MLG Drag Brace Support Brackets Cracked

<h1 style="margin: 0; font-family: serif; letter-spacing: 5px;">DESIGN RECORD BOOK</h1>		Record NO:
Prepared by Kenneth Welch		DRB No: 2016-SA-76-034
Title MLG Drag brace support brackets cracked		
Start Date: 9/2/16	Detail Dwg 76204-02008	
End Date: 9/2/16	Assy Dwg 	
No. Pages: 	Related Documents: (1) (3) (2) (4) 	
Model: S-76		
Keyword: (1) MLG Brace (2)

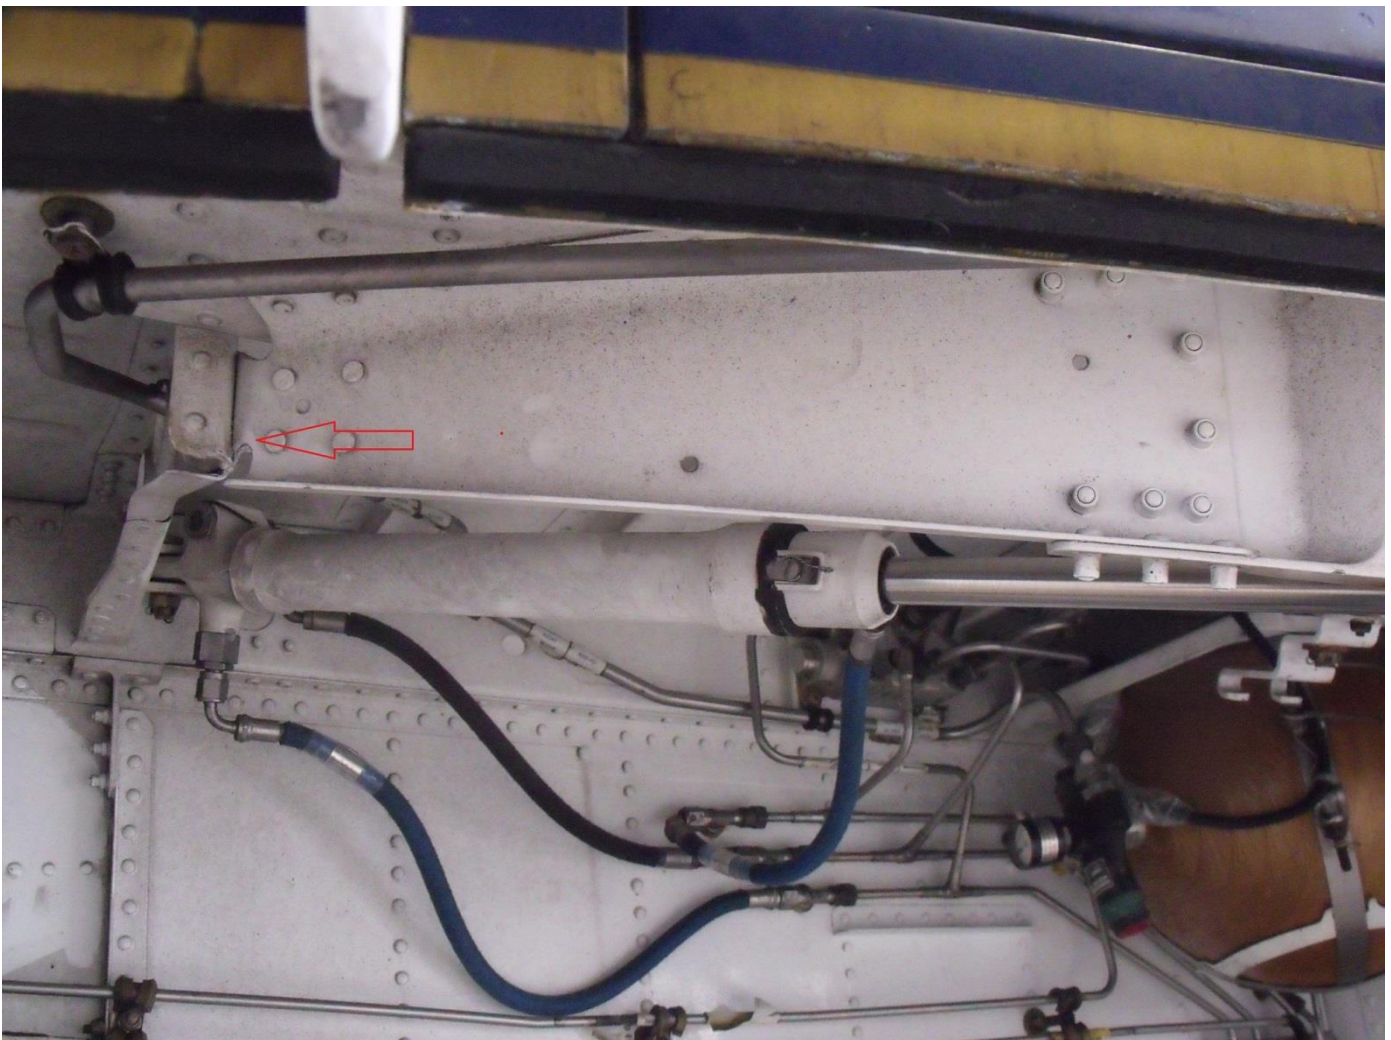
**Figure 1 – L/H Side Crack Location**PREPARED BY K. WelchLockheed Martin Proprietary/Export Controlled Information
CHECKED BY J. ScheibDATE 9/2/162
PAGE

Customers have found brackets that are cracked on both the LH and RH side. The support brackets are cracked through lower aft bend radius; refer RH & LH Drag Brace Support.jpg attached.

The repair procedures are outlined in this DRB. For FAA purposes, this repair is considered "MAJOR".
