DRB 2015-SA-76-037B

Repair Doubler on RHS Center Firewall

SIKORSKY AIRCRAFT DESIGN RECORD BOOK

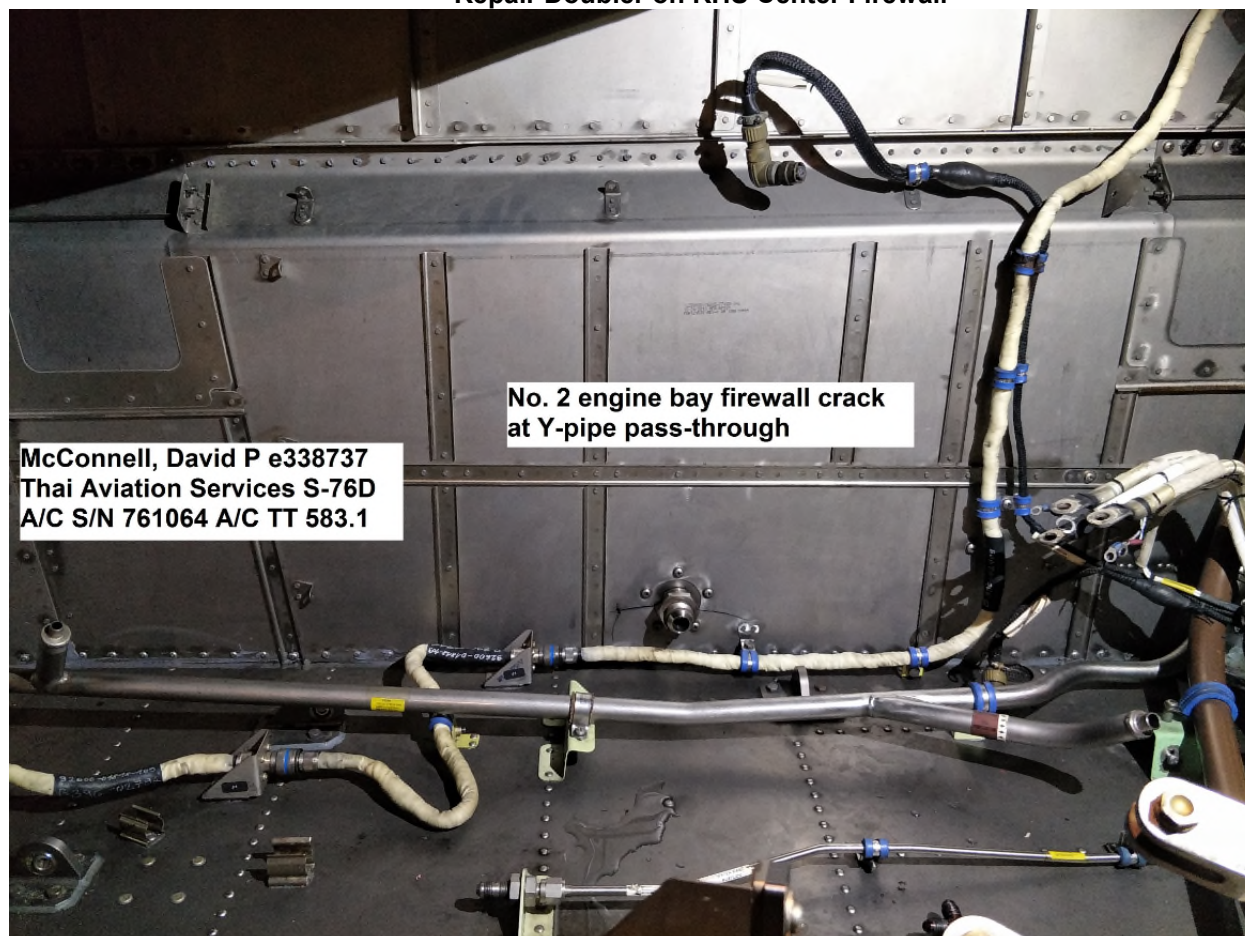
- One horizontal crack 2.5 inches long emanating from the pass-through opening at approximately the 4 o'clock position, running forward.
- One horizontal crack approximately 1.9 inches long emanating from the pass-through opening at approximately the 9 o'clock position, running aft, terminating approximately 0.030 inches from the forward edge of the vertical stiffener.
- One vertical crack approximately 1.7 inches high, approximately 0.5 inches forward of the vertical stiffener at its closest point. This crack intersects the aft horizontal crack. There are no pieces missing. The firewall deck attach angle was inspected for cracks. None were found.

Figure 1: No. 2 Engine Bay Firewall Crack at Y-Pipe Pass-Through

The recommended repair procedures for the right hand side is to stop-drill the crack and install a repair doubler as shown in Figure 5.

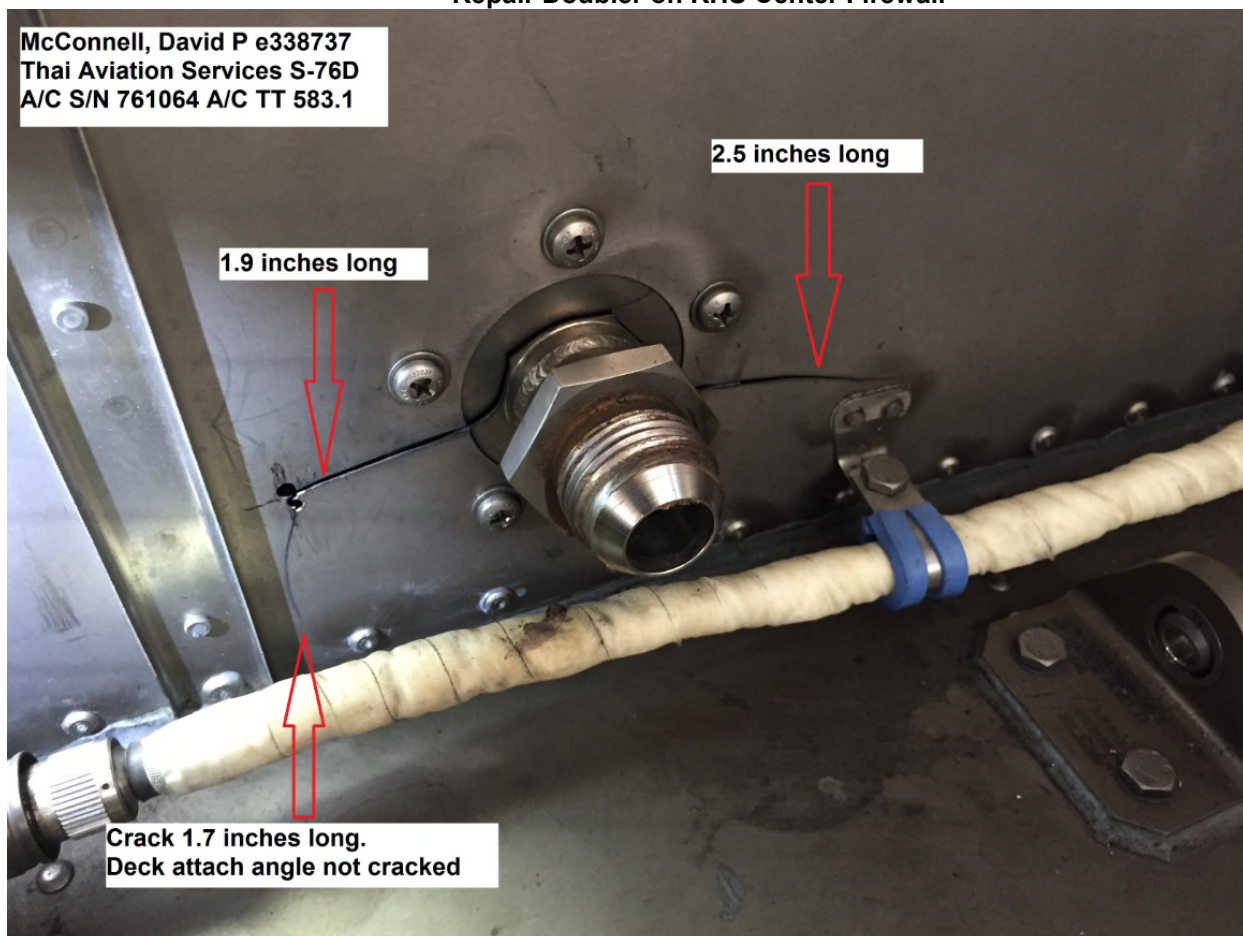
Figure 2: No. 2 Engine Bay Firewall Crack at Y-Pipe Pass-Through

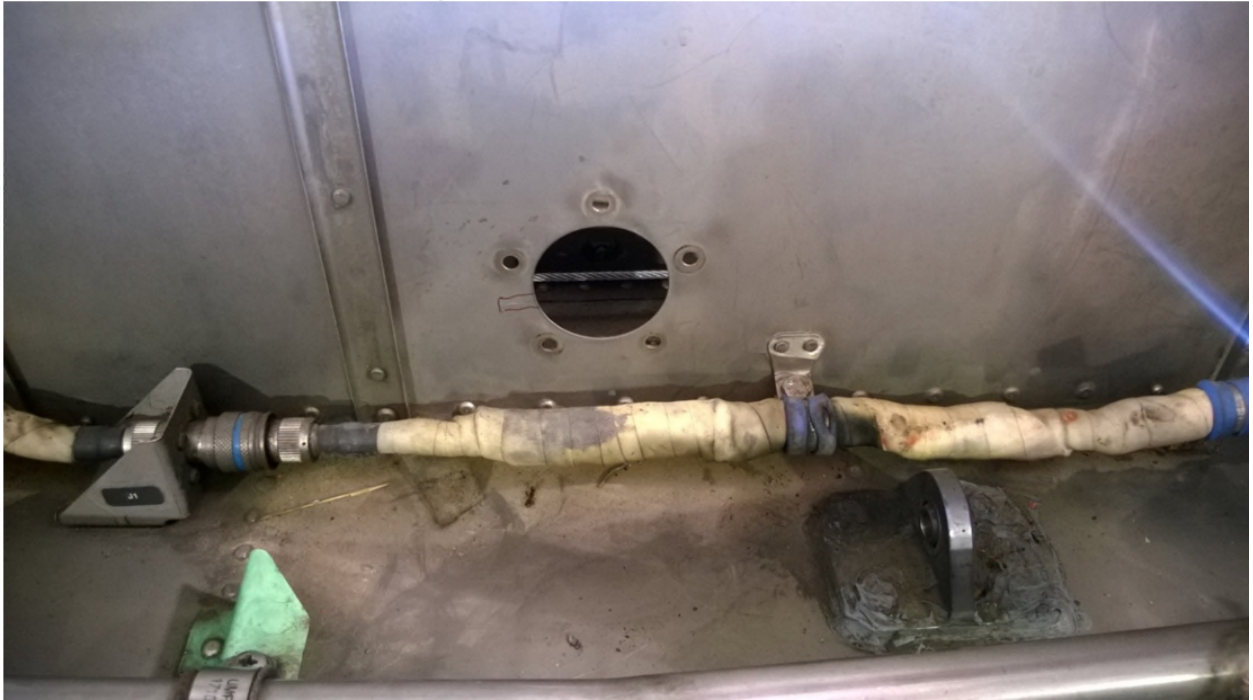
Figure 3: Removed Y-Tube

4. Remove lower cap fasteners as shown in Figure 3
5. Abrade the firewall panel in the repair area to clean titanium substrate, using scotch-brite abrasive mat, MIL-A-9962.

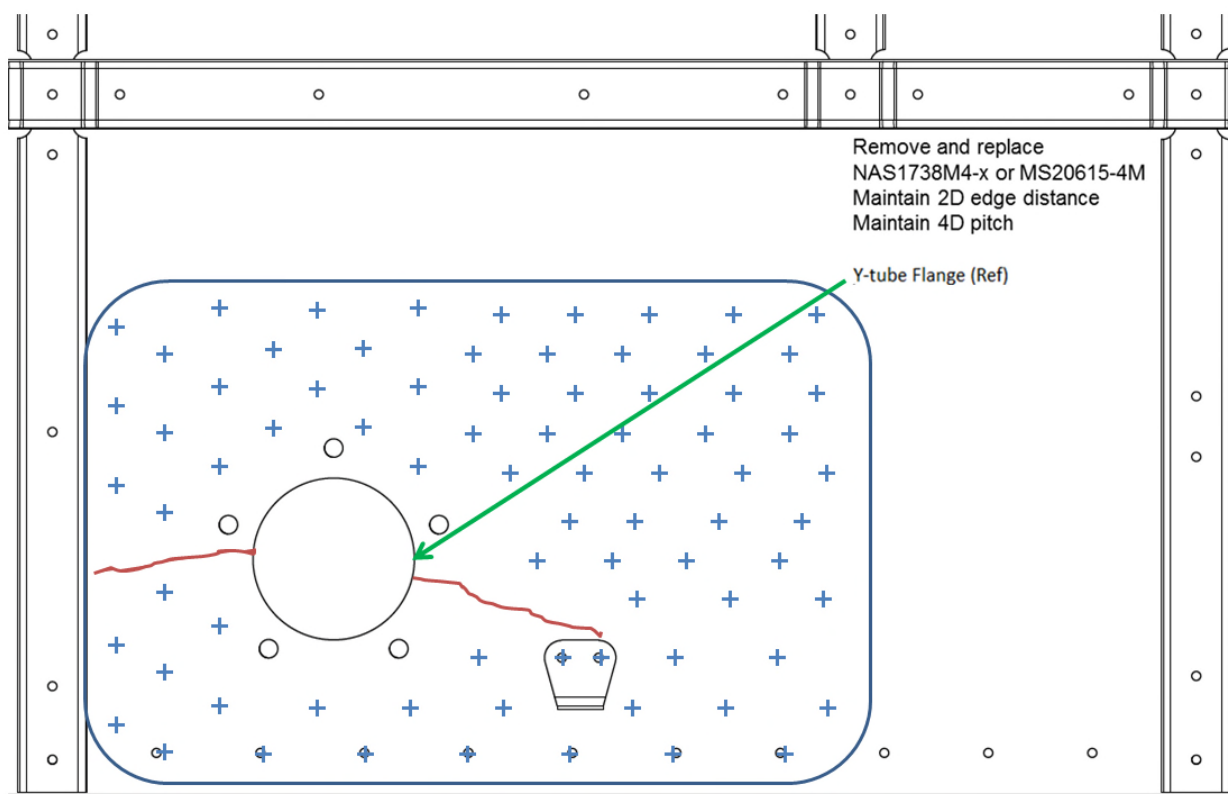
Figure 4: Doubler Installed Over RHS Y-Tube Pass Through

10. Fabricate a reinforcement doubler from cracked access panel approximately as shown in Figure 4. Reorient as necessary to avoid crack and existing fastener holes. The doubler will be made of 0.020 TI 6AL-4V, or 0.025 301 $\frac{1}{4}$ HD SS as available. The doubler will be centered on the Y-tube pass through hole on the outboard side of the RHS firewall, extended in one direction to vertical member and in the other direction past the attach clip for the hose as shown in Figure 4. The doubler shall be sized to allow a staggered row of 1/8" fasteners, maintaining 2D edge distance and a minimum of 4D pitch on the fasteners. Corner radii shall be 0.190" minimum. Deburr the edges of the doubler. Avoid Crack and existing fastener holes.

11. Temporarily locate the doubler in place. Back drill any removed fastener locations that would be common to the doubler. Transfer pass through hole and flange mounting holes to doubler using Plexiglas to trace the location of the holes as necessary from firewall as shown in Figure 4.
