Repair of MRP Sliding Fairing Track Rail Wear Damage

SIKORSKY AIRCRAFT DESIGN RECORD BOOK

Prepared by	<input type="text" value="Steven Morgan"/>	DRB No:	<input type="text" value="2018-SA-92-004"/>
Title	<input type="text" value="Repair of MRP Sliding Fairing Track Rail Wear Damage"/>		
Start Date:	<input type="text" value="2/28/2018"/>	Detail Dwg	<input type="text"/>
End Date:	<input type="text"/>	Assy Dwg	<input type="text"/>
No. Pages:	<input type="text"/>	Related Documents:	(1) <input type="text"/> (3) <input type="text"/>
Model:	<input type="text" value="S92A"/>		(2) <input type="text"/> (4) <input type="text"/>
Keyword: (1)	<input type="text" value="MRP Sliding Fairing"/>	(2)	<input type="text" value="Track Rail"/>

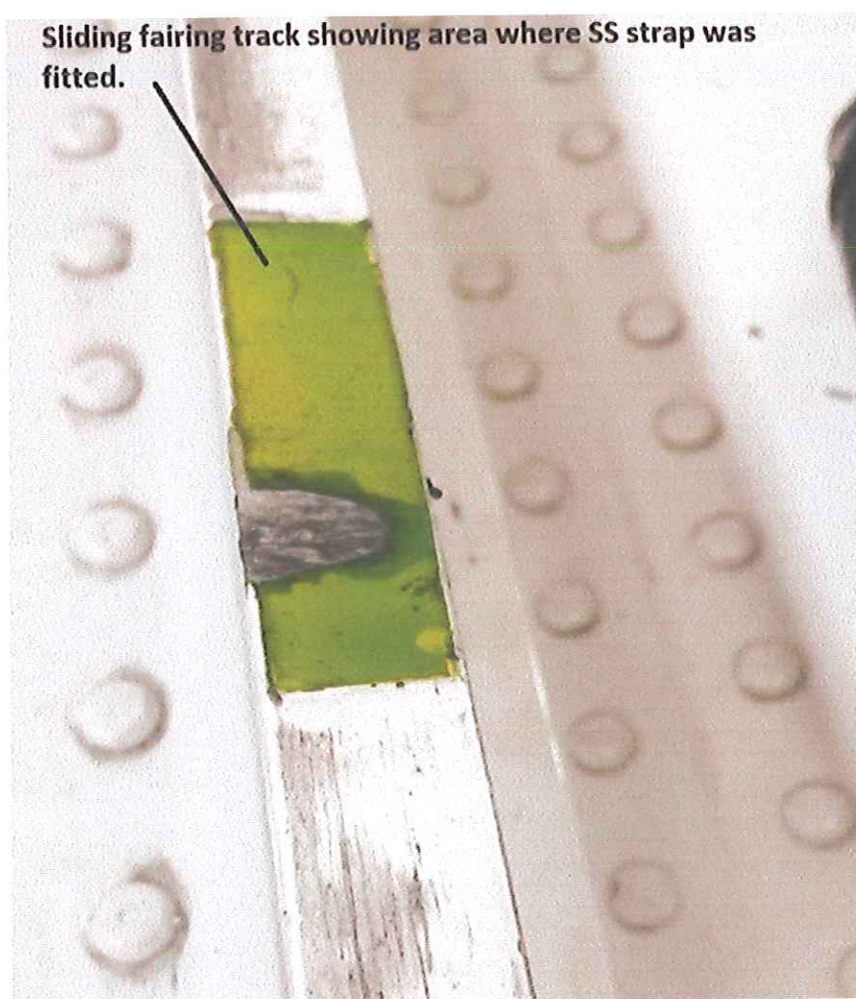
In-flight vibrations of the Main Rotor Sliding Fairing have caused fairing rollers to wear indentations into the sliding fairing tracks on numerous aircraft. The indentations occur under the rollers, in the areas where the rollers rest on the tracks in the closed and latched position.

**Figure 1 – Typical Wear on Sliding Fairing Track Rail
Repaired with a Bonded Doubler per Previous DRB**

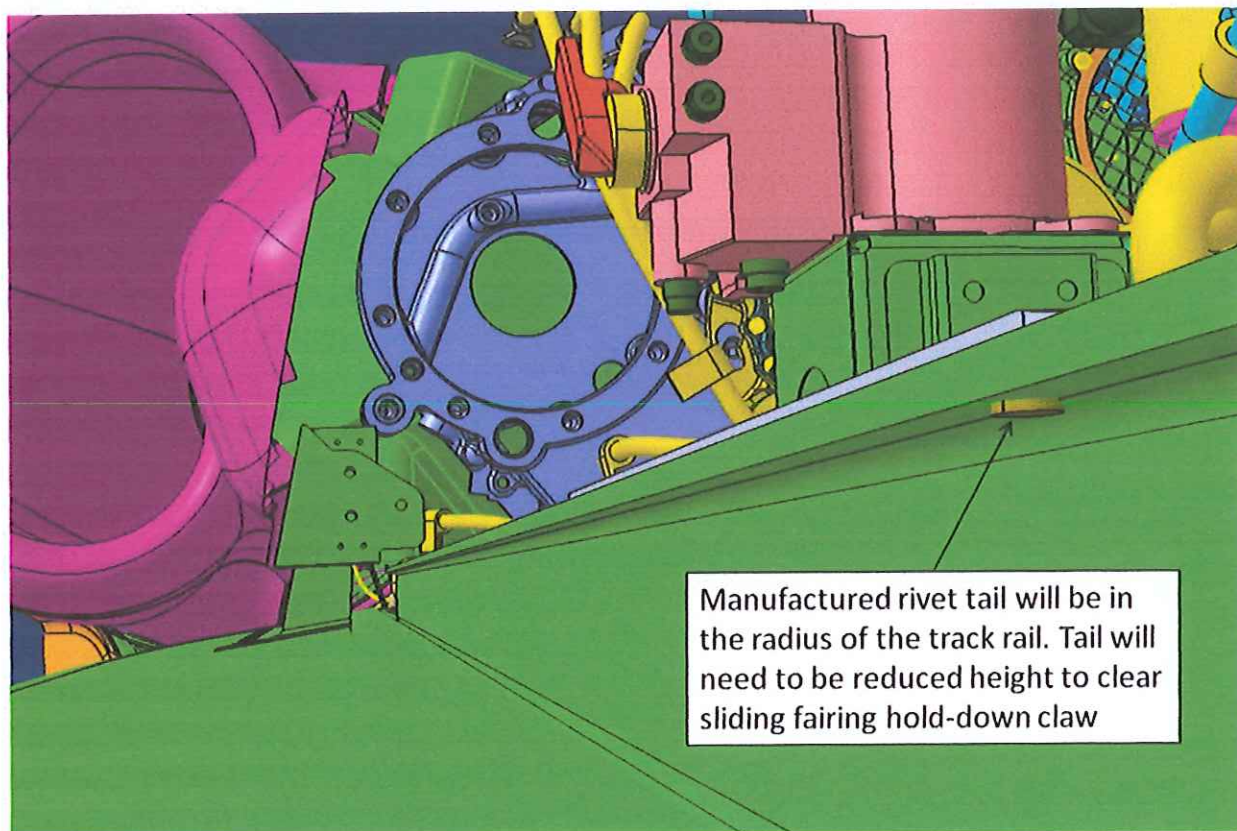
Figure 4 – Retention Rivet Clearance

- a. Use clamps and / or weights to positively hold the wear strips to the track during cure.
 - b. Cut rivets shorter than standard to ensure the manufactured buck tail of the retention rivets are reduced in height to avoid interference. Buck rivets to approximately .030-.050" height.

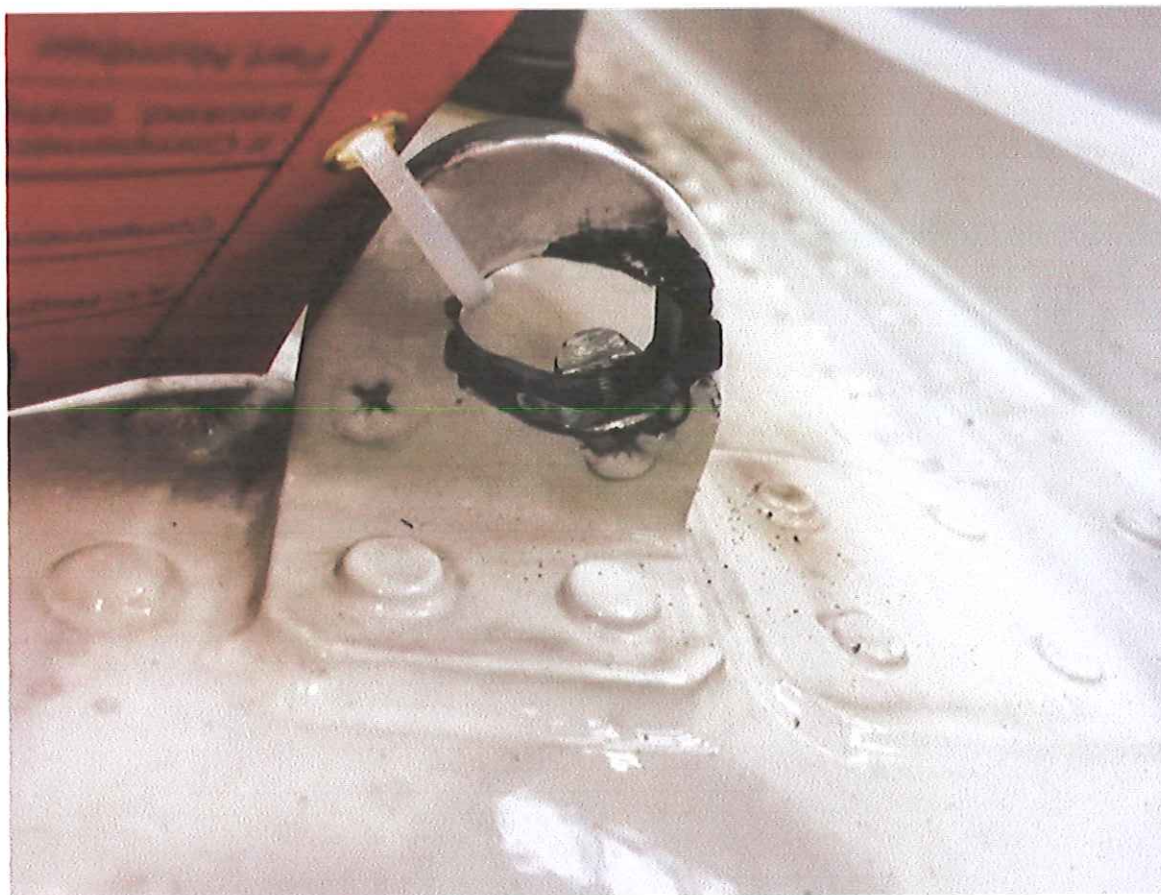
Figure 5 – Extreme Wear on Sliding Fairing Engagement Pin

19. Visually inspect all engagement (dagger) pins on the sliding fairing and their respective airframe bracket receptacles and wear blocks. Refer to Figure 5 for an extreme case of damage for an airframe receptacle. Figure 6 shows frame station locations and installation hardware for the replaceable wear blocks and the airframe bracket receptacles. Bushing part numbers and their acceptable alternative replacement parts are listed below.
