From: McConnell, DAVE P <dave.p.mcconnell@lmco.com>
Sent: Tuesday, September 27, 2016 9:53 AM
To: Liming Qi; Michael Macgowan; Mike Goodman
Cc: Manuel Padurean; Partnumber Management Norway; Grant Robinson
Subject: RE: Clevis spring rod support bracket HS-HTN PN 76400-23514-047

Customer: Thai Aviation Services Limited
Aircraft Serial Number: 760731
Aircraft Model: S-76C++
ATA: 67
Part Number: 76400-23514-047
Case Number: C0041109
Title: Balance Spring Bracket Assembly Hole Elongated

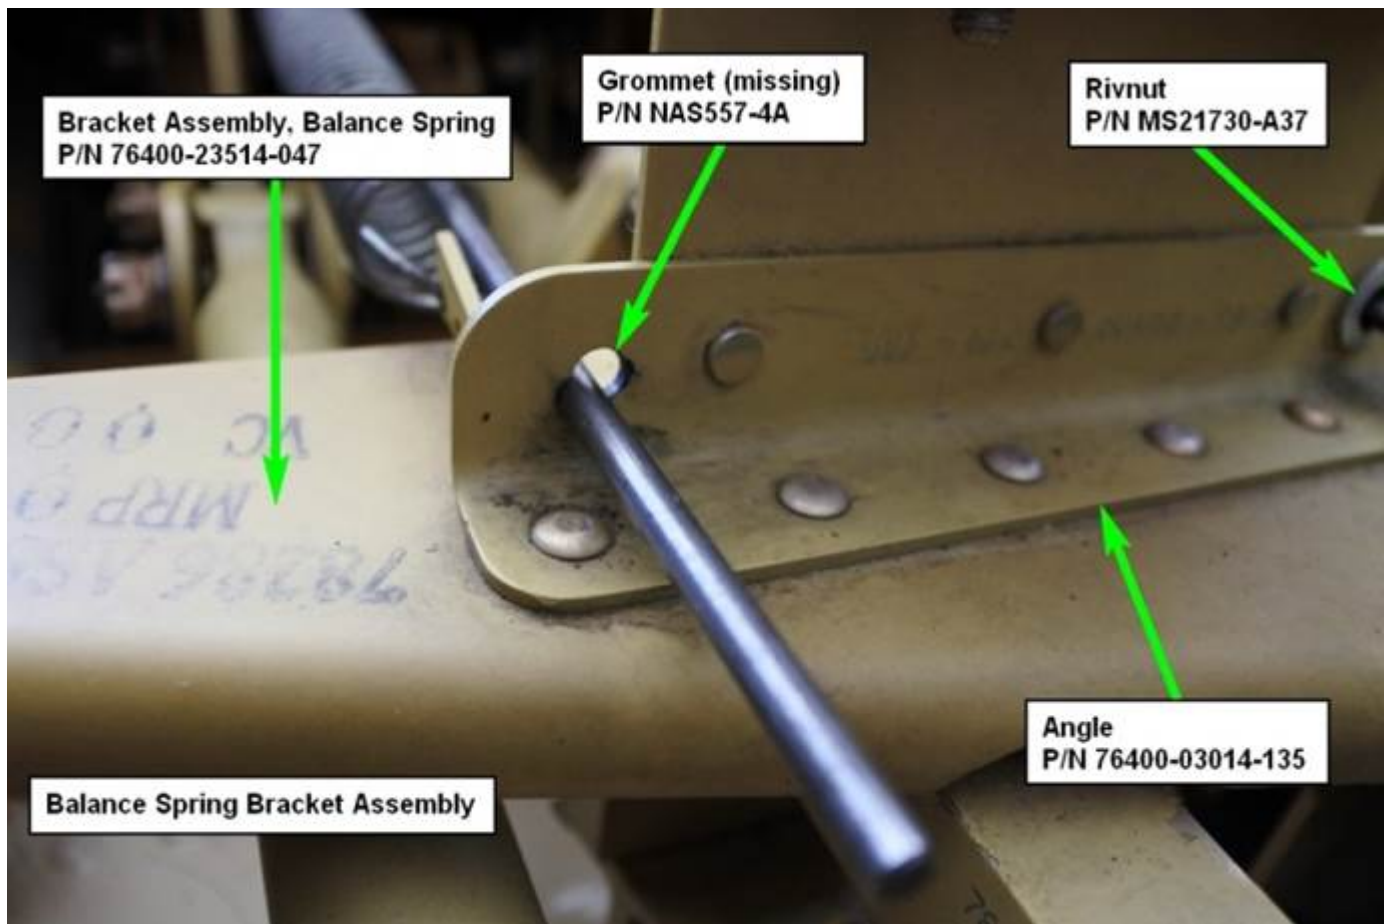
What we are looking at is a P/N 76400-23514-047 Balance Spring Bracket Assembly.

The -047 replaces the -043 and is considered to be the preferred part. I don't know why the -047 still isn't in the IPC but it seems to be a great subject for a SoundOff.

The -047 differs from the -043 in that it has one P/N MS27130-A37 rivnut mounted in the P/N 76400-03014-135 bracket to support the pitch spring rod.

The collective spring rod hole does not use a rivnut. Instead it has one P/N NAS557-4A grommet fitted. Yours is missing.

The wear in the collective spring hole appears to be too great to simply reinstall a new grommet.

Sikorsky will recommend that you order a replacement P/N 76400-23514-047 Balance Spring Bracket Assembly. In the meantime you can continue to operate as long as the collective spring rod isn't in danger of getting stuck in the keyhole slot or contacting the -135 angle. You can clean up the keyhole slot if need be to enable the rod to travel more smoothly.
