Repair of Cracks Found in Float Bottle Support Brackets

<h1 style="margin: 0;">SIKORSKY AIRCRAFT DESIGN RECORD BOOK</h1>				Record NO:
Prepared by Steve Morgan		DRB No: 2017-SA-92-081		
Title Repair of Cracks Found in Float Bottle Support Brackets				
Start Date: 8/4/2017	Detail Dwg 			
End Date: 	Assy Dwg 			
No. Pages: 	Related Documents: (1) (3) 		(2) (4) 	
Model: S-92A				
Keyword: (1) Float Bottle (2) Crack		Hours:

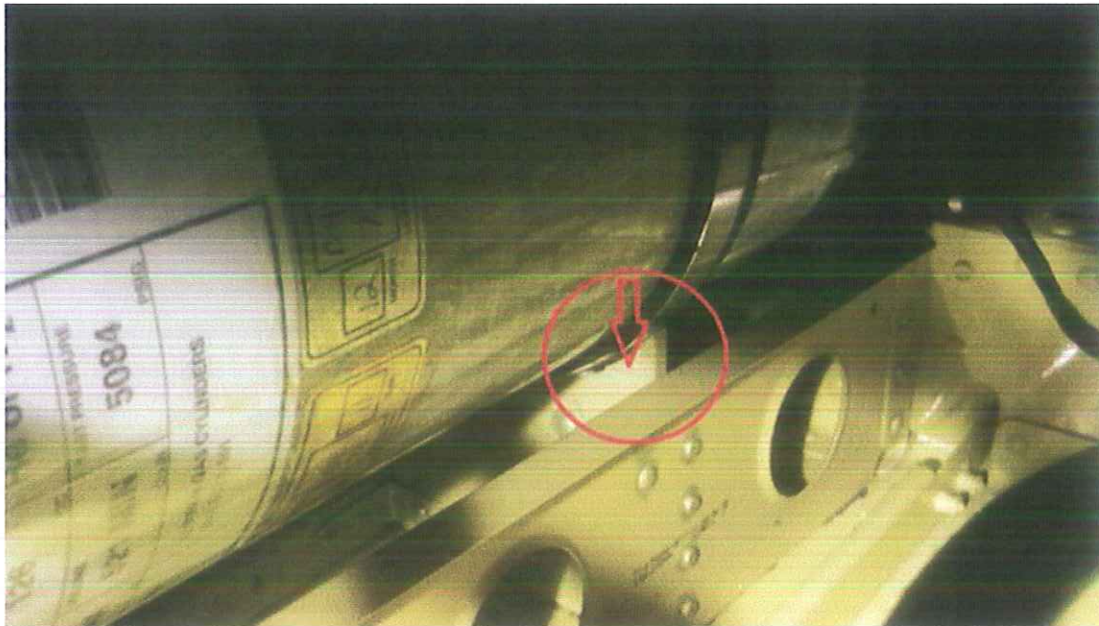
During replacement of rear float assembly the customer found the support bracket for the bottle has a small crack in the corner. Typical cracks in each bracket originate in the upper radius of the inboard attach clip and extend outboard in a downward curve. Ensure cracking does not exceed lengths shown in the Figures below.

Figure 1 – General Location of Crack

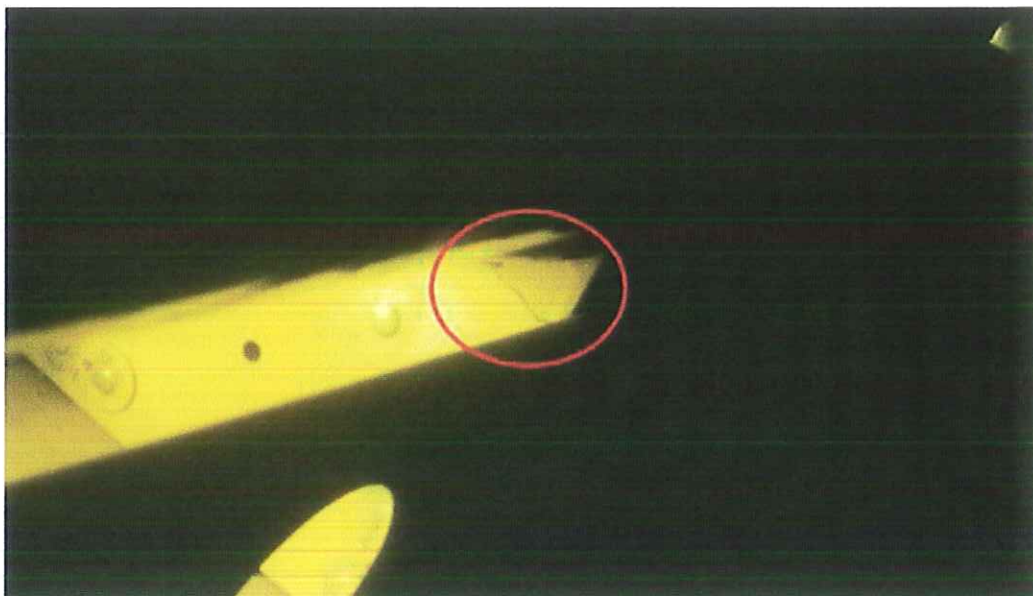
Figure 2 – Crack Location

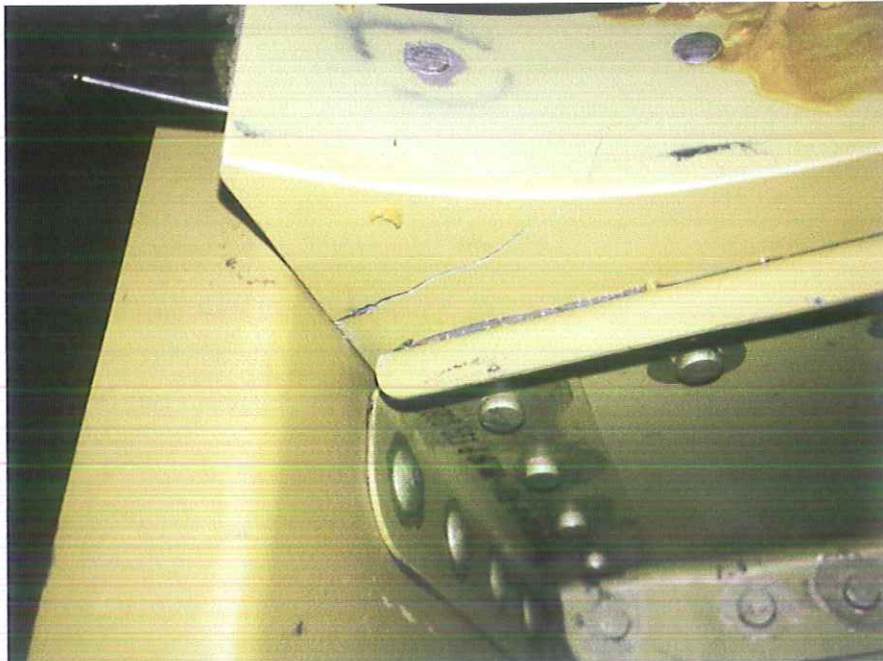
Figure 3 – Looking Down at Crack

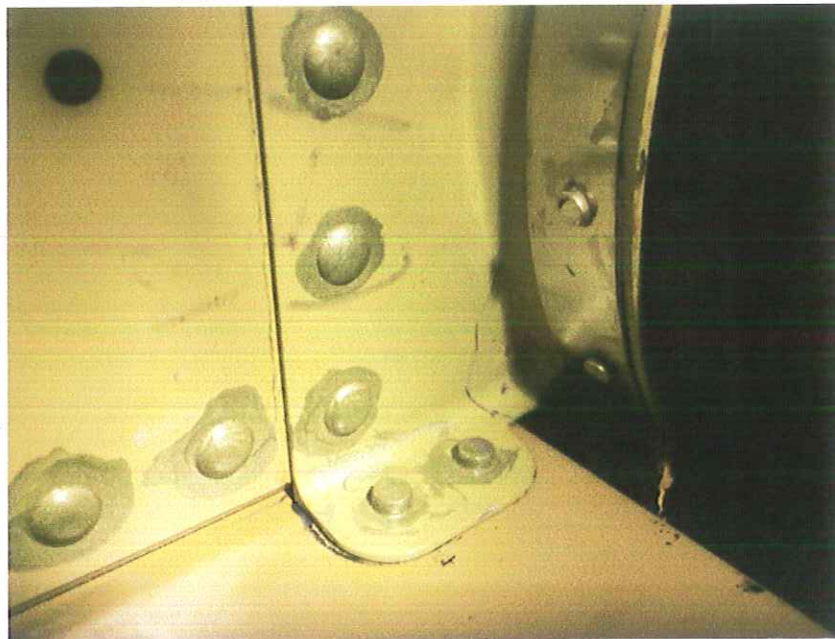
Figure 4 – View Looking Up at Crack
