DRB 2015-SA-76-037

Repair Doubler on RHS Center Firewall

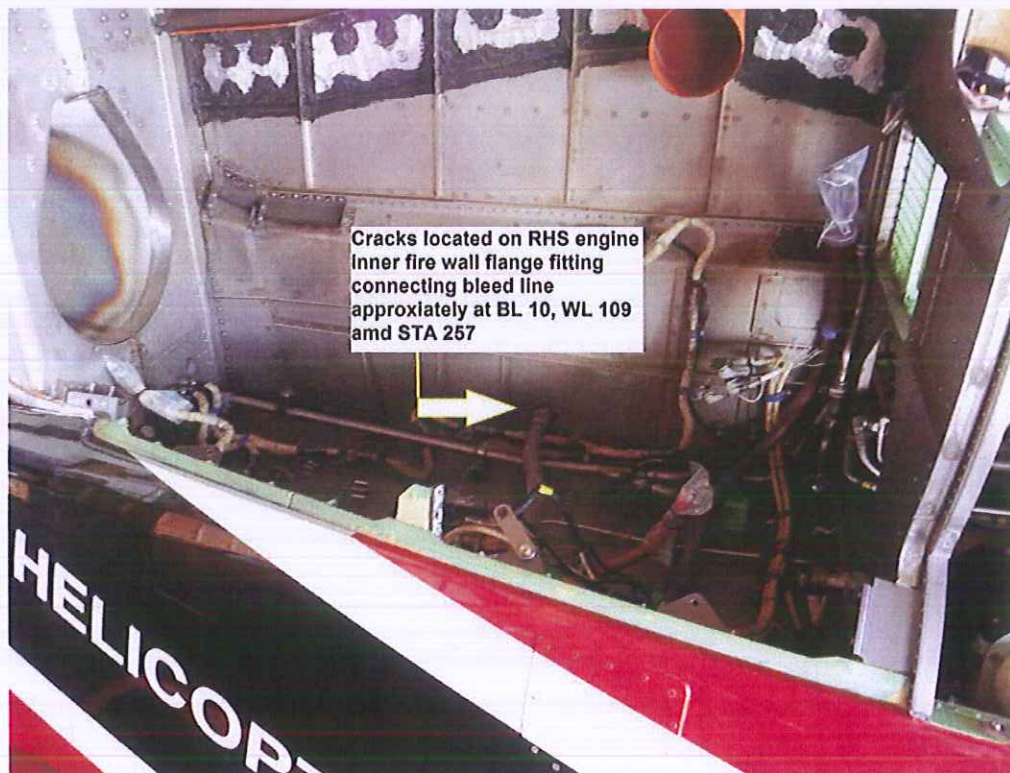
The L/H side panel P/N 76202-77003-130 is cracked on the panel skin and the #1 engine bleed air line attachment flange. The R/H side firewall skin and #2 engine bleed air line attachment flange are cracked also (R/H side attachment area differs from the L/H side, as the R/H side firewall does not have a removable panel at the bleed air line attachment flange). See attached photos for reference. Customer reports the flanges on the P/N 7435-1 "Y" pipe are cracked as well (photos have not been provided as of yet. FTR will be updates with "Y" tube photos when available).

Figure 1 Crack on RHS Center Firewall At Y-tube Flange

The recommended repair procedure for the right hand side is to stop-drill the crack and install a repair doubler as shown in Figure 5. The removable panel on the left hand side that is cracked will be removed and replaced with a new panel.

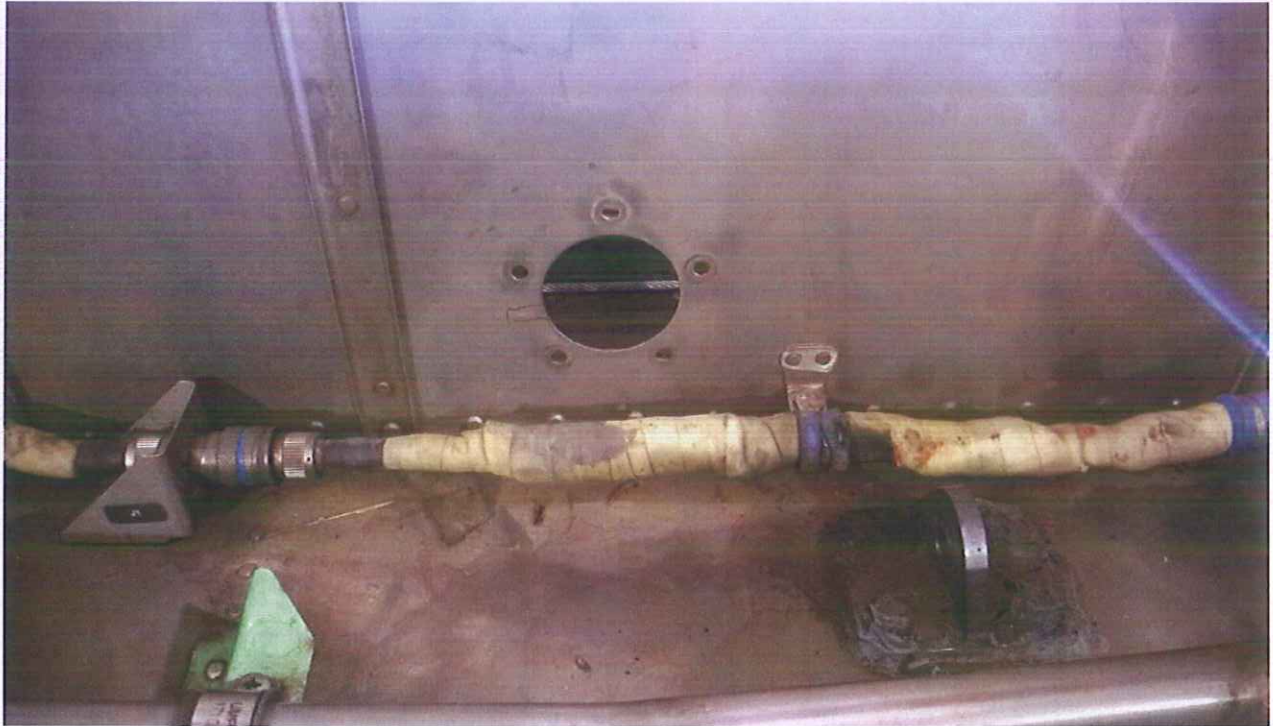
Figure 2 Crack in Firewall at Y-Tube Flange

6. Stop drill crack tip using a 0.098" diameter drill. Be careful not to damage any additional structure, wiring, hoses, etc. in this area. Deburr the holes. Vacuum the area to remove loose particles.

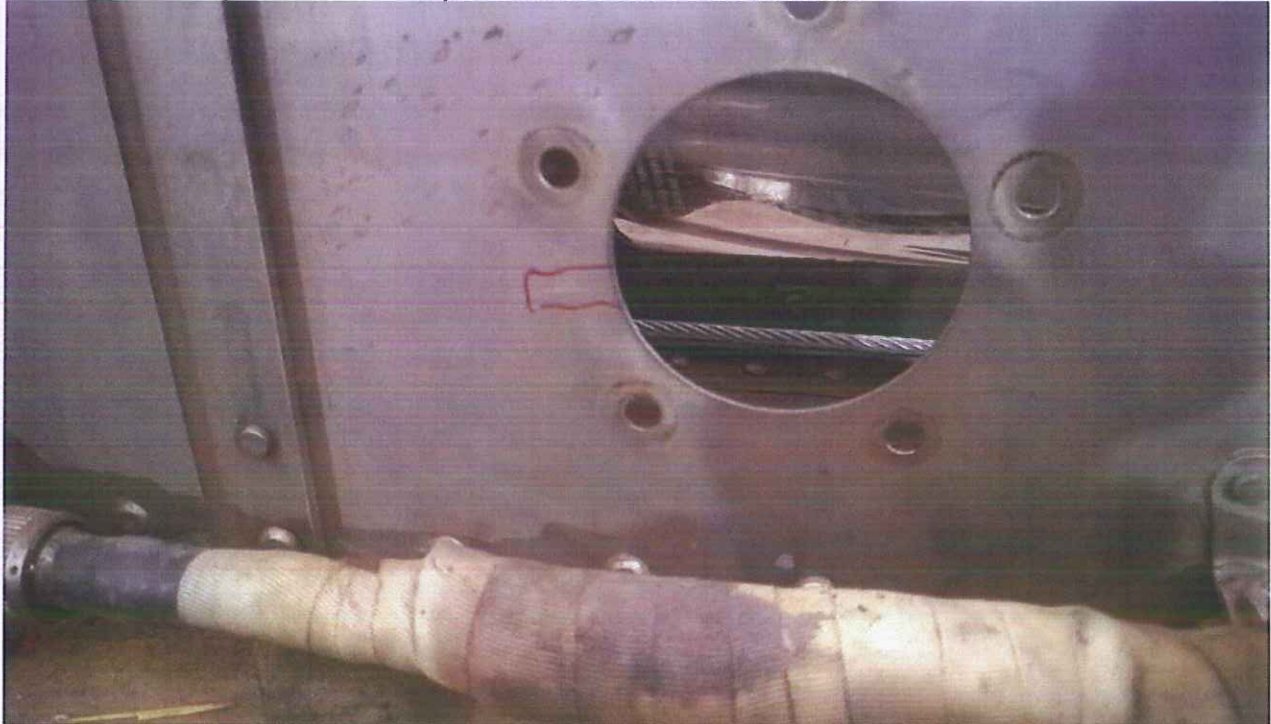
Figure 3 Tank Panel Damage

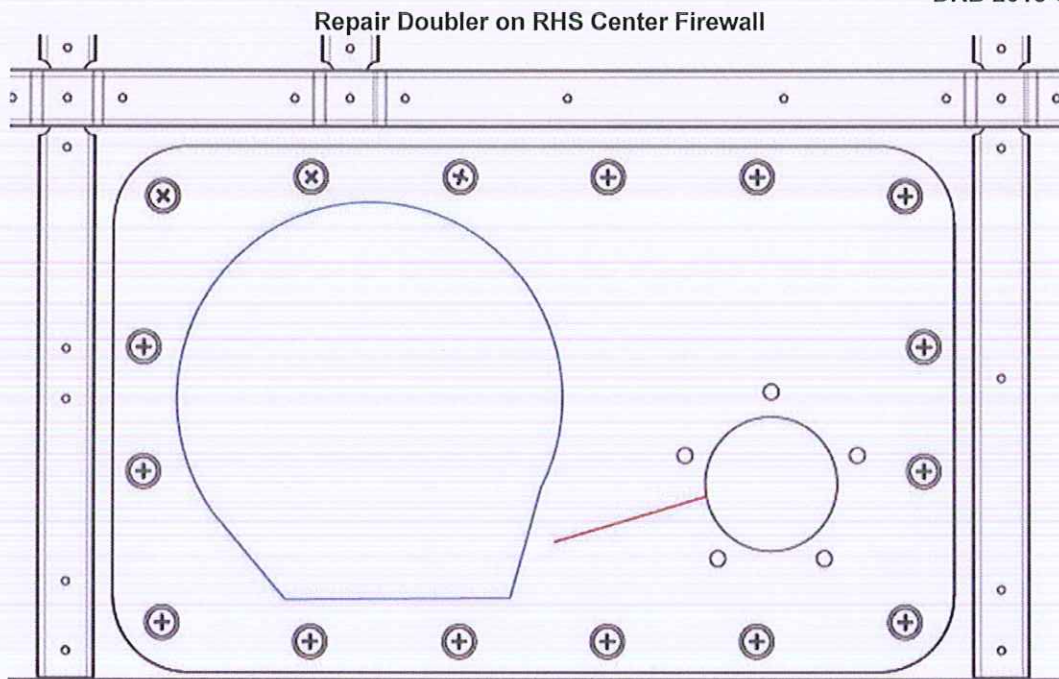
Figure 4: Doubler Fabricated from Cracked Access Cover

10. Fabricate a reinforcement ring doubler from cracked access panel approximately as shown in Figure 4. Reorient as necessary to avoid crack and existing fastener holes. The doubler will be centered on the Y-tube pass through hole on the outboard side of the RHS firewall as shown in Figure 5. The doubler shall be sized to allow a staggered row of 1/8" fasteners, maintaining 2D edge distance and a minimum of 4D pitch on the fasteners. Corner radii shall be 0.190" minimum. Deburr the edges of the doubler. Avoid Crack and existing fastener holes.

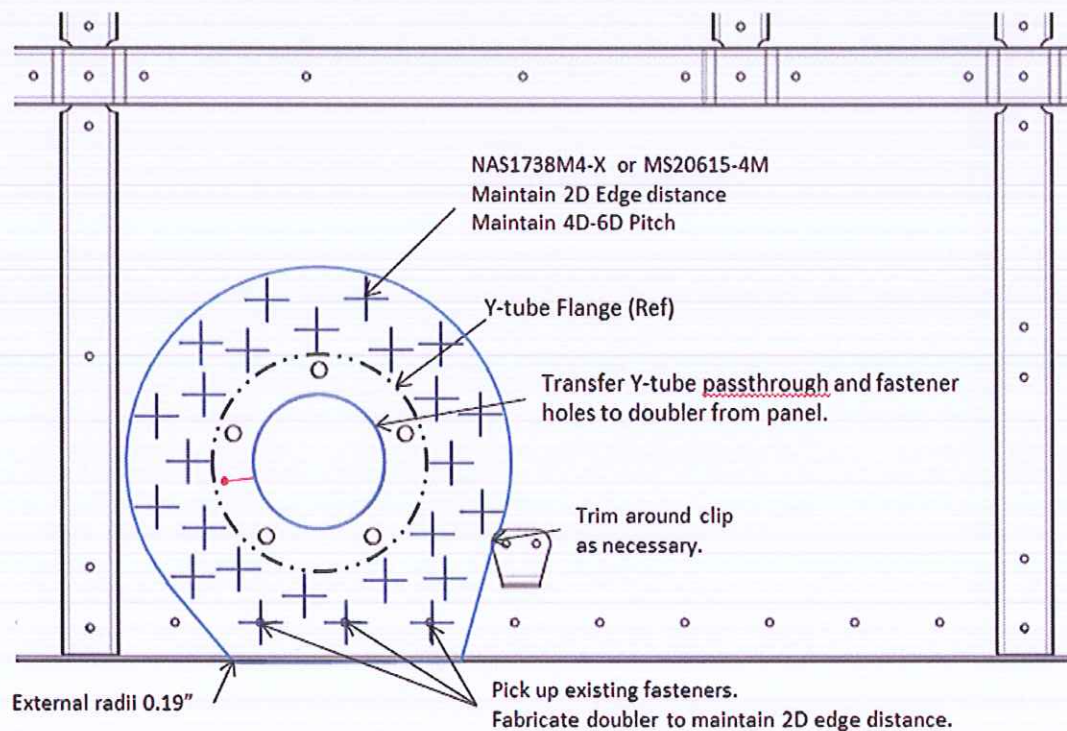
Figure 5: Doubler Installed Around RHS Y-Tube Pass Through

Results: <p>The recommended repair procedure for the right hand side is to stop-drill the crack and install a repair doubler as shown in Figure 5. The removable panel on the left hand side will be replaced with a new panel.</p> <p>The repair procedure is outlined in this DRB. For FAA purposes, this repair is considered "minor".</p>	
Assigned: J. Scheib	Approval: John W. Scheib
Approve Date: 08/29/2015

4. Remove lower cap fasteners that will be picked up as shown in Figure 5
5. Abrade the firewall panel in the repair area to clean titanium substrate, using scotch-brite abrasive mat, MIL-A-9962.

11. Temporarily locate the arc doubler in place. Back drill any removed fastener locations that would be common to the doubler. Transfer pass through hole and flange mounting holes to doubler from firewall as shown in Figure 5.
